# Manhole Inspection Report

Date:	<b>10/07/2022</b>	Weather:		Coding:	<b>RZMACP</b>
MH#:	<b>M-703-001</b>	Owner:	<b>NA</b>	Len. Surveyed:	<b>6.6</b>
P.O.#:		Surveyor:	<b>Jen Costello</b>	Rim to Invert:	<b>7.8</b>
Customer:		Cert. #:	<b>U-907-5518</b>	Wall Material:	<b>Concrete (cast in place)</b>

Street:	<b>Intersection of North Pheasant Run</b>	Project:	<b>Hobart, IN</b>
City:	<b>Hobart, IN</b>	GPS Northing:	<b>2294199.089</b>
Location:	<b>Other</b>	GPS Easting:	<b>2904561.631</b>
Drain Area:	<b>North</b>	GPS Accuracy:	<b>Sub-Meter</b>
Cover Shape:	<b>Circular</b>	Evidence of Surcharge:	<b>No</b>
Cover Size:	<b>24.0</b>	Potential for Runoff:	<b>None</b>
Comments:

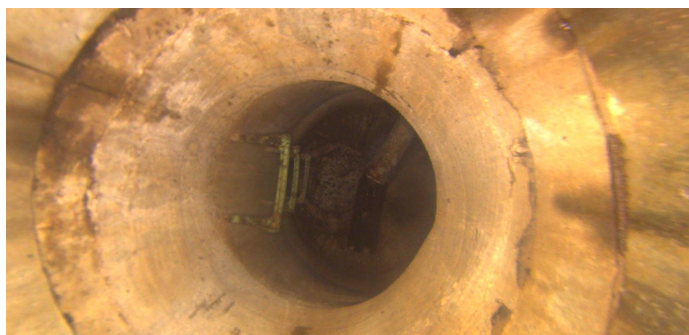
Code: **MGO**  
Description: **General Observation**

Distance (ft): **.0**  
Structural Grade: **0**  
O&M Grade: **0**  
Clock Start/From:  
Clock To:  
1st Value:  
2nd Value:  
Value Percent:  
Step: **NO**  
Remarks: **access mh**

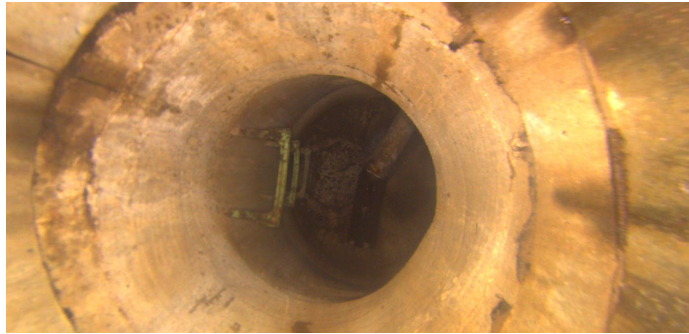
Code: **SRI**  
Description: **Surface Roughness Increased**

Distance (ft): **.0**  
Structural Grade: **1**  
O&M Grade: **0**  
Clock Start/From: **12**  
Clock To: **12**  
1st Value:  
2nd Value:  
Value Percent:  
Step: **NO**  
Remarks:

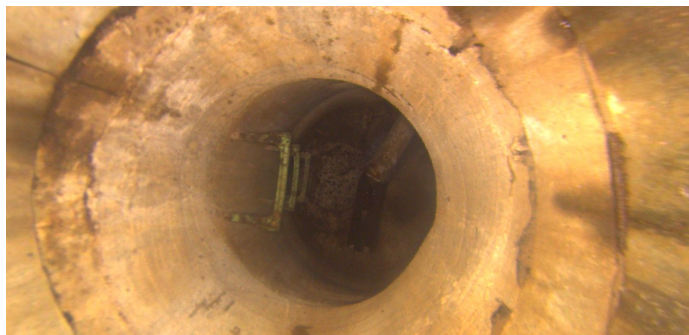
Code: **IW**  
Description: **Infil Weeper**

Distance (ft): **.0**  
Structural Grade: **0**  
O&M Grade: **2**  
Clock Start/From: **12**  
Clock To: **12**  
1st Value:  
2nd Value:  
Value Percent:  
Step: **NO**  
Remarks:

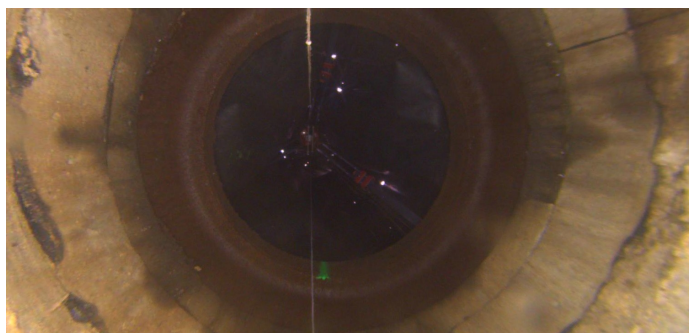
Code: **MGO**  
Description: **General Observation**

Distance (ft): **2.1**  
Structural Grade: **0**  
O&M Grade: **0**  
Clock Start/From:  
Clock To:  
1st Value:  
2nd Value:  
Value Percent:  
Step: **NO**  
Remarks: **underside of frame**

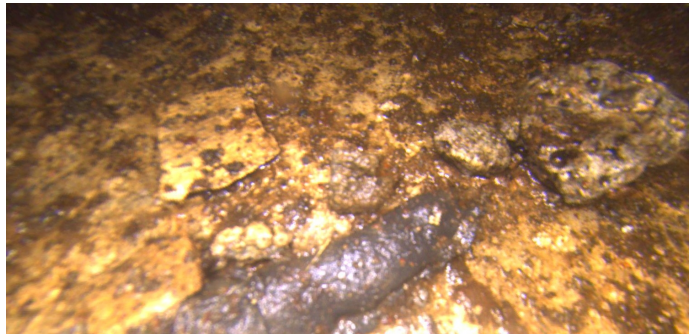
Code: **DSF**  
Description: **Deposits Settled Fine**

Distance (ft): **6.6**  
Structural Grade: **0**  
O&M Grade: **2**  
Clock Start/From: **12**  
Clock To: **12**  
1st Value:  
2nd Value:  
Value Percent: **5.000**  
Step: **NO**  
Remarks:

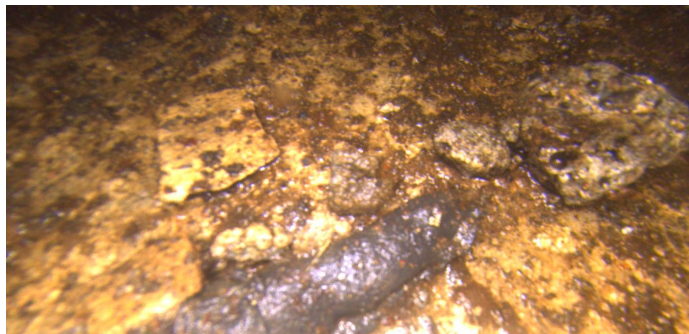
Code: **SRI**  
Description: **Surface Roughness Increased**

Distance (ft): **6.6**  
Structural Grade: **1**  
O&M Grade: **0**  
Clock Start/From: **12**  
Clock To: **12**  
1st Value:  
2nd Value:  
Value Percent:  
Step: **NO**  
Remarks:

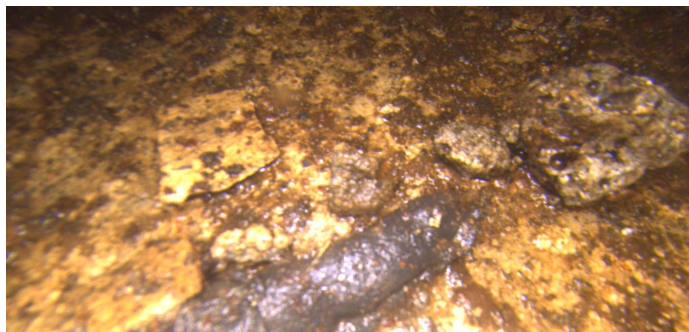
Code: **MGO**  
Description: **General Observation**

Distance (ft): **6.6**  
Structural Grade: **0**  
O&M Grade: **0**  
Clock Start/From:  
Clock To:  
1st Value:  
2nd Value:  
Value Percent:  
Step: **NO**  
Remarks: **end of survey**
