# Manhole Inspection Report

Date:	<b>03/26/2018</b>	Weather:		Coding:	<b>RZMACP</b>
MH#:	<b>M-703-003</b>	Owner:	<b>NA</b>	Len. Surveyed:	<b>9.0</b>
P.O.#:		Surveyor:	<b>John Kuglmaier</b>	Rim to Invert:	<b>9.9</b>
Customer:		Cert. #:	<b>U-1215-07002349</b>	Wall Material:	<b>Concrete (reinforced)</b>

Street:	<b>East Pheasant Run Dr. 583' West of</b>	Project:	<b>Hobart, IN</b>
City:	<b>Hobart, IN</b>	GPS Northing:	<b>0.0</b>
Location:		GPS Easting:	<b>0.0</b>
Drain Area:	<b>North</b>	GPS Accuracy:	<b>Nearest Meter</b>
Cover Shape:	<b>Circular</b>	Evidence of Surcharge:	<b>No</b>
Cover Size:	<b>23.0</b>	Potential for Runoff:	<b>None</b>
Comments:

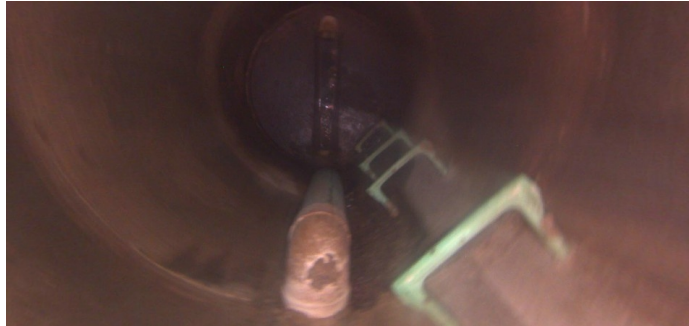
Code: **IS**  
Description: **Infil Stain**

Distance (ft): **2.0**  
Structural Grade: **0**  
O&M Grade: **0**  
Clock Start/From: **6**  
Clock To:  
1st Value:  
2nd Value:  
Value Percent:  
Step: **NO**  
Remarks:

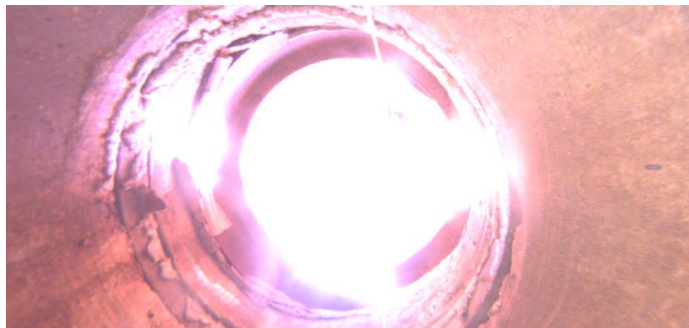
Code: **MGP**  
Description: **General Photo**

Distance (ft): **2.5**  
Structural Grade: **0**  
O&M Grade: **0**  
Clock Start/From:  
Clock To:  
1st Value:  
2nd Value:  
Value Percent:  
Step: **NO**  
Remarks:

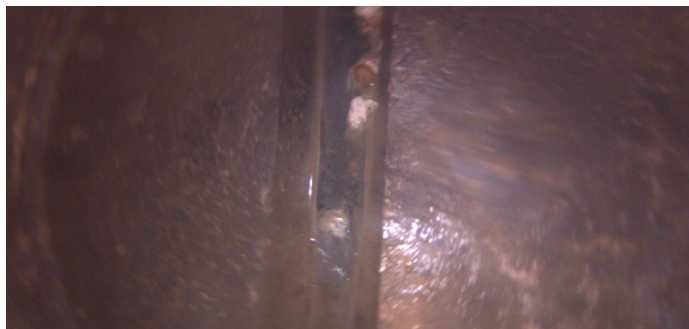
Code: **MGO**  
Description: **General Observation**

Distance (ft): **7.8**  
Structural Grade: **0**  
O&M Grade: **0**  
Clock Start/From:  
Clock To:  
1st Value:  
2nd Value:  
Value Percent:  
Step: **NO**  
Remarks: **Ins. Comp.**
