Manhole Inspection Report

Date:	03/26/2018	Weather:		Coding:	RZMACP
MH#:	M-703-004	Owner:	NA	Len. Surveyed:	9.5
P.O.#:		Surveyor:	John Kuglmaier	Rim to Invert:	11.2
Customer:		Cert. #:	U-1215-07002349	Wall Material:	Concrete (reinforced)

Street:	East Pheasant Run Dr. 284' West of	Project:	Hobart, IN
City:	Hobart, IN	GPS Northing:	0.0
Location:		GPS Easting:	0.0
Drain Area:	North	GPS Accuracy:	Nearest Meter
Cover Shape:	Circular	Evidence of Surcharge:	No
Cover Size:	23.0	Potential for Runoff:	None
Comments:

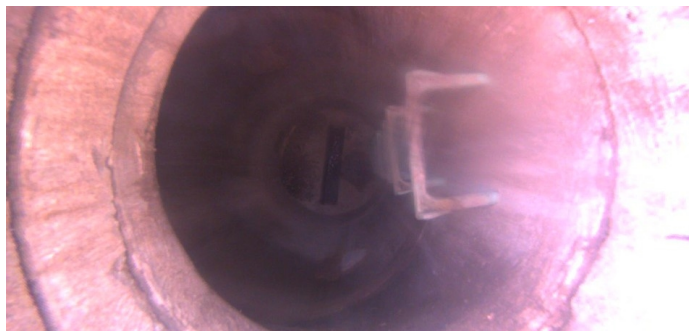
Code: **MGP**
Description: **General Photo**

Distance (ft): **.0**
Structural Grade: **0**
O&M Grade: **0**
Clock Start/From:
Clock To:
1st Value:
2nd Value:
Value Percent:
Step: **NO**
Remarks:

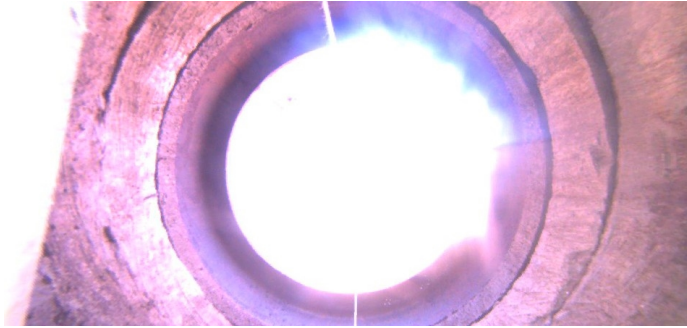
Code: **MGP**
Description: **General Photo**

Distance (ft): **2.2**
Structural Grade: **0**
O&M Grade: **0**
Clock Start/From:
Clock To:
1st Value:
2nd Value:
Value Percent:
Step: **NO**
Remarks:

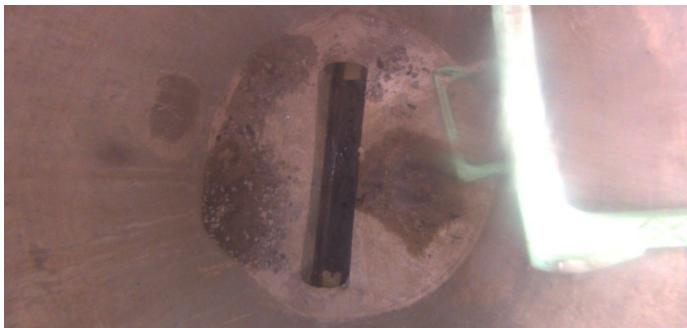
Code: **DSGV**
Description: **Deposits Settled Gravel**

Distance (ft): **6.9**
Structural Grade: **0**
O&M Grade: **2**
Clock Start/From: **7**
Clock To: **11**
1st Value:
2nd Value:
Value Percent: **5.000**
Step: **NO**
Remarks:

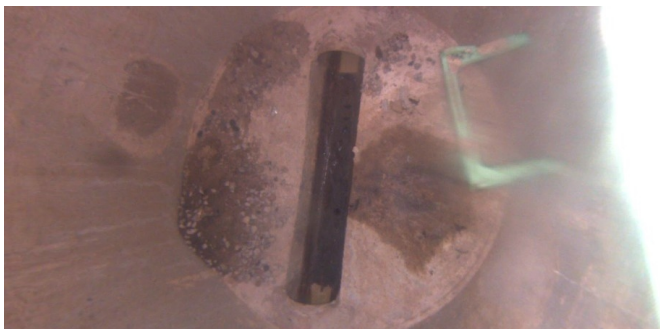
Code: **MGO**
Description: **General Observation**

Distance (ft): **7.3**
Structural Grade: **0**
O&M Grade: **0**
Clock Start/From:
Clock To:
1st Value:
2nd Value:
Value Percent:
Step: **NO**
Remarks: **Ins. Comp.**
