# Manhole Inspection Report

Date:	<b>03/26/2018</b>	Weather:		Coding:	<b>RZMACP</b>
MH#:	<b>M-703-007</b>	Owner:	<b>NA</b>	Len. Surveyed:	<b>11.9</b>
P.O.#:		Surveyor:	<b>John Kuglmaier</b>	Rim to Invert:	<b>14.4</b>
Customer:		Cert. #:	<b>U-1215-07002349</b>	Wall Material:	<b>Concrete (reinforced)</b>

Street:	<b>275' South of Deerpath Crt. 45' East</b>	Project:	<b>Hobart, IN</b>
City:	<b>Hobart, IN</b>	GPS Northing:	<b>0.0</b>
Location:		GPS Easting:	<b>0.0</b>
Drain Area:	<b>North</b>	GPS Accuracy:	<b>Nearest Meter</b>
Cover Shape:	<b>Circular</b>	Evidence of Surcharge:	<b>No</b>
Cover Size:	<b>23.0</b>	Potential for Runoff:	<b>None</b>
Comments:

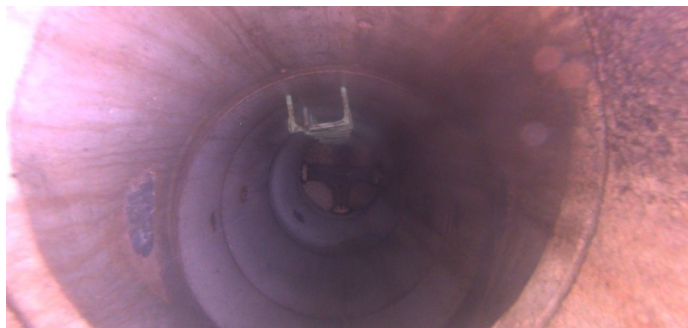
Code: **MGP**  
Description: **General Photo**

Distance (ft): **.0**  
Structural Grade: **0**  
O&M Grade: **0**  
Clock Start/From:  
Clock To:  
1st Value:  
2nd Value:  
Value Percent:  
Step: **NO**  
Remarks:

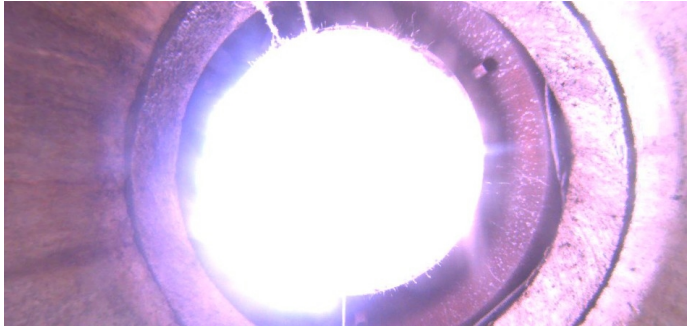
Code:	<b>MGP</b>
Description:	<b>General Photo</b>
Distance (ft):	<b>2.1</b>
Structural Grade:	<b>0</b>
O&M Grade:	<b>0</b>
Clock Start/From:	
Clock To:	
1st Value:	
2nd Value:	
Value Percent:	
Step:	<b>NO</b>
Remarks:

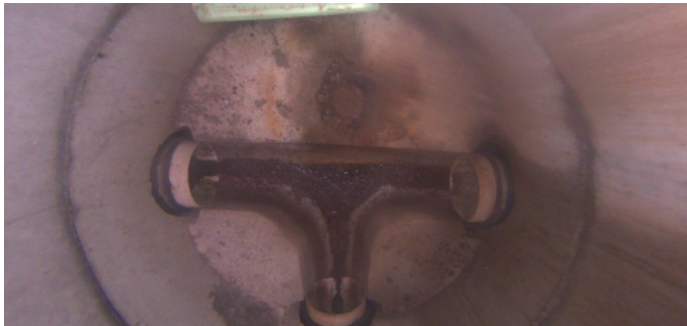
Code:	<b>MGO</b>
Description:	<b>General Observation</b>
Distance (ft):	<b>10.4</b>
Structural Grade:	<b>0</b>
O&M Grade:	<b>0</b>
Clock Start/From:	
Clock To:	
1st Value:	
2nd Value:	
Value Percent:	
Step:	<b>NO</b>
Remarks:	<b>Ins. Comp.</b>
