Manhole Inspection Report

Date:	03/26/2018	Weather:		Coding:	RZMACP
MH#:	M-703-008	Owner:	NA	Len. Surveyed:	9.7
P.O.#:		Surveyor:	John Kuglmaier	Rim to Invert:	11.3
Customer:		Cert. #:	U-1215-07002349	Wall Material:	Concrete (reinforced)

Street:	Pheasant Run Dr. 378' East of Edgewood	Project:	Hobart, IN
City:	Hobart, IN	GPS Northing:	0.0
Location:		GPS Easting:	0.0
Drain Area:	North	GPS Accuracy:	Nearest Meter
Cover Shape:	Circular	Evidence of Surcharge:	No
Cover Size:	23.0	Potential for Runoff:	None
Comments:

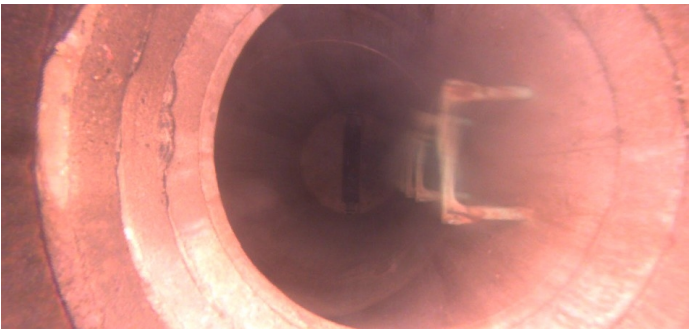
Code: **MGP**
Description: **General Photo**

Distance (ft): **.0**
Structural Grade: **0**
O&M Grade: **0**
Clock Start/From:
Clock To:
1st Value:
2nd Value:
Value Percent:
Step: **NO**
Remarks:

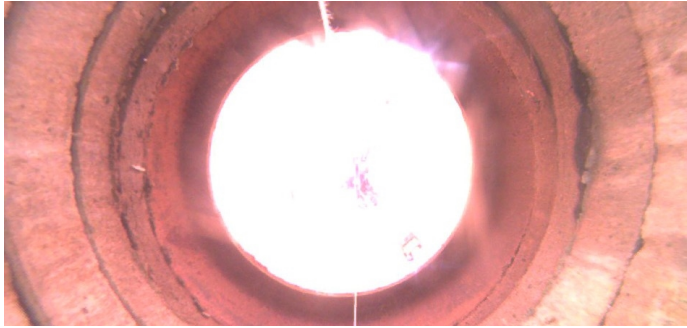
Code:	MGP
Description:	General Photo
Distance (ft):	2.0
Structural Grade:	0
O&M Grade:	0
Clock Start/From:	
Clock To:	
1st Value:	
2nd Value:	
Value Percent:	
Step:	NO
Remarks:

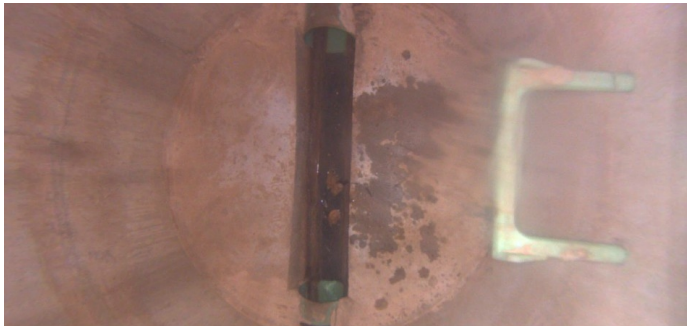
Code:	MGO
Description:	General Observation
Distance (ft):	7.5
Structural Grade:	0
O&M Grade:	0
Clock Start/From:	
Clock To:	
1st Value:	
2nd Value:	
Value Percent:	
Step:	NO
Remarks:	Ins. Comp.
