Manhole Inspection Report

Date:	03/26/2018	Weather:		Coding:	RZMACP
MH#:	M-703-009	Owner:	NA	Len. Surveyed:	8.4
P.O.#:		Surveyor:	John Kuglmaier	Rim to Invert:	10.3
Customer:		Cert. #:	U-1215-07002349	Wall Material:	Concrete (reinforced)

Street:	291' West of Quail Dr.	Project:	Hobart, IN
City:	Hobart, IN	GPS Northing:	0.0
Location:		GPS Easting:	0.0
Drain Area:	North	GPS Accuracy:	Nearest Meter
Cover Shape:	Circular	Evidence of Surcharge:	No
Cover Size:	23.0	Potential for Runoff:	None
Comments:

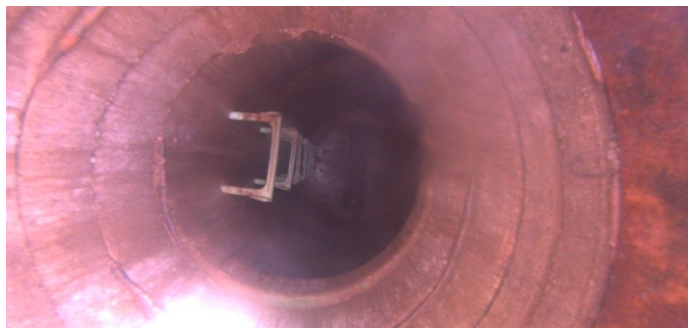
Code: **MGP**
Description: **General Photo**

Distance (ft): **.0**
Structural Grade: **0**
O&M Grade: **0**
Clock Start/From:
Clock To:
1st Value:
2nd Value:
Value Percent:
Step: **NO**
Remarks:

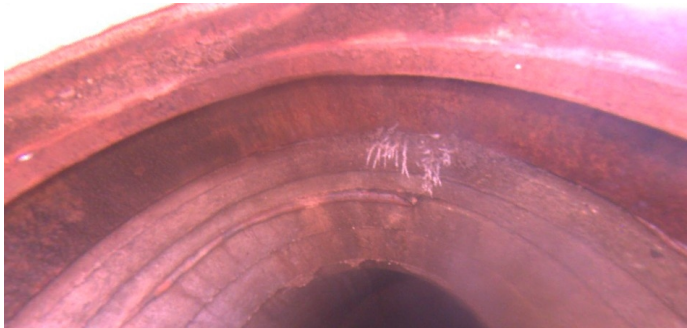
Code: **RFJ**
Description: **Roots Fine Joint**

Distance (ft): **.0**
Structural Grade: **0**
O&M Grade: **1**
Clock Start/From: **1**
Clock To:
1st Value:
2nd Value:
Value Percent:
Step: **NO**
Remarks:

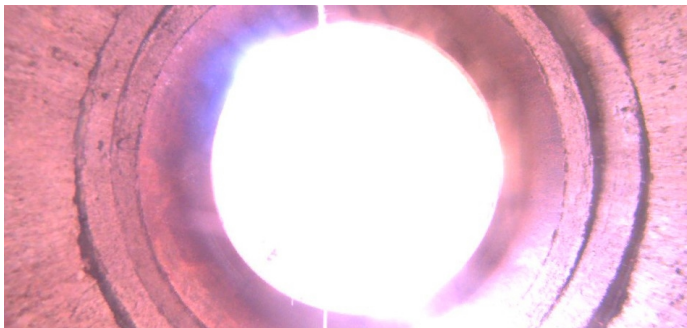
Code: **MGP**
Description: **General Photo**

Distance (ft): **2.0**
Structural Grade: **0**
O&M Grade: **0**
Clock Start/From:
Clock To:
1st Value:
2nd Value:
Value Percent:
Step: **NO**
Remarks:

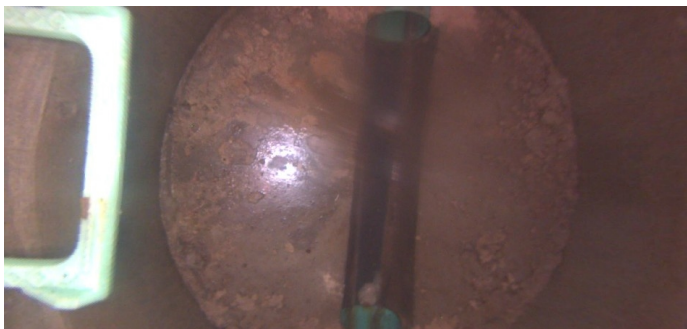
Code: **MGO**
Description: **General Observation**

Distance (ft): **7.1**
Structural Grade: **0**
O&M Grade: **0**
Clock Start/From:
Clock To:
1st Value:
2nd Value:
Value Percent:
Step: **NO**
Remarks: **Ins. Comp.**
