Manhole Inspection Report

Date:	03/26/2018	Weather:		Coding:	RZMACP
MH#:	M-703-010	Owner:	NA	Len. Surveyed:	6.6
P.O.#:		Surveyor:	John Kuglmaier	Rim to Invert:	8.0
Customer:		Cert. #:	U-1215-07002349	Wall Material:	Concrete (reinforced)

Street:	28' East of Quail Dr.	Project:	Hobart, IN
City:	Hobart, IN	GPS Northing:	0.0
Location:		GPS Easting:	0.0
Drain Area:	North	GPS Accuracy:	Nearest Meter
Cover Shape:	Circular	Evidence of Surcharge:	No
Cover Size:	23.0	Potential for Runoff:	None
Comments:

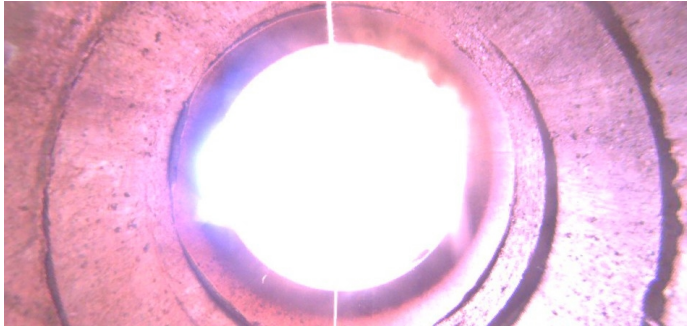
Code: **MGP**
Description: **General Photo**

Distance (ft): **2.2**
Structural Grade: **0**
O&M Grade: **0**
Clock Start/From:
Clock To:
1st Value:
2nd Value:
Value Percent:
Step: **NO**
Remarks:

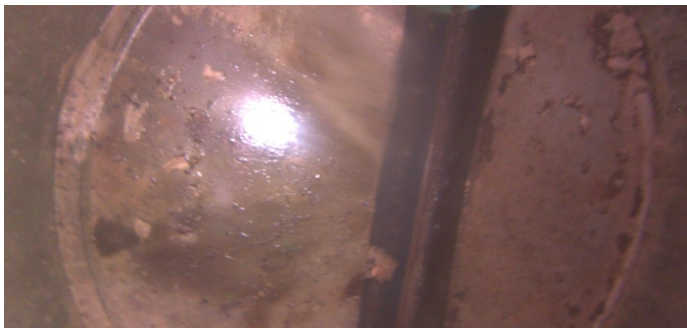
Code: **MGO**
Description: **General Observation**

Distance (ft): **5.7**
Structural Grade: **0**
O&M Grade: **0**
Clock Start/From:
Clock To:
1st Value:
2nd Value:
Value Percent:
Step: **NO**
Remarks: **Ins. Comp.**
