Manhole Inspection Report

Date:	10/07/2022	Weather:		Coding:	RZMACP
MH#:	M-703-014	Owner:	NA	Len. Surveyed:	4.0
P.O.#:		Surveyor:	Jen Costello	Rim to Invert:	5.3
Customer:		Cert. #:	U-907-5518	Wall Material:	Concrete (cast in place)

Street:	Quail Dr. 619' East of Edgewater Dr.	Project:	Hobart, IN
City:	Hobart, IN	GPS Northing:	2293876.802
Location:	Other	GPS Easting:	2906275.447
Drain Area:	North	GPS Accuracy:	Sub-Meter
Cover Shape:	Circular	Evidence of Surcharge:	Yes
Cover Size:	24.0	Potential for Runoff:	None
Comments:

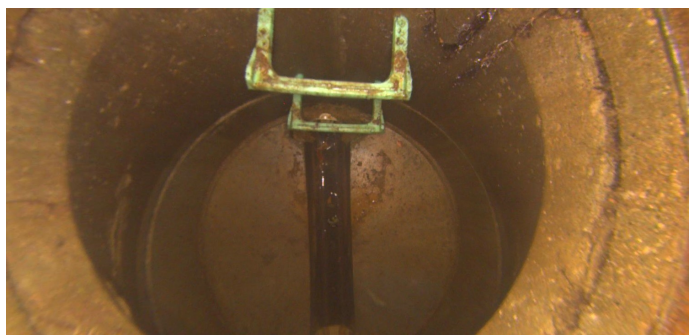
Code: **MGO**
Description: **General Observation**

Distance (ft): **.0**
Structural Grade: **0**
O&M Grade: **0**
Clock Start/From:
Clock To:
1st Value:
2nd Value:
Value Percent:
Step: **NO**
Remarks: **access mh**

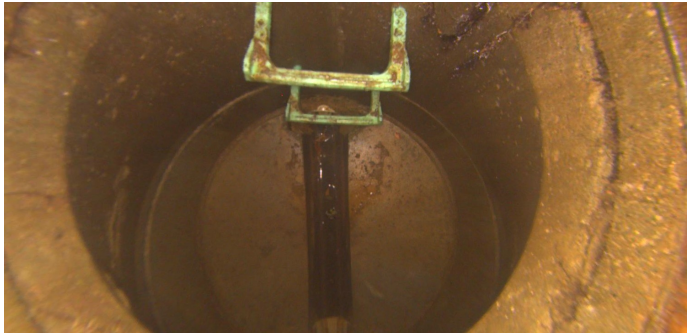
Code: **SRI**
Description: **Surface Roughness Increased**

Distance (ft): **.0**
Structural Grade: **1**
O&M Grade: **0**
Clock Start/From: **12**
Clock To: **12**
1st Value:
2nd Value:
Value Percent:
Step: **NO**
Remarks:

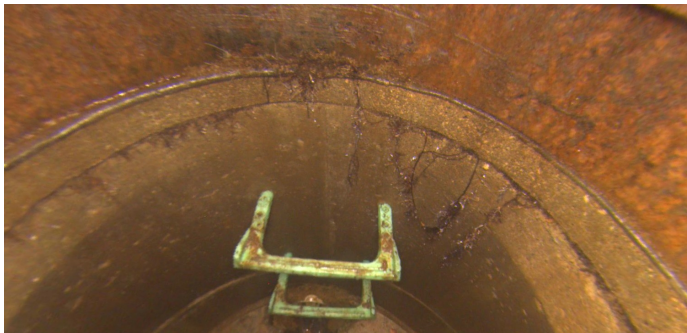
Code: **RFJ**
Description: **Roots Fine Joint**

Distance (ft): **.0**
Structural Grade: **0**
O&M Grade: **1**
Clock Start/From: **10**
Clock To: **2**
1st Value:
2nd Value:
Value Percent:
Step: **NO**
Remarks:

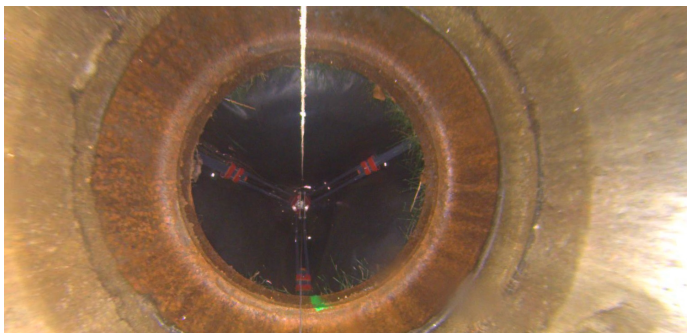
Code: **MGO**
Description: **General Observation**

Distance (ft): **2.2**
Structural Grade: **0**
O&M Grade: **0**
Clock Start/From:
Clock To:
1st Value:
2nd Value:
Value Percent:
Step: **NO**
Remarks: **underside of frame**

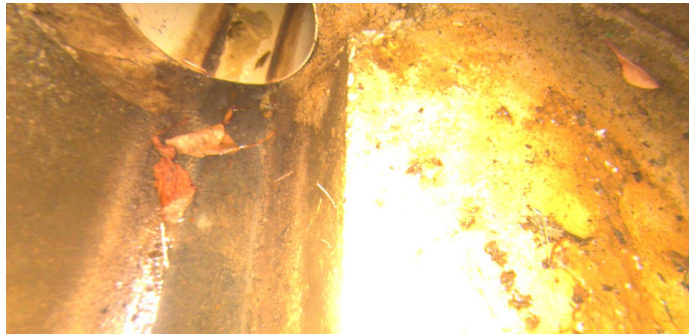
Code: **DSF**
Description: **Deposits Settled Fine**

Distance (ft): **4.0**
Structural Grade: **0**
O&M Grade: **2**
Clock Start/From: **12**
Clock To: **12**
1st Value:
2nd Value:
Value Percent: **5.000**
Step: **NO**
Remarks:

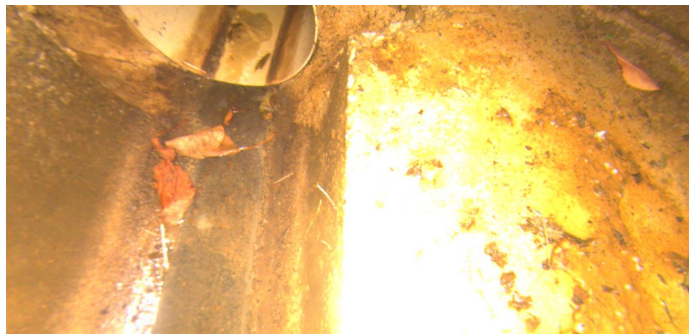
Code: **SRI**
Description: **Surface Roughness Increased**

Distance (ft): **4.0**
Structural Grade: **1**
O&M Grade: **0**
Clock Start/From: **3**
Clock To: **9**
1st Value:
2nd Value:
Value Percent:
Step: **NO**
Remarks:

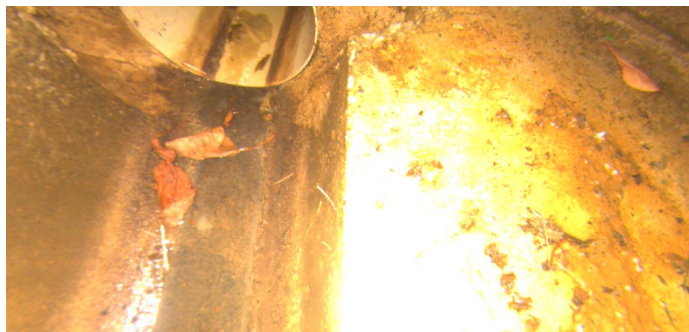
Code: **MGO**
Description: **General Observation**

Distance (ft): **4.0**
Structural Grade: **0**
O&M Grade: **0**
Clock Start/From:
Clock To:
1st Value:
2nd Value:
Value Percent:
Step: **NO**
Remarks: **end of survey**

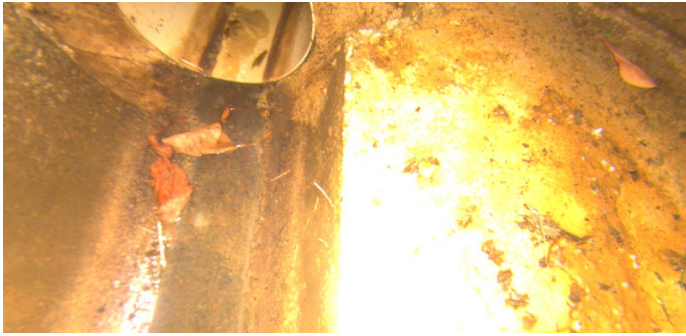
Code:	SRI
Description:	Surface Roughness Increased
Distance (ft):	4.0
Structural Grade:	1
O&M Grade:	0
Clock Start/From:	12
Clock To:	12
1st Value:	
2nd Value:	
Value Percent:	
Step:	NO
Remarks:
