Manhole Inspection Report

Date:	03/26/2018	Weather:		Coding:	RZMACP
MH#:	M-703-015	Owner:	NA	Len. Surveyed:	10.8
P.O.#:		Surveyor:	John Kuglmaier	Rim to Invert:	12.1
Customer:		Cert. #:	U-1215-07002349	Wall Material:	Concrete (reinforced)

Street:	Quail Dr. 328' East of Edgewater Dr.	Project:	Hobart, IN
City:	Hobart, IN	GPS Northing:	0.0
Location:		GPS Easting:	0.0
Drain Area:	North	GPS Accuracy:	Nearest Meter
Cover Shape:	Circular	Evidence of Surcharge:	No
Cover Size:	23.0	Potential for Runoff:	None
Comments:

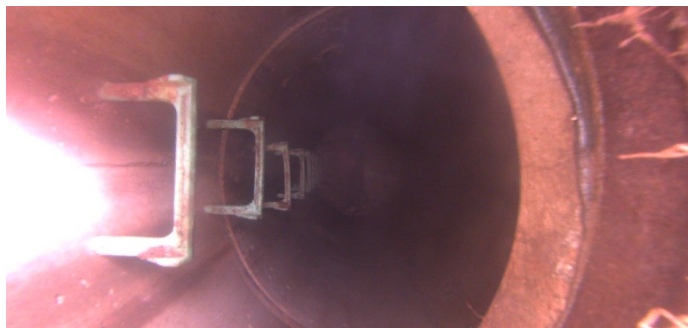
Code: **MGP**
Description: **General Photo**

Distance (ft): **.0**
Structural Grade: **0**
O&M Grade: **0**
Clock Start/From:
Clock To:
1st Value:
2nd Value:
Value Percent:
Step: **NO**
Remarks:

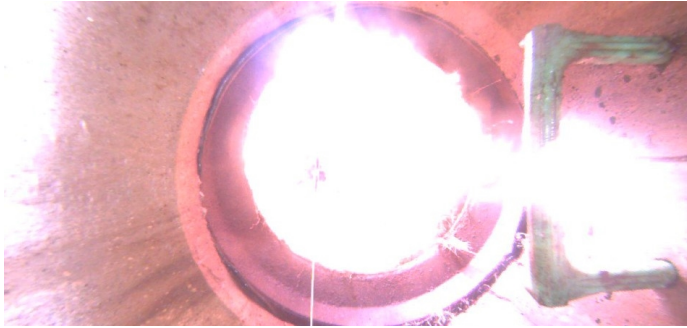
Code:	MGP
Description:	General Photo
Distance (ft):	2.3
Structural Grade:	0
O&M Grade:	0
Clock Start/From:	
Clock To:	
1st Value:	
2nd Value:	
Value Percent:	
Step:	NO
Remarks:

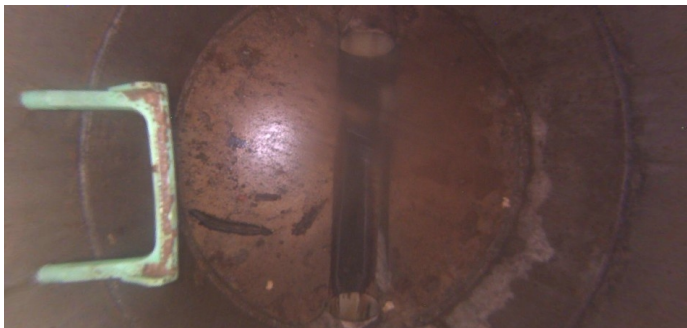
Code:	MGO
Description:	General Observation
Distance (ft):	8.8
Structural Grade:	0
O&M Grade:	0
Clock Start/From:	
Clock To:	
1st Value:	
2nd Value:	
Value Percent:	
Step:	NO
Remarks:	Ins. Comp.
