# Manhole Inspection Report

Date:	<b>03/26/2018</b>	Weather:		Coding:	<b>RZMACP</b>
MH#:	<b>M-703-016</b>	Owner:	<b>NA</b>	Len. Surveyed:	<b>13.6</b>
P.O.#:		Surveyor:	<b>John Kuglmaier</b>	Rim to Invert:	<b>15.4</b>
Customer:		Cert. #:	<b>U-1215-07002349</b>	Wall Material:	<b>Concrete (reinforced)</b>

Street:	<b>Intersection of Quail Dr. and Edgew</b>	Project:	<b>Hobart, IN</b>
City:	<b>Hobart, IN</b>	GPS Northing:	<b>0.0</b>
Location:		GPS Easting:	<b>0.0</b>
Drain Area:	<b>North</b>	GPS Accuracy:	<b>Nearest Meter</b>
Cover Shape:	<b>Circular</b>	Evidence of Surcharge:	<b>No</b>
Cover Size:	<b>23.0</b>	Potential for Runoff:	<b>None</b>
Comments:

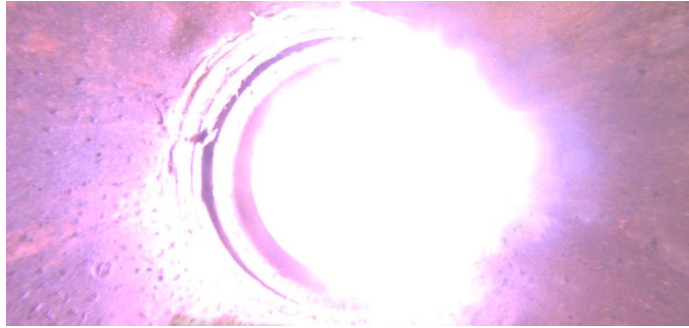
Code:	<b>MGP</b>
Description:	<b>General Photo</b>
Distance (ft):	<b>2.8</b>
Structural Grade:	<b>0</b>
O&M Grade:	<b>0</b>
Clock Start/From:	
Clock To:	
1st Value:	
2nd Value:	
Value Percent:	
Step:	<b>NO</b>
Remarks:

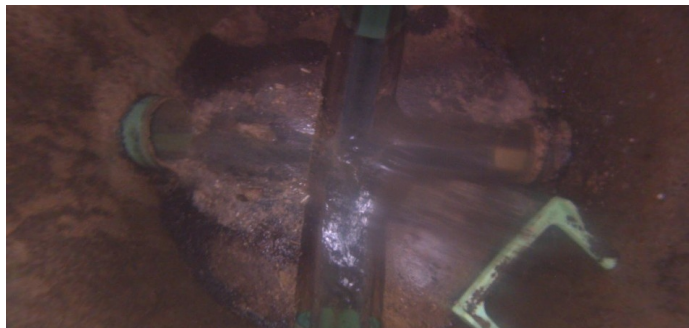
Code:	<b>MGO</b>
Description:	<b>General Observation</b>
Distance (ft):	<b>12.1</b>
Structural Grade:	<b>0</b>
O&M Grade:	<b>0</b>
Clock Start/From:	
Clock To:	
1st Value:	
2nd Value:	
Value Percent:	
Step:	<b>NO</b>
Remarks:	<b>Ins. Comp.</b>
