# Manhole Inspection Report

Date:	10/07/2022	Weather:		Coding:	RZMACP
MH#:	M-703-019	Owner:	NA	Len. Surveyed:	6.7
P.O.#:		Surveyor:	Jen Costello	Rim to Invert:	8.0
Customer:		Cert. #:	U-907-5518	Wall Material:	Concrete (cast in place)

Street:	311' North of Hidden Lake Dr. 22' W	Project:	Hobart, IN
City:	Hobart, IN	GPS Northing:	2293869.834
Location:	Other	GPS Easting:	2905059.992
Drain Area:	North	GPS Accuracy:	Sub-Meter
Cover Shape:	Circular	Evidence of Surcharge:	No
Cover Size:	24.0	Potential for Runoff:	None
Comments:

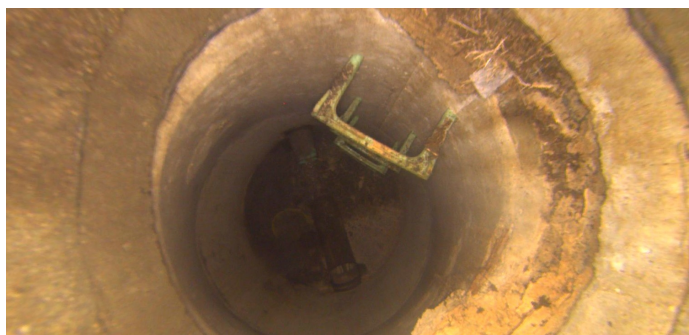
Code: **MGO**  
Description: **General Observation**

Distance (ft): **.0**  
Structural Grade: **0**  
O&M Grade: **0**  
Clock Start/From:  
Clock To:  
1st Value:  
2nd Value:  
Value Percent:  
Step: **NO**  
Remarks: **access mh**

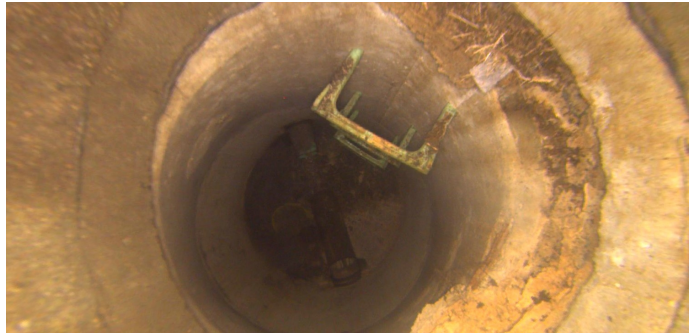
Code:	<b>SRI</b>
Description:	<b>Surface Roughness Increased</b>
Distance (ft):	<b>.0</b>
Structural Grade:	<b>1</b>
O&M Grade:	<b>0</b>
Clock Start/From:	<b>12</b>
Clock To:	<b>12</b>
1st Value:	
2nd Value:	
Value Percent:	
Step:	<b>NO</b>
Remarks:

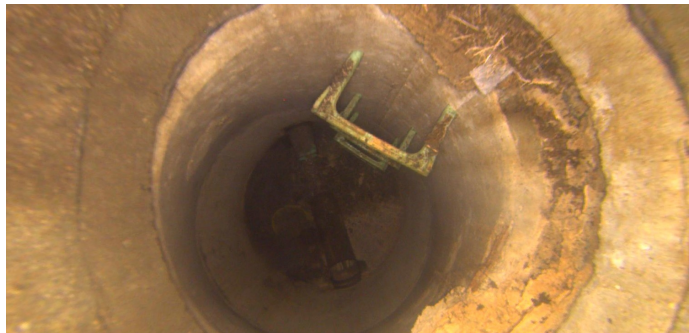
Code:	<b>ISGT</b>
Description:	<b>Intruding Sealing Grout</b>
Distance (ft):	<b>.0</b>
Structural Grade:	<b>0</b>
O&M Grade:	<b>2</b>
Clock Start/From:	<b>3</b>
Clock To:	<b>6</b>
1st Value:	
2nd Value:	
Value Percent:	<b>10.000</b>
Step:	<b>NO</b>
Remarks:

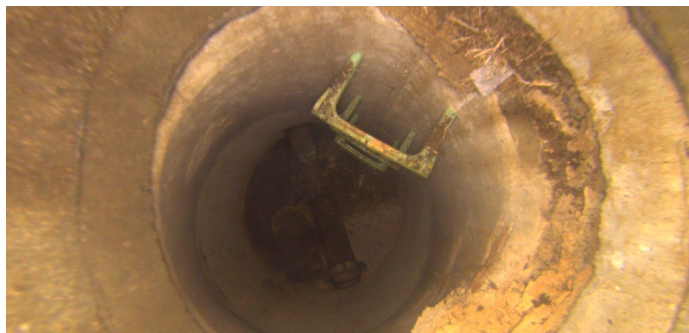
Code:	<b>RFJ</b>
Description:	<b>Roots Fine Joint</b>
Distance (ft):	<b>.0</b>
Structural Grade:	<b>0</b>
O&M Grade:	<b>1</b>
Clock Start/From:	<b>12</b>
Clock To:	<b>3</b>
1st Value:	
2nd Value:	
Value Percent:	
Step:	<b>NO</b>
Remarks:

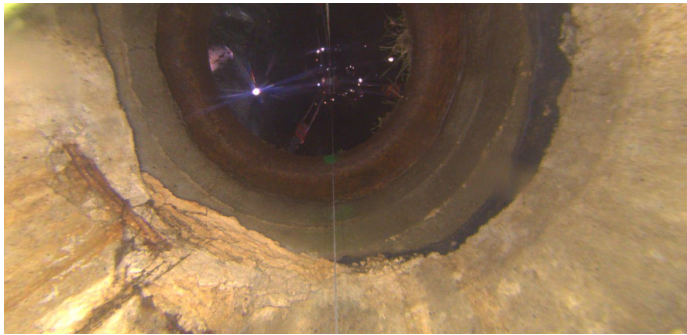
Code: **B**  
Description: **Broken**

Distance (ft): **2.7**  
Structural Grade: **5**  
O&M Grade: **0**  
Clock Start/From: **3**  
Clock To: **5**  
1st Value:  
2nd Value:  
Value Percent:  
Step: **NO**  
Remarks:

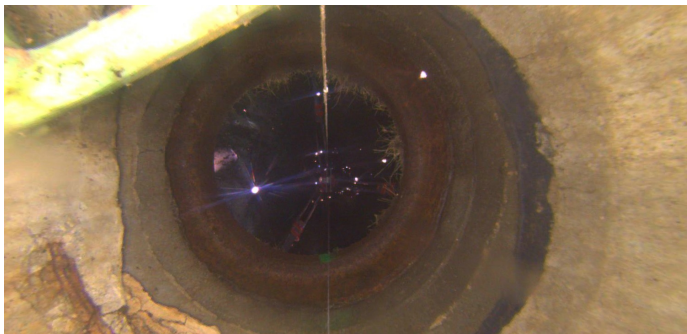
Code: **MGO**  
Description: **General Observation**

Distance (ft): **2.7**  
Structural Grade: **0**  
O&M Grade: **0**  
Clock Start/From:  
Clock To:  
1st Value:  
2nd Value:  
Value Percent:  
Step: **NO**  
Remarks: **underside of frame**

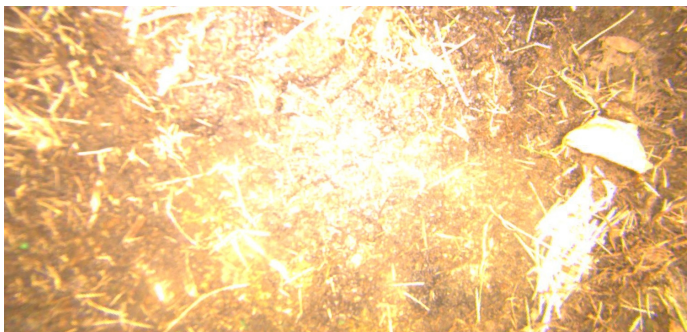
Code: **DSF**  
Description: **Deposits Settled Fine**

Distance (ft): **6.7**  
Structural Grade: **0**  
O&M Grade: **2**  
Clock Start/From: **2**  
Clock To: **12**  
1st Value:  
2nd Value:  
Value Percent: **5.000**  
Step: **NO**  
Remarks:

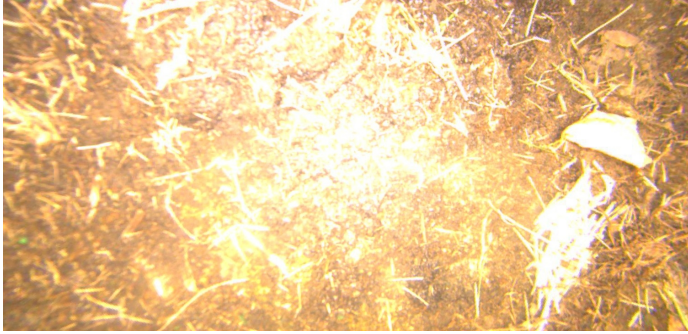
Code:	<b>MGO</b>
Description:	<b>General Observation</b>
Distance (ft):	<b>6.7</b>
Structural Grade:	<b>0</b>
O&M Grade:	<b>0</b>
Clock Start/From:	
Clock To:	
1st Value:	
2nd Value:	
Value Percent:	
Step:	<b>NO</b>
Remarks:	<b>end of survey</b>
