Manhole Inspection Report

Date:	03/26/2018	Weather:		Coding:	RZMACP
MH#:	M-703-020	Owner:	NA	Len. Surveyed:	11.7
P.O.#:		Surveyor:	John Kuglmaier	Rim to Invert:	12.8
Customer:		Cert. #:	U-1215-07002349	Wall Material:	Concrete (reinforced)

Street:	Hidden Lake Dr. 131' West of Quail	Project:	Hobart, IN
City:	Hobart, IN	GPS Northing:	0.0
Location:		GPS Easting:	0.0
Drain Area:	North	GPS Accuracy:	Nearest Meter
Cover Shape:	Circular	Evidence of Surcharge:	No
Cover Size:	23.0	Potential for Runoff:	None
Comments:

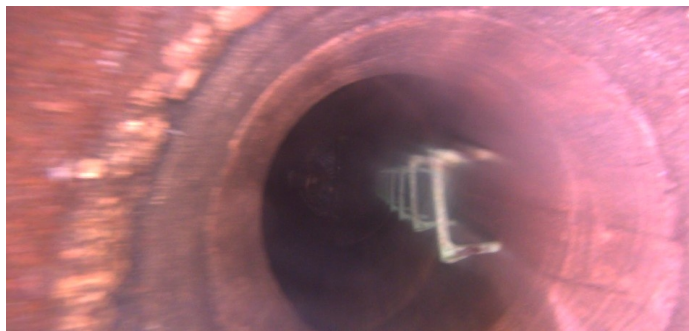
Code: **MGP**
Description: **General Photo**

Distance (ft): **.0**
Structural Grade: **0**
O&M Grade: **0**
Clock Start/From:
Clock To:
1st Value:
2nd Value:
Value Percent:
Step: **NO**
Remarks:

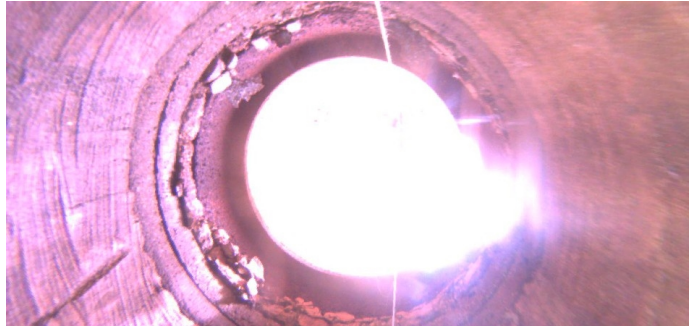
Code: **MGP**
Description: **General Photo**

Distance (ft): **2.4**
Structural Grade: **0**
O&M Grade: **0**
Clock Start/From:
Clock To:
1st Value:
2nd Value:
Value Percent:
Step: **NO**
Remarks:

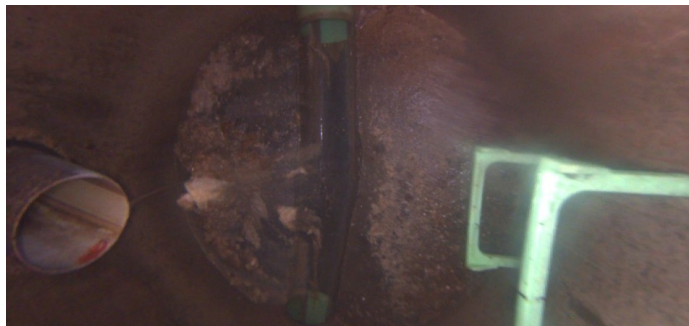
Code: **DAZ**
Description: **Deposits Attached Other**

Distance (ft): **9.2**
Structural Grade: **0**
O&M Grade: **2**
Clock Start/From: **12**
Clock To: **12**
1st Value:
2nd Value:
Value Percent: **5.000**
Step: **NO**
Remarks: **Mixed materials**

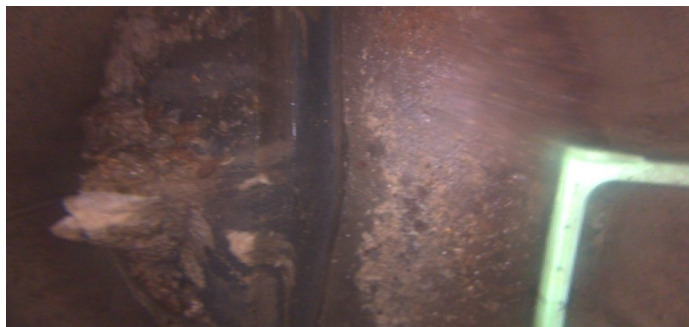
Code: **MGO**
Description: **General Observation**

Distance (ft): **10.3**
Structural Grade: **0**
O&M Grade: **0**
Clock Start/From:
Clock To:
1st Value:
2nd Value:
Value Percent:
Step: **NO**
Remarks: **Ins. Comp.**
