Manhole Inspection Report

Date:	03/29/2018	Weather:		Coding:	RZMACP
MH#:	M-703-022	Owner:	NA	Len. Surveyed:	7.6
P.O.#:		Surveyor:	John Kuglmaier	Rim to Invert:	8.9
Customer:		Cert. #:	U-1215-07002349	Wall Material:	Concrete (reinforced)

Street:	Hidden Lake Dr. 37' West of North P	Project:	Hobart, IN
City:	Hobart, IN	GPS Northing:	0.0
Location:		GPS Easting:	0.0
Drain Area:	North	GPS Accuracy:	Nearest Meter
Cover Shape:	Circular	Evidence of Surcharge:	No
Cover Size:	23.0	Potential for Runoff:	None
Comments:

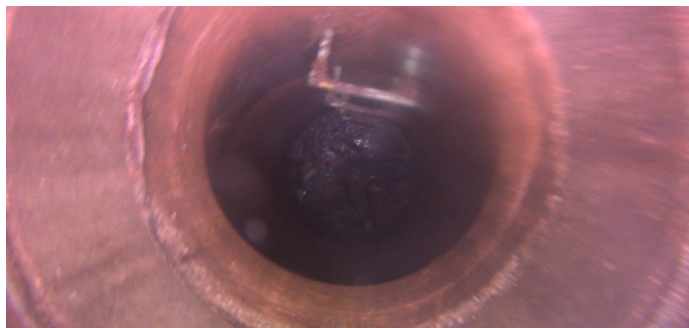
Code: **MGP**
Description: **General Photo**

Distance (ft): **.0**
Structural Grade: **0**
O&M Grade: **0**
Clock Start/From:
Clock To:
1st Value:
2nd Value:
Value Percent:
Step: **NO**
Remarks:

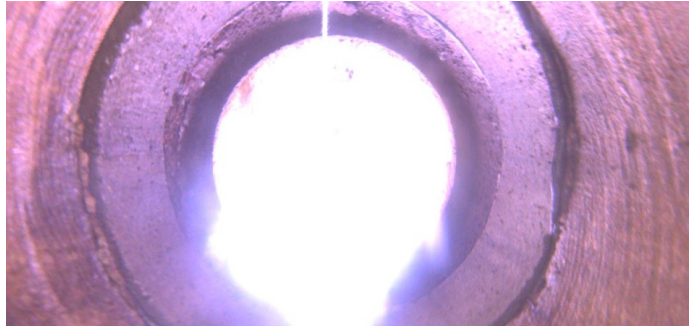
Code: **MGP**
Description: **General Photo**

Distance (ft): **2.4**
Structural Grade: **0**
O&M Grade: **0**
Clock Start/From:
Clock To:
1st Value:
2nd Value:
Value Percent:
Step: **NO**
Remarks:

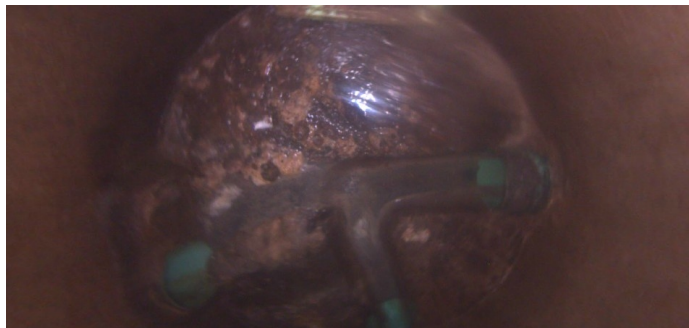
Code: **DAZ**
Description: **Deposits Attached Other**

Distance (ft): **5.8**
Structural Grade: **0**
O&M Grade: **2**
Clock Start/From: **12**
Clock To: **12**
1st Value:
2nd Value:
Value Percent: **5.000**
Step: **NO**
Remarks: **Mixed materials**

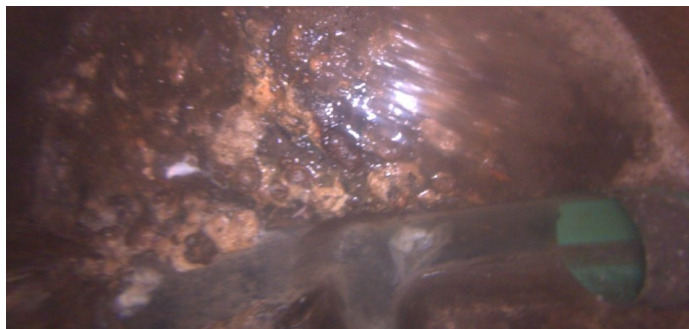
Code: **MGO**
Description: **General Observation**

Distance (ft): **6.9**
Structural Grade: **0**
O&M Grade: **0**
Clock Start/From:
Clock To:
1st Value:
2nd Value:
Value Percent:
Step: **NO**
Remarks: **Ins. Comp.**
