Manhole Inspection Report

Date:	03/26/2018	Weather:		Coding:	RZMACP
MH#:	M-703-024	Owner:	NA	Len. Surveyed:	5.9
P.O.#:		Surveyor:	John Kuglmaier	Rim to Invert:	5.6
Customer:		Cert. #:	U-1215-07002349	Wall Material:	Concrete (reinforced)

Street:	275' South of Deerpath Crt. 45' East	Project:	Hobart, IN
City:	Hobart, IN	GPS Northing:	0.0
Location:		GPS Easting:	0.0
Drain Area:	North	GPS Accuracy:	Nearest Meter
Cover Shape:	Circular	Evidence of Surcharge:	No
Cover Size:	23.0	Potential for Runoff:	None
Comments:

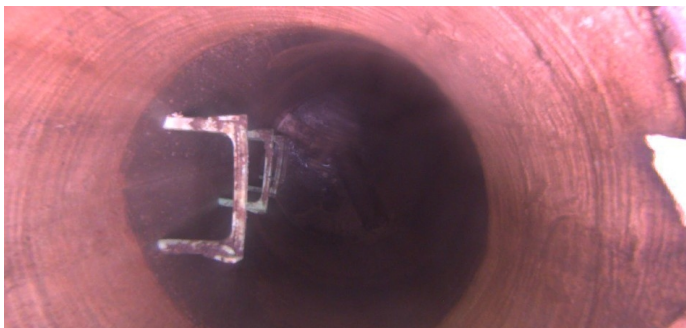
Code:	MGP
Description:	General Photo

Distance (ft):	.0
Structural Grade:	0
O&M Grade:	0
Clock Start/From:	
Clock To:	
1st Value:	
2nd Value:	
Value Percent:	
Step:	NO
Remarks:

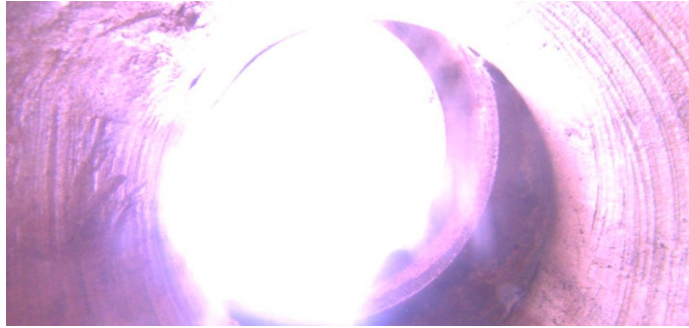
Code: **MGP**
Description: **General Photo**

Distance (ft): **2.1**
Structural Grade: **0**
O&M Grade: **0**
Clock Start/From:
Clock To:
1st Value:
2nd Value:
Value Percent:
Step: **NO**
Remarks:

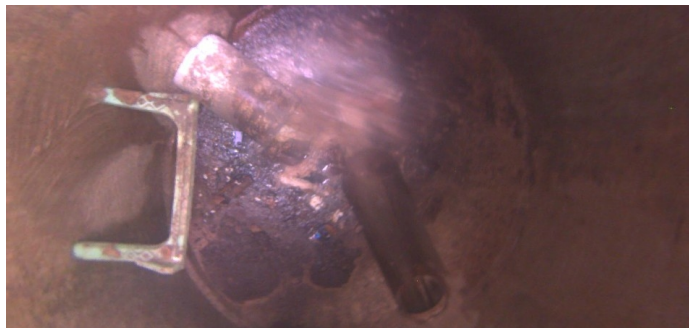
Code: **DAZ**
Description: **Deposits Attached Other**

Distance (ft): **4.2**
Structural Grade: **0**
O&M Grade: **2**
Clock Start/From: **12**
Clock To: **12**
1st Value:
2nd Value:
Value Percent: **5.000**
Step: **NO**
Remarks: **Mixed materials**

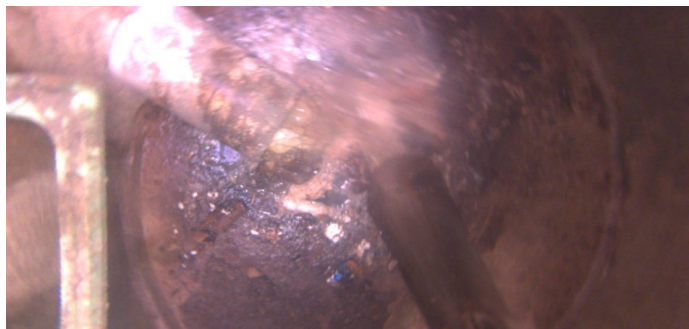
Code: **MGO**
Description: **General Observation**

Distance (ft): **4.9**
Structural Grade: **0**
O&M Grade: **0**
Clock Start/From:
Clock To:
1st Value:
2nd Value:
Value Percent:
Step: **NO**
Remarks: **Ins. Comp.**
