# Manhole Inspection Report

Date:	<b>03/29/2018</b>	Weather:		Coding:	<b>RZMACP</b>
MH#:	<b>M-703-025</b>	Owner:	<b>NA</b>	Len. Surveyed:	<b>5.4</b>
P.O.#:		Surveyor:	<b>John Kuglmaier</b>	Rim to Invert:	<b>7.0</b>
Customer:		Cert. #:	<b>U-1215-07002349</b>	Wall Material:	<b>Concrete (reinforced)</b>

Street:	<b>North Pheasant Run Dr. 67' South of</b>	Project:	<b>Hobart, IN</b>
City:	<b>Hobart, IN</b>	GPS Northing:	<b>0.0</b>
Location:		GPS Easting:	<b>0.0</b>
Drain Area:	<b>North</b>	GPS Accuracy:	<b>Nearest Meter</b>
Cover Shape:	<b>Circular</b>	Evidence of Surcharge:	<b>No</b>
Cover Size:	<b>23.0</b>	Potential for Runoff:	<b>None</b>
Comments:

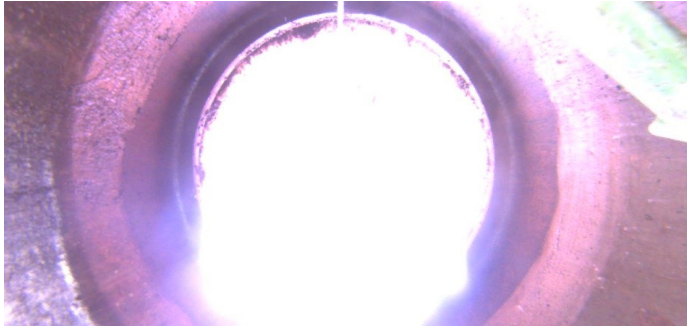
Code: **MGP**  
Description: **General Photo**

Distance (ft): **2.2**  
Structural Grade: **0**  
O&M Grade: **0**  
Clock Start/From:  
Clock To:  
1st Value:  
2nd Value:  
Value Percent:  
Step: **NO**  
Remarks:

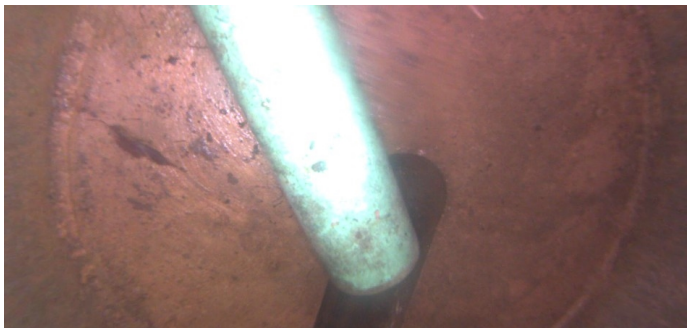
Code: **MGO**  
Description: **General Observation**

Distance (ft): **4.8**  
Structural Grade: **0**  
O&M Grade: **0**  
Clock Start/From:  
Clock To:  
1st Value:  
2nd Value:  
Value Percent:  
Step: **NO**  
Remarks: **Ins. Comp.**
