Manhole Inspection Report

Date:	03/29/2018	Weather:		Coding:	RZMACP
MH#:	M-703-026	Owner:	NA	Len. Surveyed:	7.1
P.O.#:		Surveyor:	John Kuglmaier	Rim to Invert:	8.9
Customer:		Cert. #:	U-1215-07002349	Wall Material:	Concrete (reinforced)

Street:	Manor Drive (Private) 132' South of	Project:	Hobart, IN
City:	Hobart, IN	GPS Northing:	0.0
Location:		GPS Easting:	0.0
Drain Area:	North	GPS Accuracy:	Nearest Meter
Cover Shape:	Circular	Evidence of Surcharge:	No
Cover Size:	23.0	Potential for Runoff:	None
Comments:

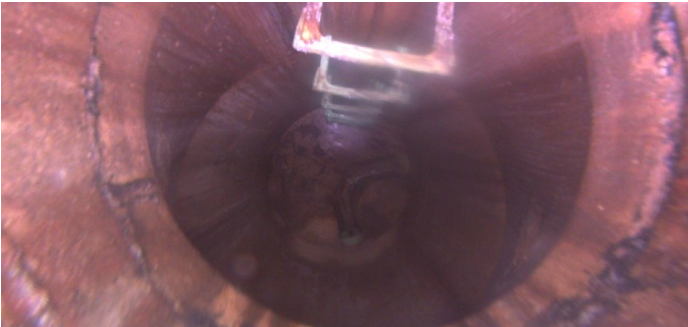
Code:

MGP

Description:

General Photo

Distance (ft):

.0

Structural Grade:

0

O&M Grade:

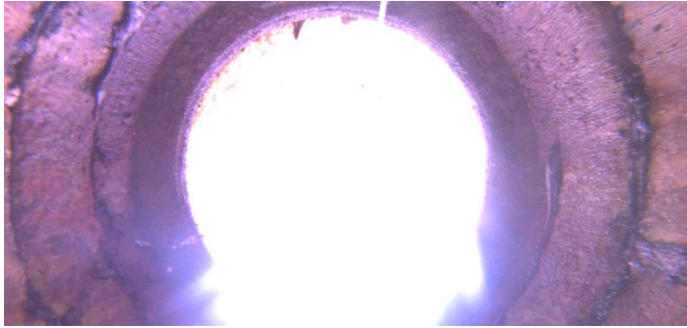
Code: **MGP**
Description: **General Photo**

Distance (ft): **1.9**
Structural Grade: **0**
O&M Grade: **0**
Clock Start/From:
Clock To:
1st Value:
2nd Value:
Value Percent:
Step: **NO**
Remarks:

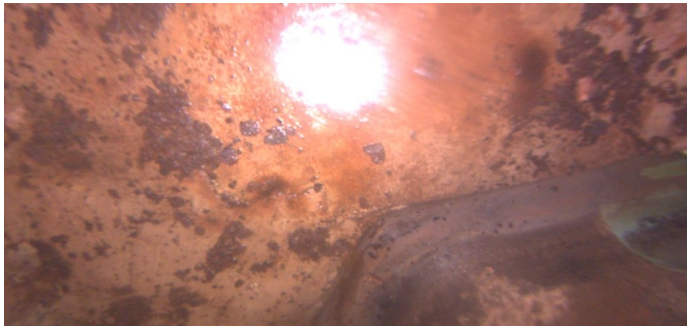
Code: **MGO**
Description: **General Observation**

Distance (ft): **6.6**
Structural Grade: **0**
O&M Grade: **0**
Clock Start/From:
Clock To:
1st Value:
2nd Value:
Value Percent:
Step: **NO**
Remarks: **Ins. Comp.**
