Manhole Inspection Report

Date:	03/29/2018	Weather:		Coding:	RZMACP
MH#:	M-703-027	Owner:	NA	Len. Surveyed:	3.0
P.O.#:		Surveyor:	John Kuglmaier	Rim to Invert:	4.2
Customer:		Cert. #:	U-1215-07002349	Wall Material:	Concrete (reinforced)

Street:	Manor Drive (Private). 194' South of	Project:	Hobart, IN
City:	Hobart, IN	GPS Northing:	0.0
Location:		GPS Easting:	0.0
Drain Area:	North	GPS Accuracy:	Nearest Meter
Cover Shape:	Circular	Evidence of Surcharge:	No
Cover Size:	23.0	Potential for Runoff:	None
Comments:

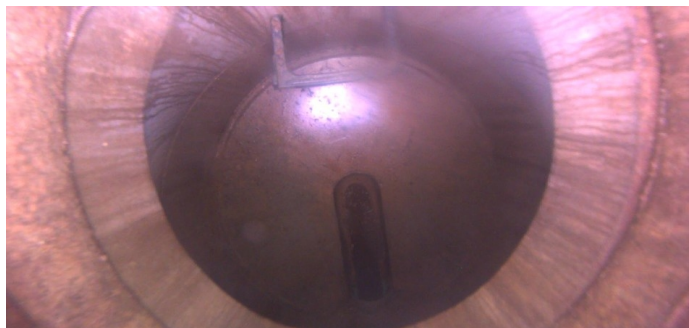
Code: **MGP**
Description: **General Photo**

Distance (ft): **.0**
Structural Grade: **0**
O&M Grade: **0**
Clock Start/From:
Clock To:
1st Value:
2nd Value:
Value Percent:
Step: **NO**
Remarks:

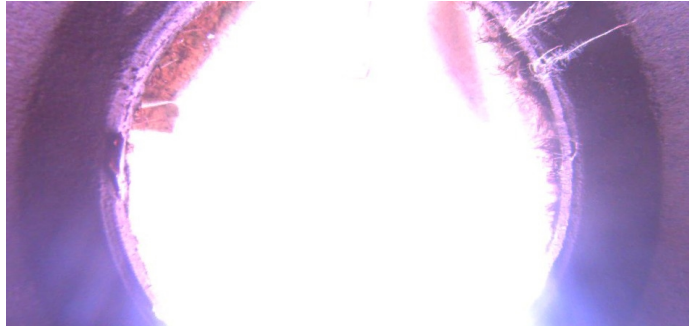
Code: **MGP**
Description: **General Photo**

Distance (ft): **1.4**
Structural Grade: **0**
O&M Grade: **0**
Clock Start/From:
Clock To:
1st Value:
2nd Value:
Value Percent:
Step: **NO**
Remarks:

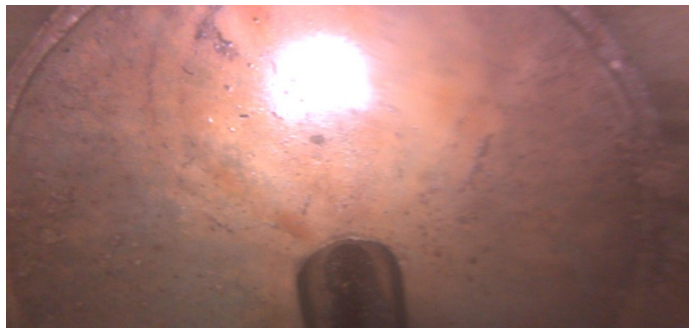
Code: **MGO**
Description: **General Observation**

Distance (ft): **2.4**
Structural Grade: **0**
O&M Grade: **0**
Clock Start/From:
Clock To:
1st Value:
2nd Value:
Value Percent:
Step: **NO**
Remarks: **Ins. Comp.**
