Manhole Inspection Report

Date:	03/29/2018	Weather:		Coding:	RZMACP
MH#:	M-703-028	Owner:	NA	Len. Surveyed:	4.0
P.O.#:		Surveyor:	John Kuglmaier	Rim to Invert:	5.3
Customer:		Cert. #:	U-1215-07002349	Wall Material:	Concrete (reinforced)

Street:	Manor Drive (Private). 261' South of	Project:	Hobart, IN
City:	Hobart, IN	GPS Northing:	0.0
Location:		GPS Easting:	0.0
Drain Area:	North	GPS Accuracy:	Nearest Meter
Cover Shape:	Circular	Evidence of Surcharge:	No
Cover Size:	23.0	Potential for Runoff:	None
Comments:

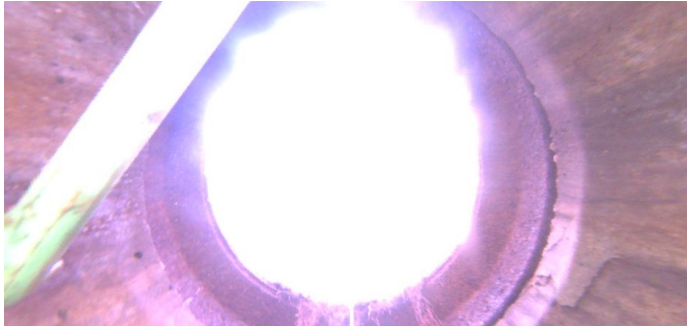
Code:	MGP
Description:	General Photo

Distance (ft):	.0
Structural Grade:	0
O&M Grade:	0
Clock Start/From:	
Clock To:	
1st Value:	
2nd Value:	
Value Percent:	
Step:	NO
Remarks:

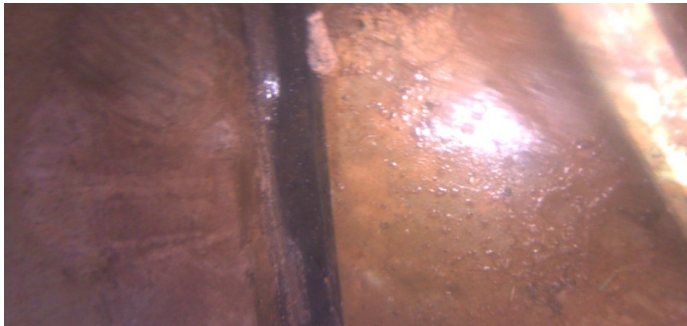
Code:	MGP
Description:	General Photo
Distance (ft):	2.0
Structural Grade:	0
O&M Grade:	0
Clock Start/From:	
Clock To:	
1st Value:	
2nd Value:	
Value Percent:	
Step:	NO
Remarks:
