Manhole Inspection Report

Date:	03/26/2018	Weather:		Coding:	RZMACP
MH#:	M-703-030	Owner:	NA	Len. Surveyed:	4.9
P.O.#:		Surveyor:	John Kuglmaier	Rim to Invert:	6.1
Customer:		Cert. #:	U-1215-07002349	Wall Material:	Concrete (reinforced)

Street:	Manor Drive (Private). 277' East of L	Project:	Hobart, IN
City:	Hobart, IN	GPS Northing:	0.0
Location:		GPS Easting:	0.0
Drain Area:	North	GPS Accuracy:	Nearest Meter
Cover Shape:	Circular	Evidence of Surcharge:	No
Cover Size:	23.0	Potential for Runoff:	None
Comments:

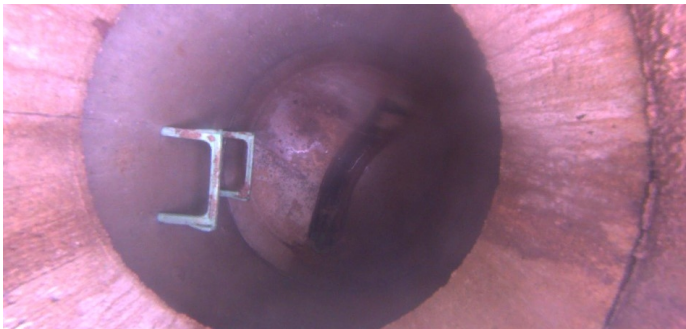
Code:	MGP
Description:	General Photo

Distance (ft):	.0
Structural Grade:	0
O&M Grade:	0
Clock Start/From:	
Clock To:	
1st Value:	
2nd Value:	
Value Percent:	
Step:	NO
Remarks:

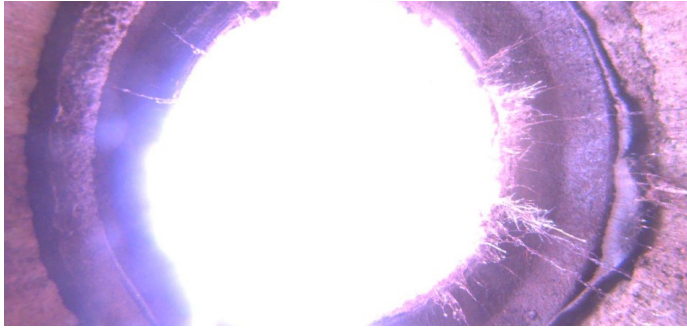
Code:	MGP
Description:	General Photo
Distance (ft):	1.7
Structural Grade:	0
O&M Grade:	0
Clock Start/From:	
Clock To:	
1st Value:	
2nd Value:	
Value Percent:	
Step:	NO
Remarks:

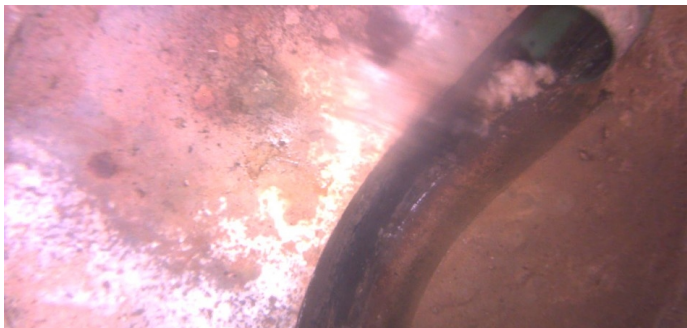
Code:	MGO
Description:	General Observation
Distance (ft):	4.1
Structural Grade:	0
O&M Grade:	0
Clock Start/From:	
Clock To:	
1st Value:	
2nd Value:	
Value Percent:	
Step:	NO
Remarks:	Ins. Comp.
