Manhole Inspection Report

Date:	03/26/2018	Weather:		Coding:	RZMACP
MH#:	M-703-031	Owner:	NA	Len. Surveyed:	5.6
P.O.#:		Surveyor:	John Kuglmaier	Rim to Invert:	6.8
Customer:		Cert. #:	U-1215-07002349	Wall Material:	Concrete (reinforced)

Street:	Manor Drive (Private). 346' East of L	Project:	Hobart, IN
City:	Hobart, IN	GPS Northing:	0.0
Location:		GPS Easting:	0.0
Drain Area:	North	GPS Accuracy:	Nearest Meter
Cover Shape:	Circular	Evidence of Surcharge:	No
Cover Size:	23.0	Potential for Runoff:	None
Comments:

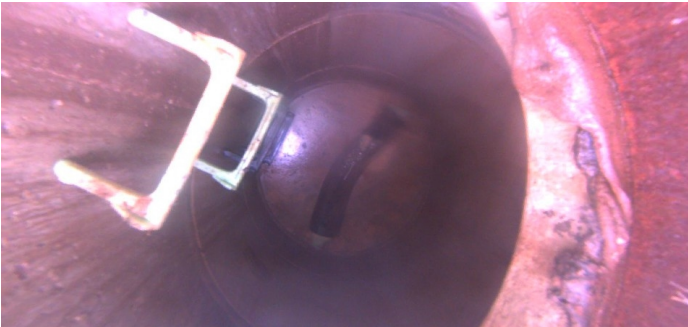
Code:

MGP

Description:

General Photo

Distance (ft):

.0

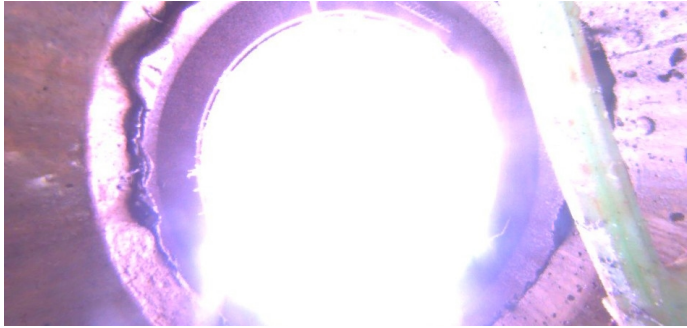
Code: **MGP**
Description: **General Photo**

Distance (ft): **2.0**
Structural Grade: **0**
O&M Grade: **0**
Clock Start/From:
Clock To:
1st Value:
2nd Value:
Value Percent:
Step: **NO**
Remarks:

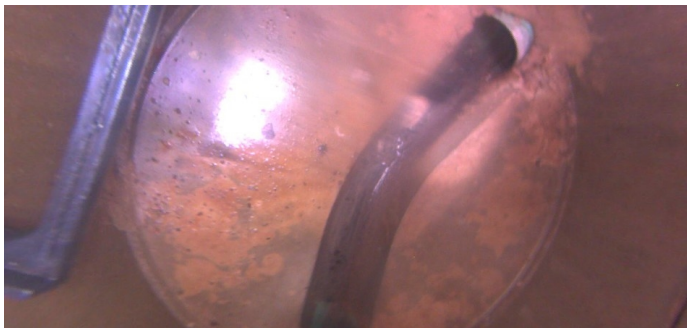
Code: **MGO**
Description: **General Observation**

Distance (ft): **4.1**
Structural Grade: **0**
O&M Grade: **0**
Clock Start/From:
Clock To:
1st Value:
2nd Value:
Value Percent:
Step: **NO**
Remarks: **Ins. Comp.**
