# Manhole Inspection Report

Date:	<b>03/26/2018</b>	Weather:		Coding:	<b>RZMACP</b>
MH#:	<b>M-703-035</b>	Owner:	<b>NA</b>	Len. Surveyed:	<b>13.4</b>
P.O.#:		Surveyor:	<b>John Kuglmaier</b>	Rim to Invert:	<b>14.6</b>
Customer:		Cert. #:	<b>U-1215-07002349</b>	Wall Material:	<b>Concrete (reinforced)</b>

Street:	<b>Intersection of Edgewater Dr. and D</b>	Project:	<b>Hobart, IN</b>
City:	<b>Hobart, IN</b>	GPS Northing:	<b>0.0</b>
Location:		GPS Easting:	<b>0.0</b>
Drain Area:	<b>North</b>	GPS Accuracy:	<b>Nearest Meter</b>
Cover Shape:	<b>Circular</b>	Evidence of Surcharge:	<b>Yes</b>
Cover Size:	<b>23.0</b>	Potential for Runoff:	<b>None</b>
Comments:

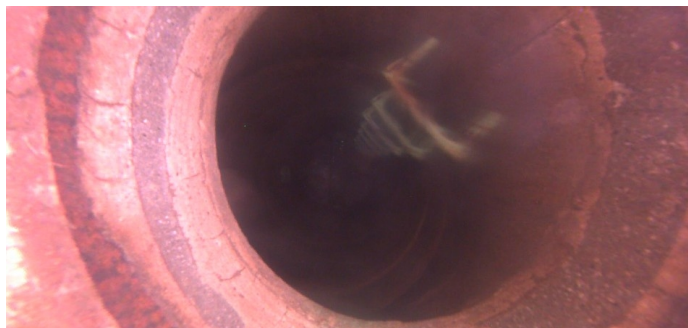
Code: **MGP**  
Description: **General Photo**

Distance (ft): **.0**  
Structural Grade: **0**  
O&M Grade: **0**  
Clock Start/From:  
Clock To:  
1st Value:  
2nd Value:  
Value Percent:  
Step: **NO**  
Remarks:

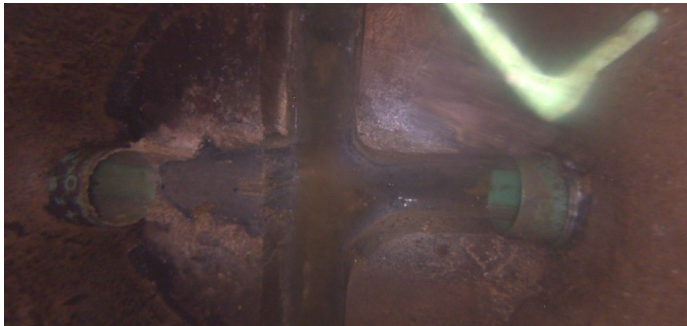
Code: **MGO**  
Description: **General Observation**

Distance (ft): **11.8**  
Structural Grade: **0**  
O&M Grade: **0**  
Clock Start/From:  
Clock To:  
1st Value:  
2nd Value:  
Value Percent:  
Step: **NO**  
Remarks: **Ins. Comp.**
