Manhole Inspection Report

Date:	03/26/2018	Weather:		Coding:	RZMACP
MH#:	M-703-036	Owner:	NA	Len. Surveyed:	12.5
P.O.#:		Surveyor:	John Kuglmaier	Rim to Invert:	14.1
Customer:		Cert. #:	U-1215-07002349	Wall Material:	Concrete (reinforced)

Street:	Edgewater Dr. 79' South of Deerpath	Project:	Hobart, IN
City:	Hobart, IN	GPS Northing:	0.0
Location:		GPS Easting:	0.0
Drain Area:	North	GPS Accuracy:	Nearest Meter
Cover Shape:	Circular	Evidence of Surcharge:	Yes
Cover Size:	23.0	Potential for Runoff:	None
Comments:

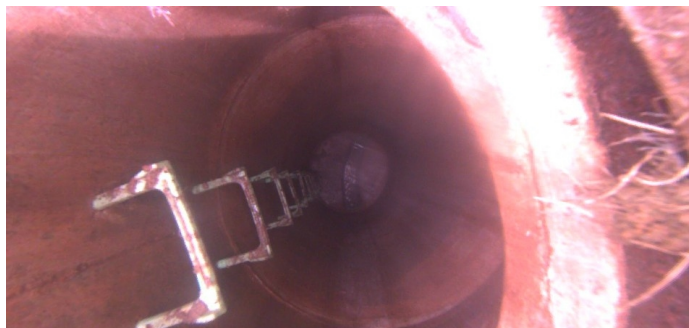
Code: **MGP**
Description: **General Photo**

Distance (ft): **.0**
Structural Grade: **0**
O&M Grade: **0**
Clock Start/From:
Clock To:
1st Value:
2nd Value:
Value Percent:
Step: **NO**
Remarks:

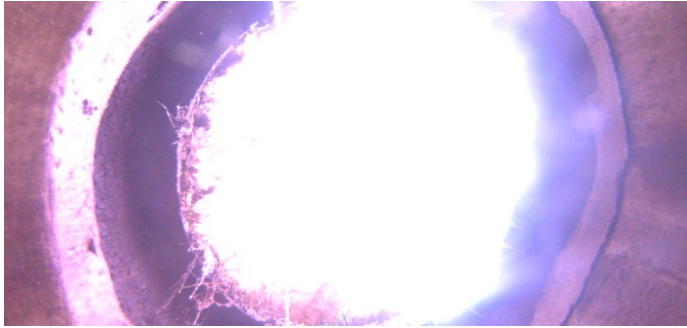
Code:	MGP
Description:	General Photo
Distance (ft):	1.6
Structural Grade:	0
O&M Grade:	0
Clock Start/From:	
Clock To:	
1st Value:	
2nd Value:	
Value Percent:	
Step:	NO
Remarks:

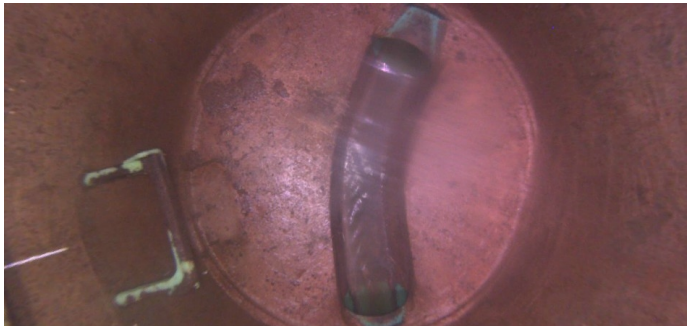
Code:	MGO
Description:	General Observation
Distance (ft):	10.2
Structural Grade:	0
O&M Grade:	0
Clock Start/From:	
Clock To:	
1st Value:	
2nd Value:	
Value Percent:	
Step:	NO
Remarks:	Ins. Comp.
