Manhole Inspection Report

Date:	03/26/2018	Weather:		Coding:	RZMACP
MH#:	M-703-037	Owner:	NA	Len. Surveyed:	11.6
P.O.#:		Surveyor:	John Kuglmaier	Rim to Invert:	13.0
Customer:		Cert. #:	U-1215-07002349	Wall Material:	Concrete (reinforced)

Street:	275' South of Deerpath Crt. 45' East	Project:	Hobart, IN
City:	Hobart, IN	GPS Northing:	0.0
Location:		GPS Easting:	0.0
Drain Area:	North	GPS Accuracy:	Nearest Meter
Cover Shape:	Circular	Evidence of Surcharge:	Yes
Cover Size:	23.0	Potential for Runoff:	None
Comments:

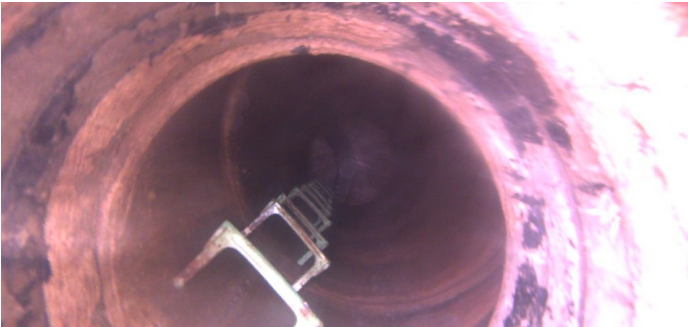
Code:

MGP

Description:

General Photo

Distance (ft):

.0

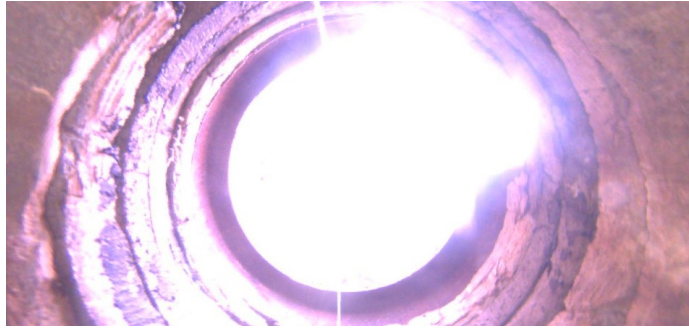
Code: **MGP**
Description: **General Photo**

Distance (ft): **2.3**
Structural Grade: **0**
O&M Grade: **0**
Clock Start/From:
Clock To:
1st Value:
2nd Value:
Value Percent:
Step: **NO**
Remarks:

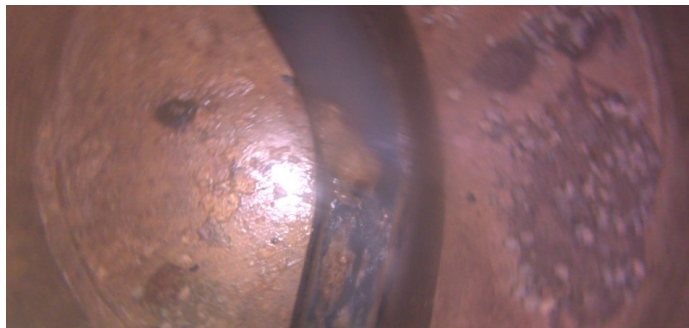
Code: **MGO**
Description: **General Observation**

Distance (ft): **10.6**
Structural Grade: **0**
O&M Grade: **0**
Clock Start/From:
Clock To:
1st Value:
2nd Value:
Value Percent:
Step: **NO**
Remarks: **Ins. Comp.**
