Manhole Inspection Report

Date:	03/26/2018	Weather:		Coding:	RZMACP
MH#:	M-703-042	Owner:	NA	Len. Surveyed:	4.8
P.O.#:		Surveyor:	John Kuglmaier	Rim to Invert:	5.9
Customer:		Cert. #:	U-1215-07002349	Wall Material:	Concrete (reinforced)

Street:	Intersection of Edgewater Dr. and D	Project:	Hobart, IN
City:	Hobart, IN	GPS Northing:	0.0
Location:		GPS Easting:	0.0
Drain Area:	North	GPS Accuracy:	Nearest Meter
Cover Shape:	Circular	Evidence of Surcharge:	No
Cover Size:	23.0	Potential for Runoff:	None
Comments:

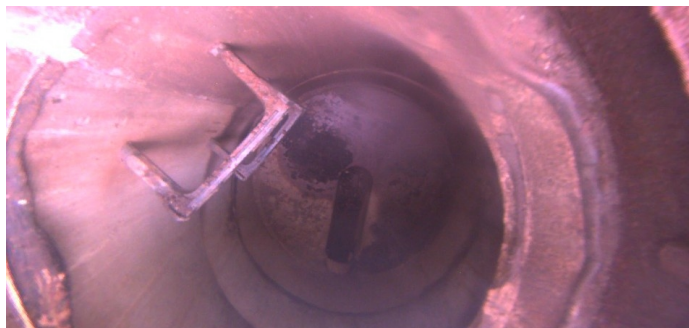
Code: **MGP**
Description: **General Photo**

Distance (ft): **.0**
Structural Grade: **0**
O&M Grade: **0**
Clock Start/From:
Clock To:
1st Value:
2nd Value:
Value Percent:
Step: **NO**
Remarks:

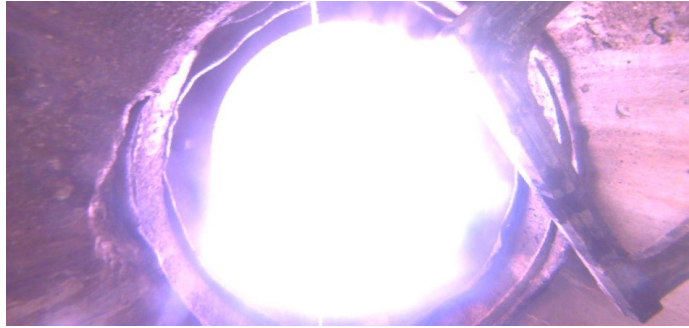
Code: **MGP**
Description: **General Photo**

Distance (ft): **2.3**
Structural Grade: **0**
O&M Grade: **0**
Clock Start/From:
Clock To:
1st Value:
2nd Value:
Value Percent:
Step: **NO**
Remarks:

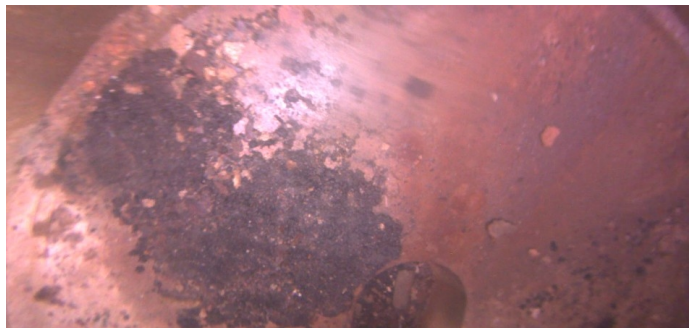
Code: **MGO**
Description: **General Observation**

Distance (ft): **4.0**
Structural Grade: **0**
O&M Grade: **0**
Clock Start/From:
Clock To:
1st Value:
2nd Value:
Value Percent:
Step: **NO**
Remarks: **Ins. Comp.**
