Manhole Inspection Report

Date:	05/06/2018	Weather:		Coding:	RZMACP
MH#:	M-704-002	Owner:	NA	Len. Surveyed:	4.0
P.O.#:		Surveyor:	Jen Costello	Rim to Invert:	4.6
Customer:		Cert. #:	U-907-5518	Wall Material:	Brick

Street:	Linda St. 612' North of Cleveland Av	Project:	Hobart, IN
City:	Hobart, IN	GPS Northing:	2907123.255
Location:		GPS Easting:	2907123.255
Drain Area:	Northeast	GPS Accuracy:	Sub-Meter
Cover Shape:	Circular	Evidence of Surcharge:	No
Cover Size:	22.5	Potential for Runoff:	None
Comments:

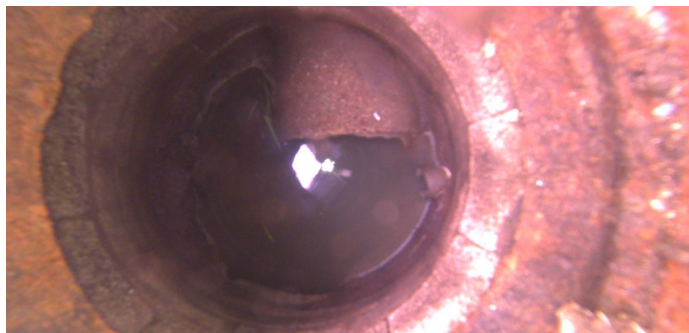
Code: **MGP**
Description: **General Photo**

Distance (ft): **.0**
Structural Grade: **0**
O&M Grade: **0**
Clock Start/From:
Clock To:
1st Value:
2nd Value:
Value Percent:
Step: **NO**
Remarks: **ACCESS MH**

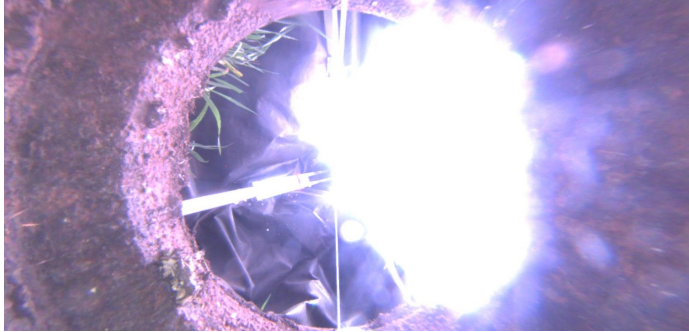
Code:	MGO
Description:	General Observation
Distance (ft):	1.6
Structural Grade:	0
O&M Grade:	0
Clock Start/From:	
Clock To:	
1st Value:	
2nd Value:	
Value Percent:	
Step:	NO
Remarks:	UNDERSIDE OF FRAME

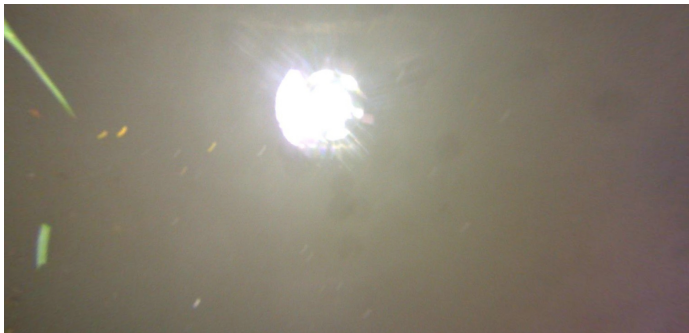
Code:	MGO
Description:	General Observation
Distance (ft):	4.0
Structural Grade:	0
O&M Grade:	0
Clock Start/From:	
Clock To:	
1st Value:	
2nd Value:	
Value Percent:	
Step:	NO
Remarks:	END SURVEY
