Manhole Inspection Report

Date:	04/29/2018	Weather:		Coding:	RZMACP
MH#:	M-704-004	Owner:	NA	Len. Surveyed:	16.8
P.O.#:		Surveyor:	Jen Costello	Rim to Invert:	18.8
Customer:		Cert. #:	U-907-5518	Wall Material:	Concrete (reinforced)

Street:	Linda St. 41' North of Home Ave.	Project:	Hobart, IN
City:	Hobart, IN	GPS Northing:	41.53818512
Location:		GPS Easting:	-87.25004578
Drain Area:	Northeast	GPS Accuracy:	Nearest Meter
Cover Shape:	Circular	Evidence of Surcharge:	No
Cover Size:	22.5	Potential for Runoff:	None
Comments:

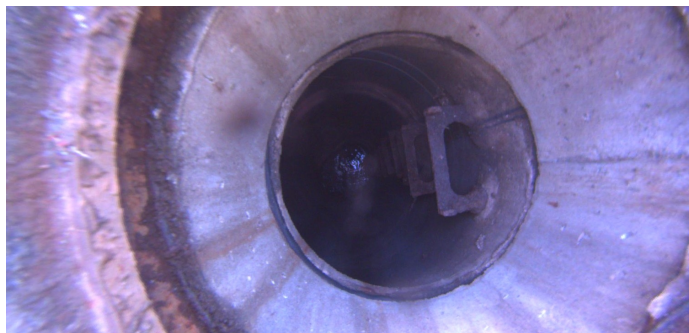
Code: **MGO**
Description: **General Observation**

Distance (ft): **.0**
Structural Grade: **0**
O&M Grade: **0**
Clock Start/From:
Clock To:
1st Value:
2nd Value:
Value Percent:
Step: **NO**
Remarks: **ACCESS MH**

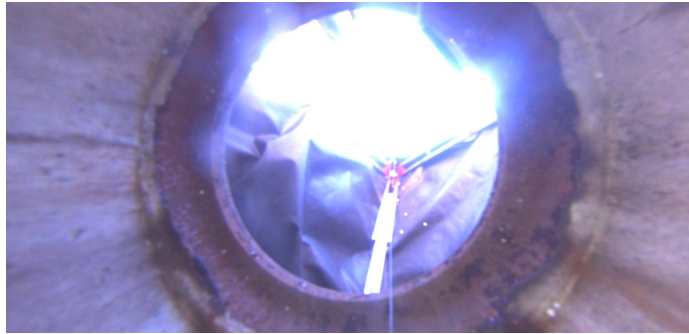
Code:	MGP
Description:	General Photo
Distance (ft):	1.6
Structural Grade:	0
O&M Grade:	0
Clock Start/From:	
Clock To:	
1st Value:	
2nd Value:	
Value Percent:	
Step:	NO
Remarks:	UNDERSIDE OF FRAME

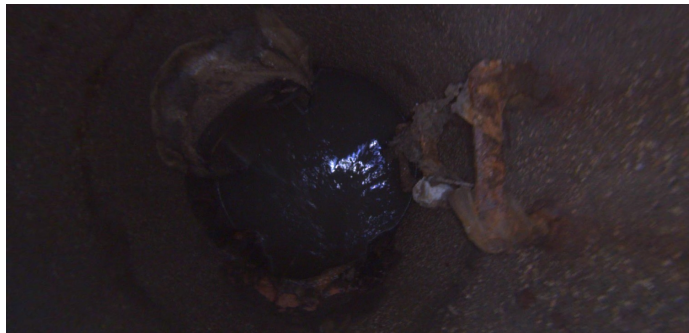
Code:	SAV
Description:	Surface Aggregate Visible
Distance (ft):	14.1
Structural Grade:	3
O&M Grade:	0
Clock Start/From:	12
Clock To:	12
1st Value:	
2nd Value:	
Value Percent:	
Step:	NO
Remarks:

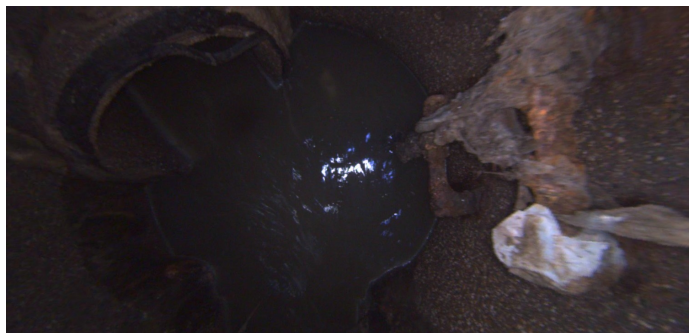
Code:	DAR
Description:	Deposits Attached Ragging
Distance (ft):	16.0
Structural Grade:	0
O&M Grade:	2
Clock Start/From:	2
Clock To:	4
1st Value:	
2nd Value:	
Value Percent:	10.000
Step:	YES
Remarks:

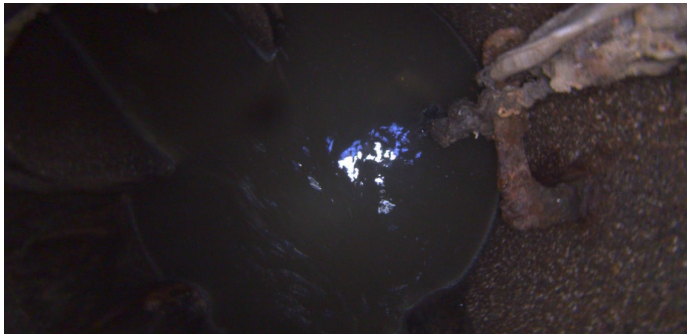
Code: **MGO**
Description: **General Observation**

Distance (ft): **16.8**
Structural Grade: **0**
O&M Grade: **0**
Clock Start/From:
Clock To:
1st Value:
2nd Value:
Value Percent:
Step: **NO**
Remarks: **END SURVEY**
