Manhole Inspection Report

Date:	04/29/2018	Weather:		Coding:	RZMACP
MH#:	M-704-005	Owner:	NA	Len. Surveyed:	16.5
P.O.#:		Surveyor:	Jen Costello	Rim to Invert:	18.8
Customer:		Cert. #:	U-907-5518	Wall Material:	Concrete (reinforced)

Street:	Linda St. 49' North of Home Ave.	Project:	Hobart, IN
City:	Hobart, IN	GPS Northing:	41.53816605
Location:		GPS Easting:	-87.25005341
Drain Area:	Northeast	GPS Accuracy:	Nearest Meter
Cover Shape:	Circular	Evidence of Surcharge:	No
Cover Size:	22.5	Potential for Runoff:	None
Comments:

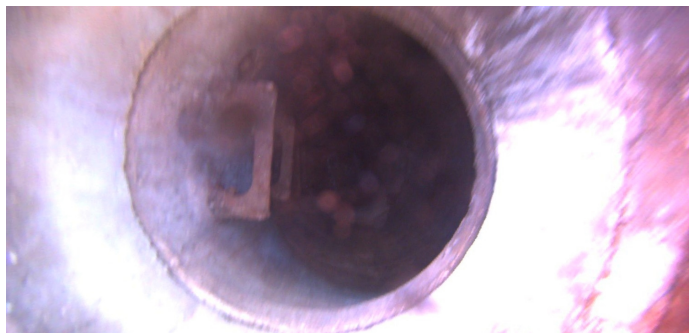
Code: **MGP**
Description: **General Photo**

Distance (ft): **.0**
Structural Grade: **0**
O&M Grade: **0**
Clock Start/From:
Clock To:
1st Value:
2nd Value:
Value Percent:
Step: **NO**
Remarks: **ACCESS MH**

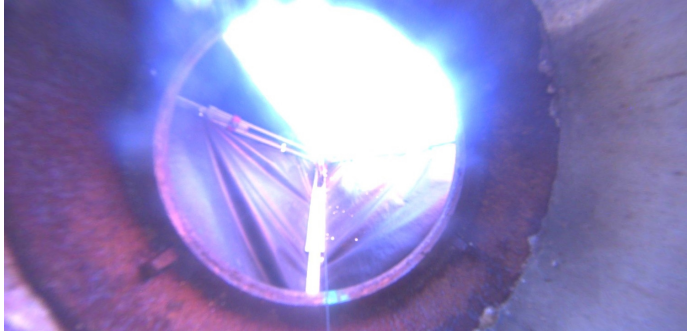
Code:	MGO
Description:	General Observation
Distance (ft):	1.3
Structural Grade:	0
O&M Grade:	0
Clock Start/From:	
Clock To:	
1st Value:	
2nd Value:	
Value Percent:	
Step:	NO
Remarks:	UNDERSIDE OF FRAME

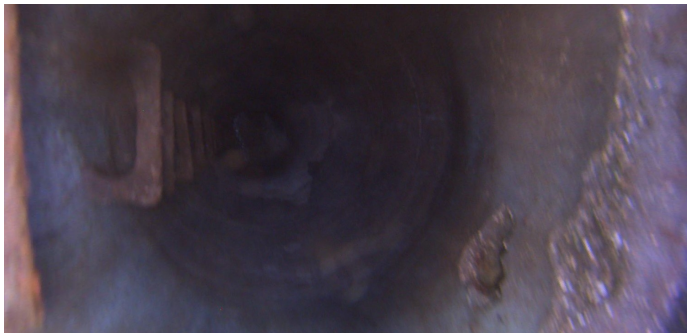
Code:	SSS
Description:	Surface Spalling
Distance (ft):	1.3
Structural Grade:	2
O&M Grade:	0
Clock Start/From:	3
Clock To:	5
1st Value:	
2nd Value:	
Value Percent:	
Step:	NO
Remarks:
