Manhole Inspection Report

Date:	04/29/2018	Weather:		Coding:	RZMACP
MH#:	M-704-008	Owner:	NA	Len. Surveyed:	16.7
P.O.#:		Surveyor:	Jen Costello	Rim to Invert:	18.2
Customer:		Cert. #:	U-907-5518	Wall Material:	Concrete (reinforced)

Street:	Cleveland Ave. 241' East of Michigan	Project:	Hobart, IN
City:	Hobart, IN	GPS Northing:	41.53617859
Location:		GPS Easting:	-87.25134277
Drain Area:	Northeast	GPS Accuracy:	Nearest Meter
Cover Shape:	Circular	Evidence of Surcharge:	No
Cover Size:	22.5	Potential for Runoff:	None
Comments:

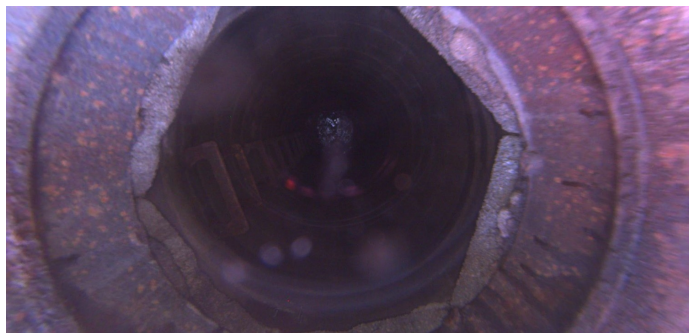
Code: **MGO**
Description: **General Observation**

Distance (ft): **.0**
Structural Grade: **0**
O&M Grade: **0**
Clock Start/From:
Clock To:
1st Value:
2nd Value:
Value Percent:
Step: **NO**
Remarks: **ACCESS MH**

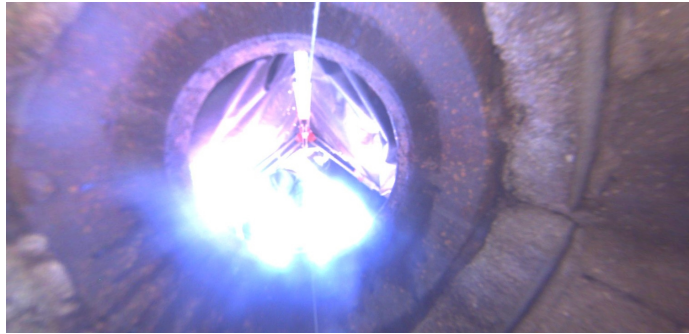
Code: **MGO**
Description: **General Observation**

Distance (ft): **2.2**
Structural Grade: **0**
O&M Grade: **0**
Clock Start/From:
Clock To:
1st Value:
2nd Value:
Value Percent:
Step: **NO**
Remarks: **UNDERSIDE OF FRAME**

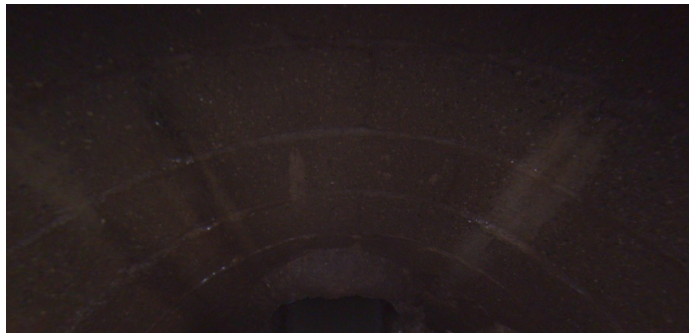
Code: **IW**
Description: **Infil Weeper**

Distance (ft): **13.6**
Structural Grade: **0**
O&M Grade: **2**
Clock Start/From: **10**
Clock To: **2**
1st Value:
2nd Value:
Value Percent:
Step: **NO**
Remarks:

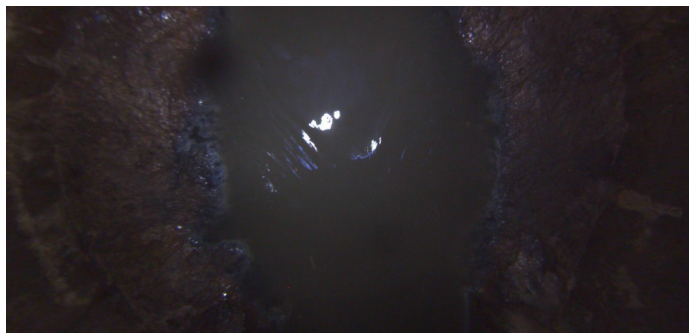
Code: **MGO**
Description: **General Observation**

Distance (ft): **16.7**
Structural Grade: **0**
O&M Grade: **0**
Clock Start/From:
Clock To:
1st Value:
2nd Value:
Value Percent:
Step: **NO**
Remarks: **END SURVEY**
