Manhole Inspection Report

Date:	04/29/2018	Weather:		Coding:	RZMACP
MH#:	M-704-013	Owner:	NA	Len. Surveyed:	12.8
P.O.#:		Surveyor:	Jen Costello	Rim to Invert:	13.7
Customer:		Cert. #:	U-907-5518	Wall Material:	Brick

Street:	Michigan Ave. 305' South of Home A	Project:	Hobart, IN
City:	Hobart, IN	GPS Northing:	41.53712845
Location:		GPS Easting:	-87.25209808
Drain Area:	Northeast	GPS Accuracy:	Nearest Meter
Cover Shape:	Circular	Evidence of Surcharge:	No
Cover Size:	22.5	Potential for Runoff:	None
Comments:

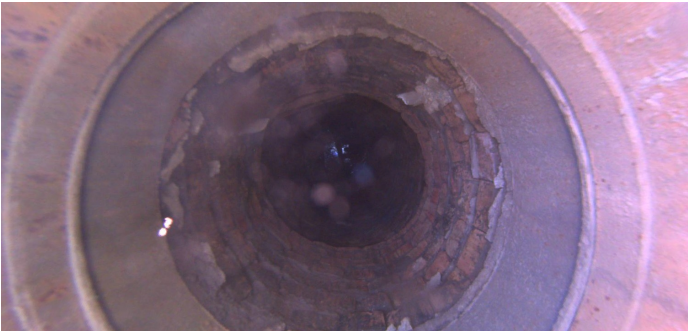
MGP

General Photo

ACCESS MH

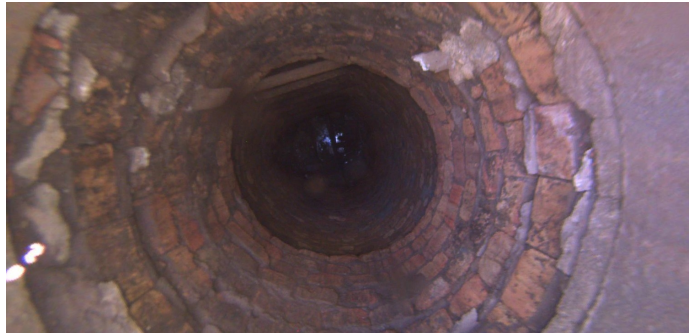
Code:	DAE
Description:	Deposits Attached Encrustation
Distance (ft):	.7
Structural Grade:	0
O&M Grade:	2
Clock Start/From:	12
Clock To:	12
1st Value:	
2nd Value:	
Value Percent:	5.000
Step:	NO
Remarks:

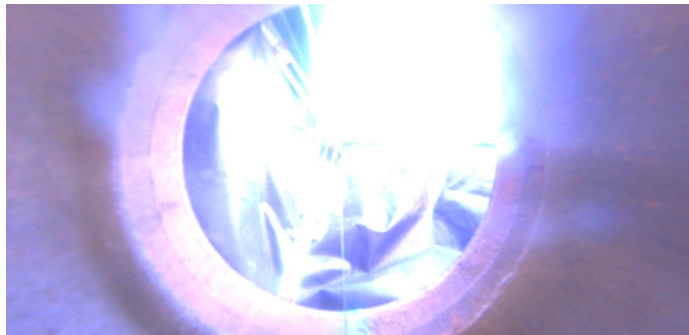
Code:	MGO
Description:	General Observation
Distance (ft):	1.7
Structural Grade:	0
O&M Grade:	0
Clock Start/From:	
Clock To:	
1st Value:	
2nd Value:	
Value Percent:	
Step:	NO
Remarks:	UNDERSIDE OF FRAME

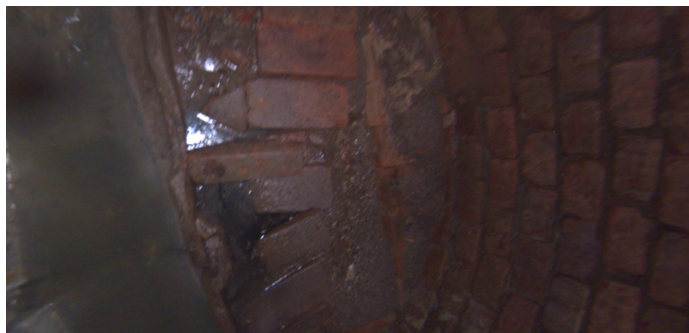
Code:	DB
Description:	Displaced Brick
Distance (ft):	12.0
Structural Grade:	3
O&M Grade:	0
Clock Start/From:	12
Clock To:	6
1st Value:	
2nd Value:	
Value Percent:	
Step:	NO
Remarks:

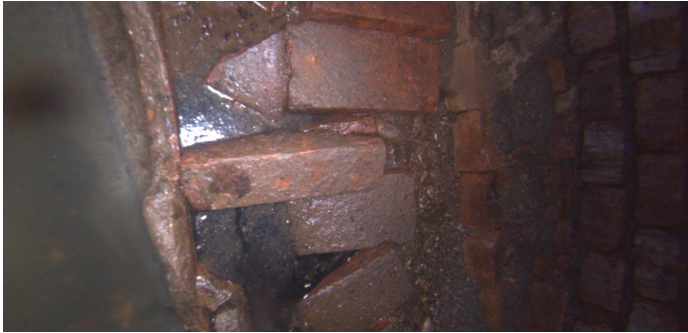
Code:	MGO
Description:	General Observation
Distance (ft):	12.8
Structural Grade:	0
O&M Grade:	0
Clock Start/From:	
Clock To:	
1st Value:	
2nd Value:	
Value Percent:	
Step:	NO
Remarks:	END SURVEY
