Manhole Inspection Report

Date:	04/29/2018	Weather:		Coding:	RZMACP
MH#:	M-704-015	Owner:	NA	Len. Surveyed:	10.3
P.O.#:		Surveyor:	Jen Costello	Rim to Invert:	10.7
Customer:		Cert. #:	U-907-5518	Wall Material:	Brick

Street:	Home Ave. 116' West of Linda St.	Project:	Hobart, IN
City:	Hobart, IN	GPS Northing:	41.53803253
Location:		GPS Easting:	-87.25050354
Drain Area:	Northeast	GPS Accuracy:	Nearest Meter
Cover Shape:	Circular	Evidence of Surcharge:	No
Cover Size:	22.5	Potential for Runoff:	None
Comments:

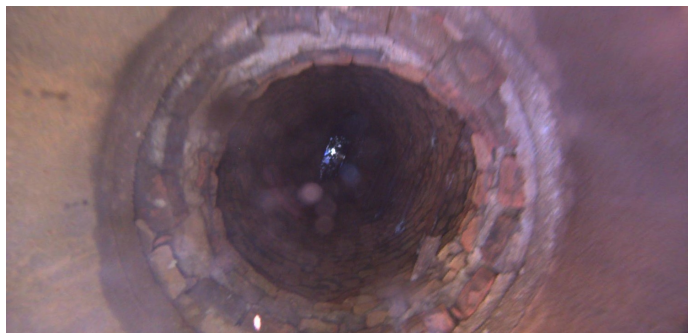
Code: **MGO**
Description: **General Observation**

Distance (ft): **.0**
Structural Grade: **0**
O&M Grade: **0**
Clock Start/From:
Clock To:
1st Value:
2nd Value:
Value Percent:
Step: **NO**
Remarks: **access mh**

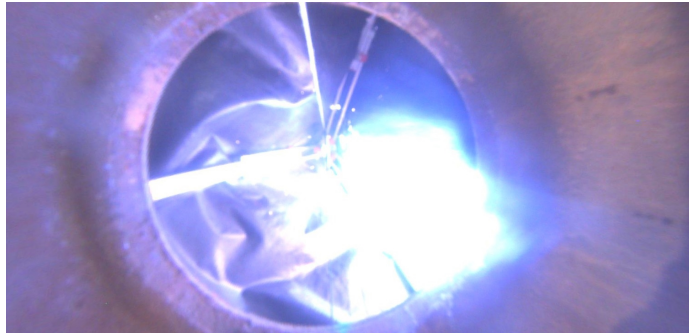
Code:	MGP
Description:	General Photo
Distance (ft):	1.6
Structural Grade:	0
O&M Grade:	0
Clock Start/From:	
Clock To:	
1st Value:	
2nd Value:	
Value Percent:	
Step:	NO
Remarks:	underside of frame

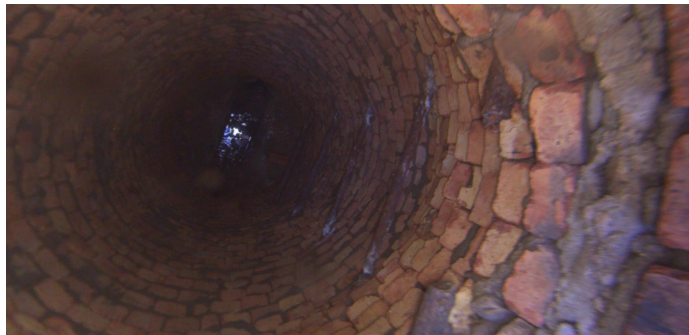
Code:	MGO
Description:	General Observation
Distance (ft):	1.6
Structural Grade:	0
O&M Grade:	0
Clock Start/From:	
Clock To:	
1st Value:	
2nd Value:	
Value Percent:	
Step:	YES
Remarks:	broken step

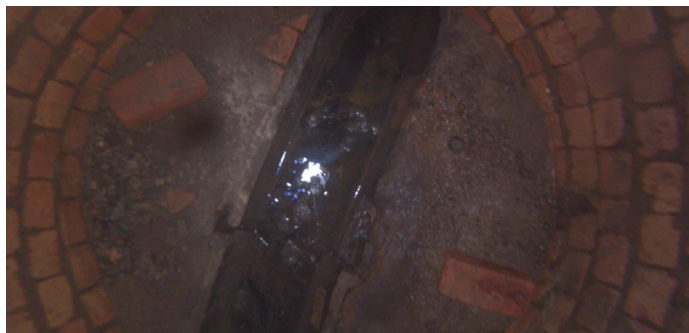
Code:	OBR
Description:	Obstacle Rocks
Distance (ft):	8.6
Structural Grade:	0
O&M Grade:	2
Clock Start/From:	9
Clock To:	3
1st Value:	
2nd Value:	
Value Percent:	5.000
Step:	NO
Remarks:

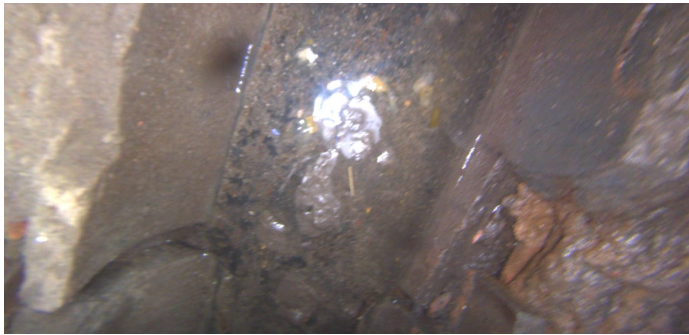
Code: **MGO**
Description: **General Observation**

Distance (ft): **10.3**
Structural Grade: **0**
O&M Grade: **0**
Clock Start/From:
Clock To:
1st Value:
2nd Value:
Value Percent:
Step: **NO**
Remarks: **end survey**
