Manhole Inspection Report

Date:	05/16/2018	Weather:		Coding:	RZMACP
MH#:	M-704-017	Owner:	NA	Len. Surveyed:	8.2
P.O.#:		Surveyor:	Jen Costello	Rim to Invert:	9.2
Customer:		Cert. #:	U-907-5518	Wall Material:	Asbestos Cement

Street:	Michigan Ave. 670' North of Home A	Project:	Hobart, IN
City:	Hobart, IN	GPS Northing:	2906655.707
Location:		GPS Easting:	2906655.707
Drain Area:	Northeast	GPS Accuracy:	Sub-Meter
Cover Shape:	Circular	Evidence of Surcharge:	No
Cover Size:	22.5	Potential for Runoff:	None
Comments:

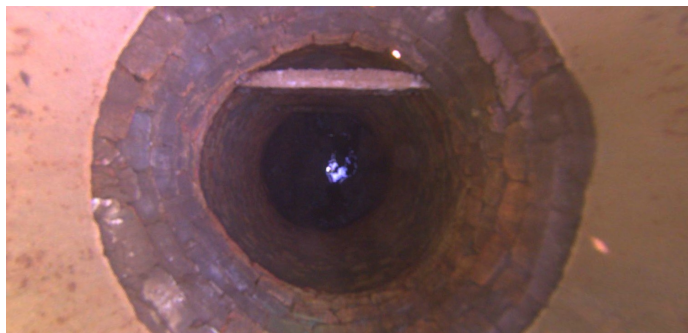
Code:	MGP
Description:	General Photo
Distance (ft):	.0
Structural Grade:	0
O&M Grade:	0
Clock Start/From:	
Clock To:	
1st Value:	
2nd Value:	
Value Percent:	
Step:	NO
Remarks:	ACCESS MH

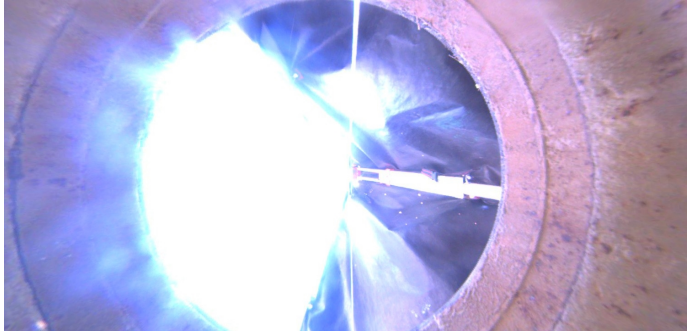
Code: **MGO**
Description: **General Observation**

Distance (ft): **1.1**
Structural Grade: **0**
O&M Grade: **0**
Clock Start/From:
Clock To:
1st Value:
2nd Value:
Value Percent:
Step: **NO**
Remarks: **END SURVEY**

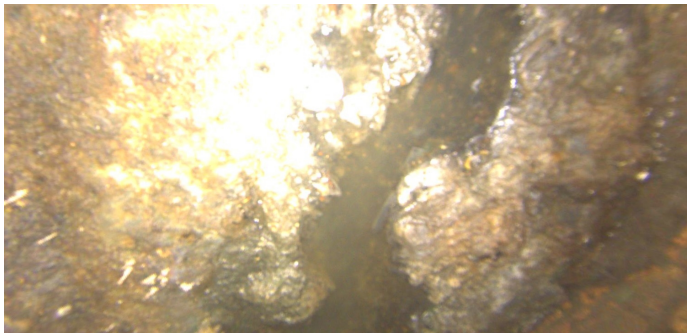
Code: **MGO**
Description: **General Observation**

Distance (ft): **8.2**
Structural Grade: **0**
O&M Grade: **0**
Clock Start/From:
Clock To:
1st Value:
2nd Value:
Value Percent:
Step: **NO**
Remarks: **END SURVEY**
