Manhole Inspection Report

Date:	05/16/2018	Weather:		Coding:	RZMACP
MH#:	M-704-019	Owner:	NA	Len. Surveyed:	4.5
P.O.#:		Surveyor:	Jen Costello	Rim to Invert:	4.7
Customer:		Cert. #:	U-907-5518	Wall Material:	Concrete (reinforced)

Street:	Michigan Ave. 403' South of South S	Project:	Hobart, IN
City:	Hobart, IN	GPS Northing:	2906729.141
Location:		GPS Easting:	2906729.141
Drain Area:	Northeast	GPS Accuracy:	Sub-Meter
Cover Shape:	Circular	Evidence of Surcharge:	No
Cover Size:	22.5	Potential for Runoff:	None
Comments:

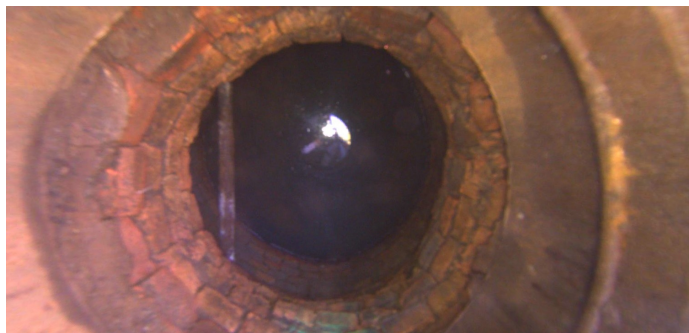
Code: **MGP**
Description: **General Photo**

Distance (ft): **.0**
Structural Grade: **0**
O&M Grade: **0**
Clock Start/From:
Clock To:
1st Value:
2nd Value:
Value Percent:
Step: **NO**
Remarks: **access mh**

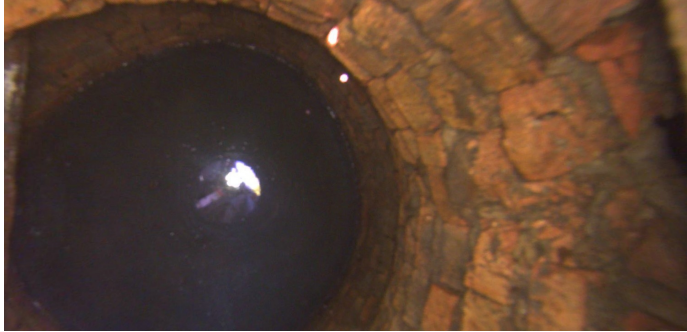
Code: **DB**
Description: **Displaced Brick**

Distance (ft): **1.1**
Structural Grade: **3**
O&M Grade: **0**
Clock Start/From: **2**
Clock To: **3**
1st Value:
2nd Value:
Value Percent:
Step: **NO**
Remarks:

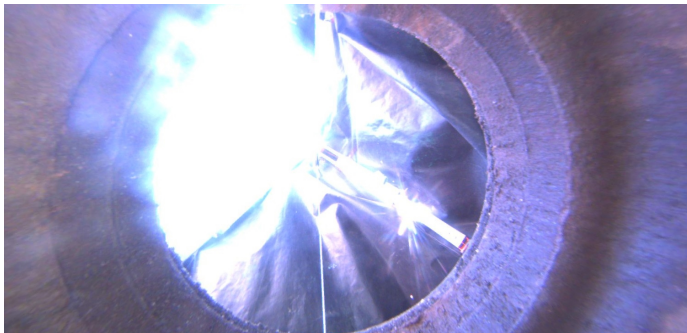
Code: **MGO**
Description: **General Observation**

Distance (ft): **1.2**
Structural Grade: **0**
O&M Grade: **0**
Clock Start/From:
Clock To:
1st Value:
2nd Value:
Value Percent:
Step: **NO**
Remarks: **underside of frame**

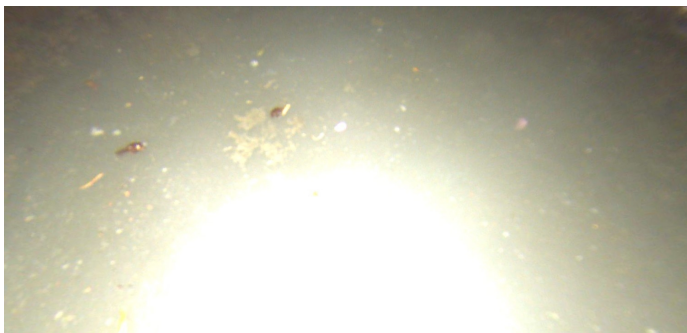
Code: **MSA**
Description: **Abandoned Survey**

Distance (ft): **4.5**
Structural Grade: **0**
O&M Grade: **0**
Clock Start/From:
Clock To:
1st Value:
2nd Value:
Value Percent:
Step: **NO**
Remarks: **submerged**
