# Manhole Inspection Report

Date:	05/06/2018	Weather:		Coding:	RZMACP
MH#:	M-704-029	Owner:	NA	Len. Surveyed:	14.3
P.O.#:		Surveyor:	Jen Costello	Rim to Invert:	13.8
Customer:		Cert. #:	U-907-5518	Wall Material:	Concrete (reinforced)

Street:	Old Ridge Rd. 542' East of Lake Park	Project:	Hobart, IN
City:	Hobart, IN	GPS Northing:	2904929.016
Location:		GPS Easting:	2904929.016
Drain Area:	Northwest	GPS Accuracy:	Sub-Meter
Cover Shape:	Circular	Evidence of Surcharge:	No
Cover Size:	22.5	Potential for Runoff:	None
Comments:

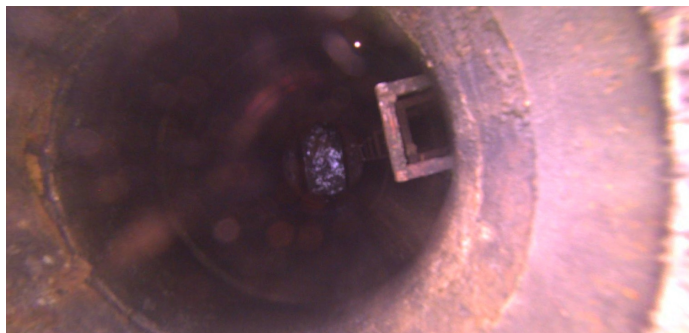
Code: **MGP**  
Description: **General Photo**

Distance (ft): **.0**  
Structural Grade: **0**  
O&M Grade: **0**  
Clock Start/From:  
Clock To:  
1st Value:  
2nd Value:  
Value Percent:  
Step: **NO**  
Remarks: **ACCESS MH**

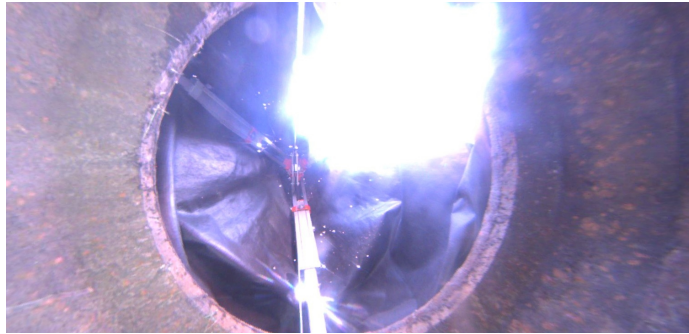
Code: **MGO**  
Description: **General Observation**

Distance (ft): **1.6**  
Structural Grade: **0**  
O&M Grade: **0**  
Clock Start/From:  
Clock To:  
1st Value:  
2nd Value:  
Value Percent:  
Step: **NO**  
Remarks: **UNDERSIDE OF FRAME**

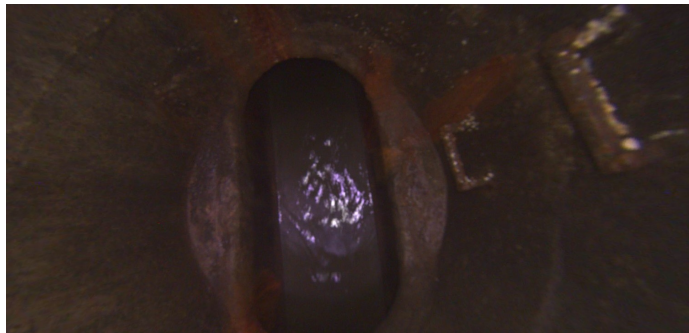
Code: **IW**  
Description: **Infil Weeper**

Distance (ft): **10.7**  
Structural Grade: **0**  
O&M Grade: **2**  
Clock Start/From: **12**  
Clock To: **2**  
1st Value:  
2nd Value:  
Value Percent:  
Step: **NO**  
Remarks:

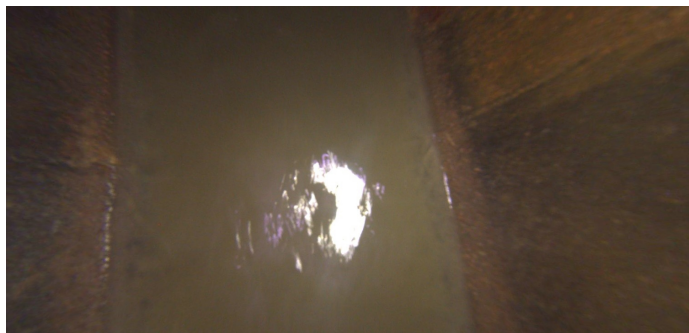
Code: **MGO**  
Description: **General Observation**

Distance (ft): **14.3**  
Structural Grade: **0**  
O&M Grade: **0**  
Clock Start/From:  
Clock To:  
1st Value:  
2nd Value:  
Value Percent:  
Step: **NO**  
Remarks: **END SURVEY**
