# Manhole Inspection Report

Date:	05/01/2018	Weather:		Coding:	RZMACP
MH#:	M-704-030	Owner:	NA	Len. Surveyed:	15.6
P.O.#:		Surveyor:	Jen Costello	Rim to Invert:	15.7
Customer:		Cert. #:	U-907-5518	Wall Material:	Concrete (reinforced)

Street:	Old Ridge Rd. 235' East of Lake Park	Project:	Hobart, IN
City:	Hobart, IN	GPS Northing:	41.53696823
Location:		GPS Easting:	-87.25902557
Drain Area:	Northwest	GPS Accuracy:	Nearest Meter
Cover Shape:	Circular	Evidence of Surcharge:	No
Cover Size:	22.5	Potential for Runoff:	None
Comments:

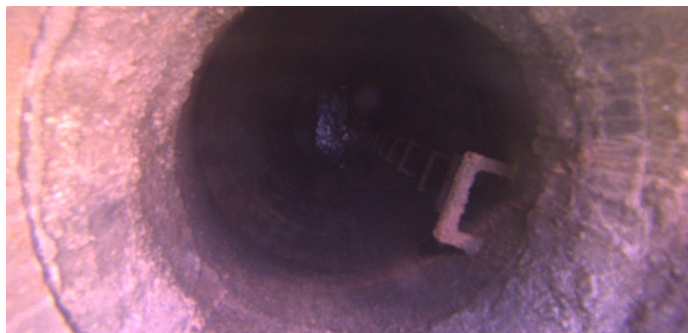
Code: **MGO**  
Description: **General Observation**

Distance (ft): **.0**  
Structural Grade: **0**  
O&M Grade: **0**  
Clock Start/From:  
Clock To:  
1st Value:  
2nd Value:  
Value Percent:  
Step: **NO**  
Remarks: **ACCESS MH**

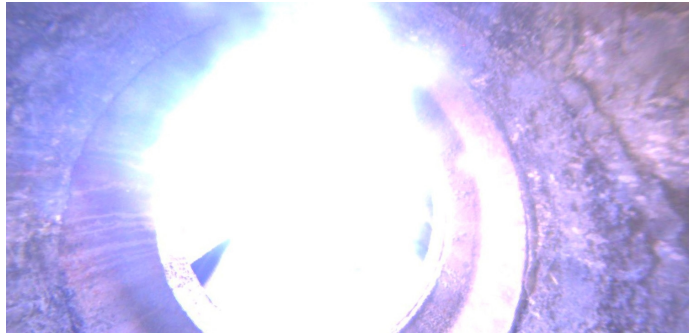
Code:	<b>MGO</b>
Description:	<b>General Observation</b>
Distance (ft):	<b>2.1</b>
Structural Grade:	<b>0</b>
O&M Grade:	<b>0</b>
Clock Start/From:	
Clock To:	
1st Value:	
2nd Value:	
Value Percent:	
Step:	<b>NO</b>
Remarks:	<b>UNDERSIDE OF FRAME</b>

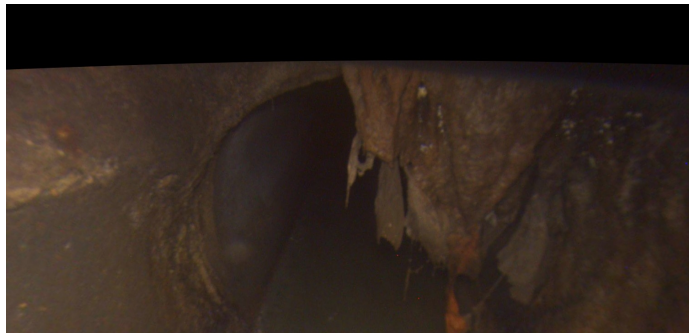
Code:	<b>DAR</b>
Description:	<b>Deposits Attached Ragging</b>
Distance (ft):	<b>15.0</b>
Structural Grade:	<b>0</b>
O&M Grade:	<b>4</b>
Clock Start/From:	<b>12</b>
Clock To:	<b>4</b>
1st Value:	
2nd Value:	
Value Percent:	<b>30.000</b>
Step:	<b>NO</b>
Remarks:

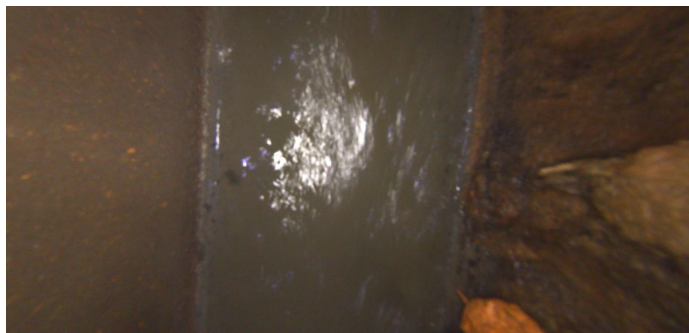
Code:	<b>MGO</b>
Description:	<b>General Observation</b>
Distance (ft):	<b>15.0</b>
Structural Grade:	<b>0</b>
O&M Grade:	<b>0</b>
Clock Start/From:	
Clock To:	
1st Value:	
2nd Value:	
Value Percent:	
Step:	<b>NO</b>
Remarks:	<b>END SURVEY</b>
