Manhole Inspection Report

Date:	05/01/2018	Weather:		Coding:	RZMACP
MH#:	M-704-032	Owner:	NA	Len. Surveyed:	8.9
P.O.#:		Surveyor:	Jen Costello	Rim to Invert:	9.7
Customer:		Cert. #:	U-907-5518	Wall Material:	Brick

Street:	Old Ridge Rd. 188' East of Lake Park	Project:	Hobart, IN
City:	Hobart, IN	GPS Northing:	41.53714371
Location:		GPS Easting:	-87.25906372
Drain Area:	North	GPS Accuracy:	Nearest Meter
Cover Shape:	Circular	Evidence of Surcharge:	No
Cover Size:	22.5	Potential for Runoff:	None
Comments:

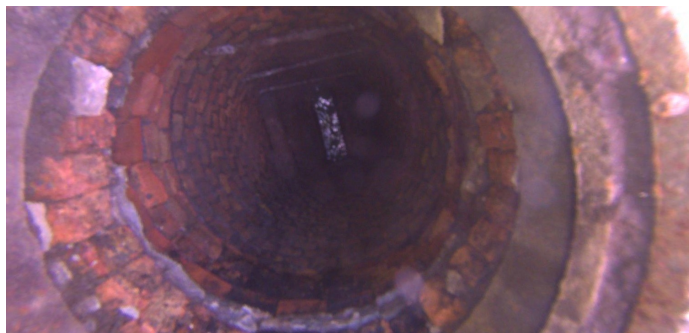
Code: **MGP**
Description: **General Photo**

Distance (ft): **.0**
Structural Grade: **0**
O&M Grade: **0**
Clock Start/From:
Clock To:
1st Value:
2nd Value:
Value Percent:
Step: **NO**
Remarks: **ACCESS MH**

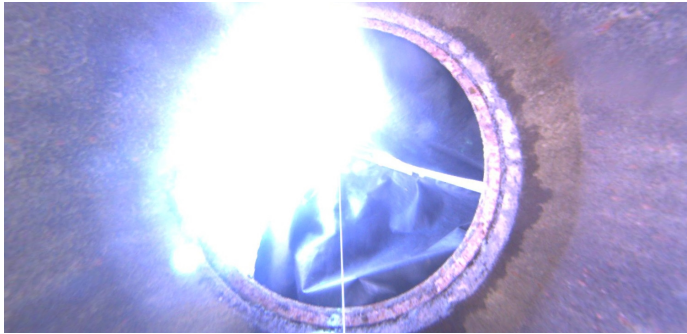
Code: **MGO**
Description: **General Observation**

Distance (ft): **1.8**
Structural Grade: **0**
O&M Grade: **0**
Clock Start/From:
Clock To:
1st Value:
2nd Value:
Value Percent:
Step: **NO**
Remarks: **UNDERSIDE OF FRAME**

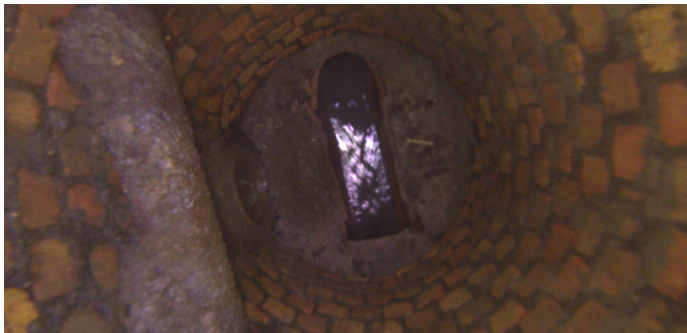
Code: **OBP**
Description: **Obstacle External Pipe or Cable**

Distance (ft): **5.4**
Structural Grade: **0**
O&M Grade: **2**
Clock Start/From: **7**
Clock To: **11**
1st Value:
2nd Value:
Value Percent: **10.000**
Step: **NO**
Remarks:

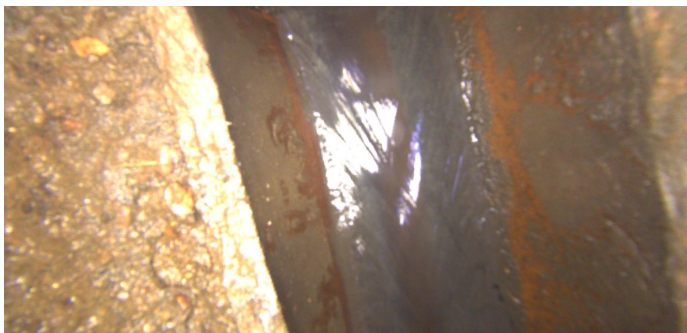
Code: **MGO**
Description: **General Observation**

Distance (ft): **8.9**
Structural Grade: **0**
O&M Grade: **0**
Clock Start/From:
Clock To:
1st Value:
2nd Value:
Value Percent:
Step: **NO**
Remarks: **END SURVEY**
