Manhole Inspection Report

Date:	10/10/2022	Weather:		Coding:	RZMACP
MH#:	M-704-053	Owner:	NA	Len. Surveyed:	3.4
P.O.#:		Surveyor:	Jen Costello	Rim to Invert:	4.0
Customer:		Cert. #:	U-907-5518	Wall Material:	Concrete (cast in place)

Street:	338' East of Lake Park Ave. 182' North	Project:	Hobart, IN
City:	Hobart, IN	GPS Northing:	2292223.925
Location:	Other	GPS Easting:	2904789.576
Drain Area:	North	GPS Accuracy:	Sub-Meter
Cover Shape:	Circular	Evidence of Surcharge:	Yes
Cover Size:	24.0	Potential for Runoff:	None
Comments:

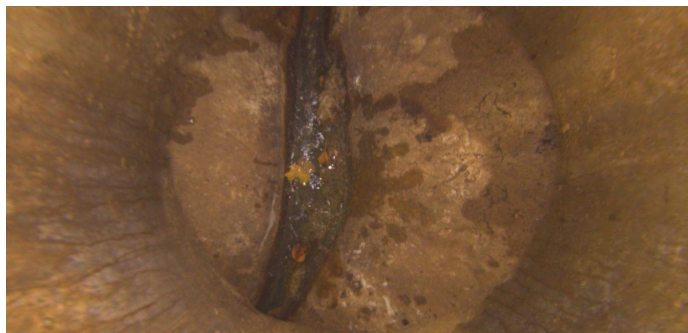
Code: **MGO**
Description: **General Observation**

Distance (ft): **.0**
Structural Grade: **0**
O&M Grade: **0**
Clock Start/From:
Clock To:
1st Value:
2nd Value:
Value Percent:
Step: **NO**
Remarks: **access mh**

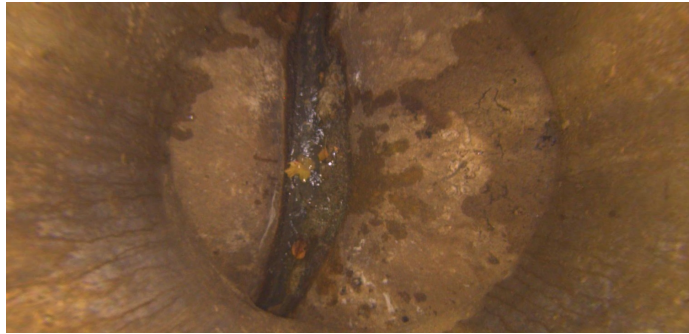
Code: **SRI**
Description: **Surface Roughness Increased**

Distance (ft): **.0**
Structural Grade: **1**
O&M Grade: **0**
Clock Start/From: **12**
Clock To: **12**
1st Value:
2nd Value:
Value Percent:
Step: **NO**
Remarks:

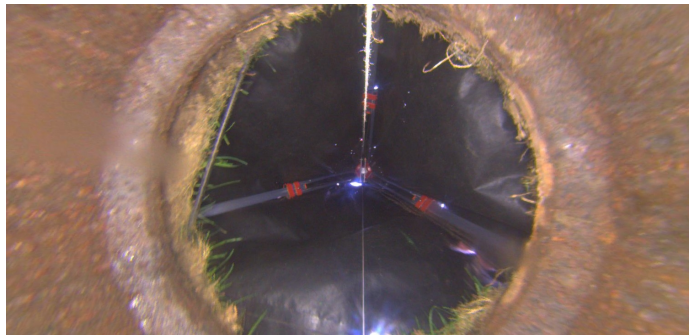
Code: **MGO**
Description: **General Observation**

Distance (ft): **.9**
Structural Grade: **0**
O&M Grade: **0**
Clock Start/From:
Clock To:
1st Value:
2nd Value:
Value Percent:
Step: **NO**
Remarks: **underside of frame**

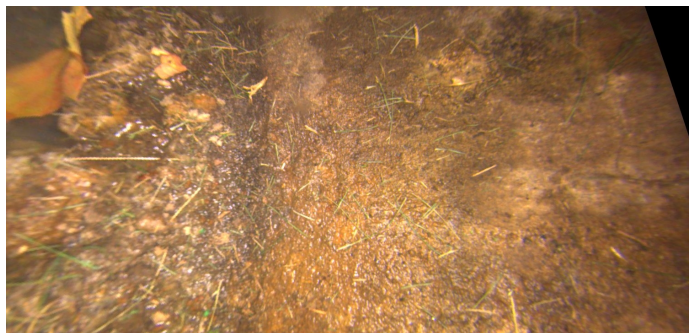
Code: **SRI**
Description: **Surface Roughness Increased**

Distance (ft): **3.2**
Structural Grade: **1**
O&M Grade: **0**
Clock Start/From: **12**
Clock To: **12**
1st Value:
2nd Value:
Value Percent:
Step: **NO**
Remarks:

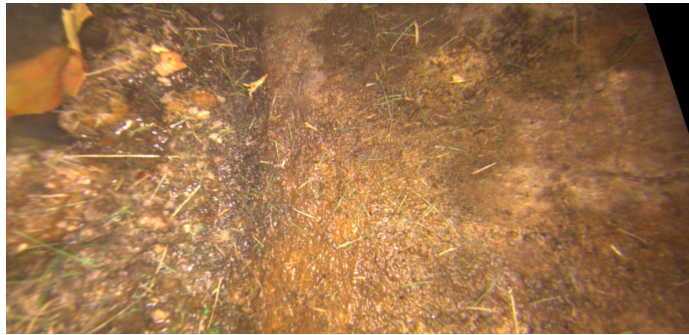
Code: **SRI**
Description: **Surface Roughness Increased**

Distance (ft): **3.2**
Structural Grade: **1**
O&M Grade: **0**
Clock Start/From: **3**
Clock To: **9**
1st Value:
2nd Value:
Value Percent:
Step: **NO**
Remarks:

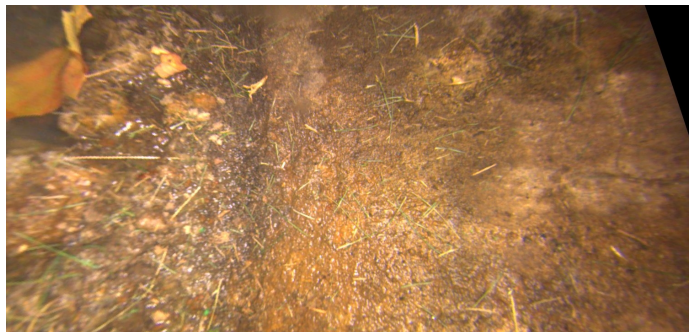
Code: **DSF**
Description: **Deposits Settled Fine**

Distance (ft): **3.2**
Structural Grade: **0**
O&M Grade: **3**
Clock Start/From: **4**
Clock To: **8**
1st Value:
2nd Value:
Value Percent: **20.000**
Step: **NO**
Remarks:

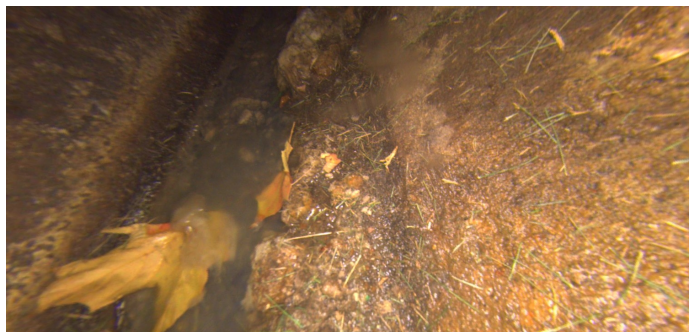
Code: **SRI**
Description: **Surface Roughness Increased**

Distance (ft): **3.2**
Structural Grade: **1**
O&M Grade: **0**
Clock Start/From: **12**
Clock To: **12**
1st Value:
2nd Value:
Value Percent:
Step: **NO**
Remarks:

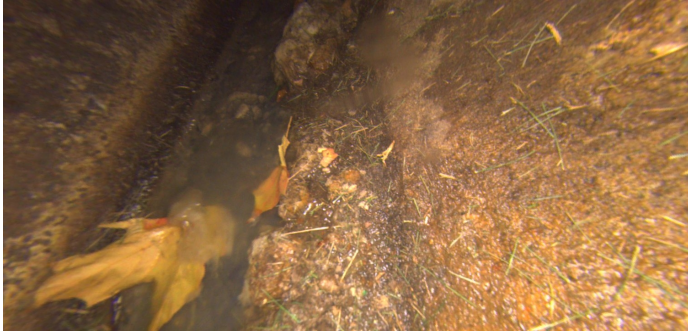
Code:	MGO
Description:	General Observation
Distance (ft):	3.2
Structural Grade:	0
O&M Grade:	0
Clock Start/From:	
Clock To:	
1st Value:	
2nd Value:	
Value Percent:	
Step:	NO
Remarks:	end of survey
