Manhole Inspection Report

Date:	10/10/2022	Weather:		Coding:	RZMACP
MH#:	M-704-054	Owner:	NA	Len. Surveyed:	3.3
P.O.#:		Surveyor:	Jen Costello	Rim to Invert:	4.0
Customer:		Cert. #:	U-907-5518	Wall Material:	Concrete (cast in place)

Street:	143' East of Lake Park Ave. 155' North	Project:	Hobart, IN
City:	Hobart, IN	GPS Northing:	2292233.573
Location:	Other	GPS Easting:	2904622.834
Drain Area:	North	GPS Accuracy:	Sub-Meter
Cover Shape:	Circular	Evidence of Surcharge:	No
Cover Size:	24.0	Potential for Runoff:	None
Comments:

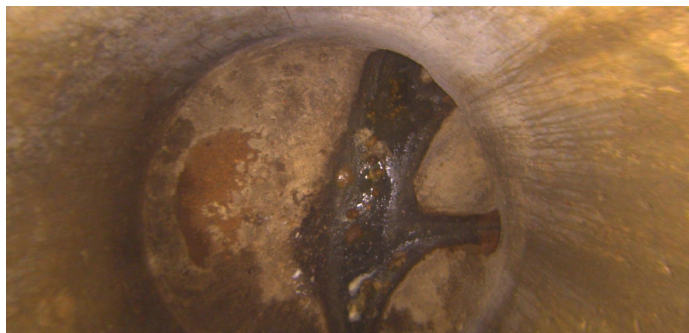
Code: **MGO**
Description: **General Observation**

Distance (ft): **.0**
Structural Grade: **0**
O&M Grade: **0**
Clock Start/From:
Clock To:
1st Value:
2nd Value:
Value Percent:
Step: **NO**
Remarks: **access mh**

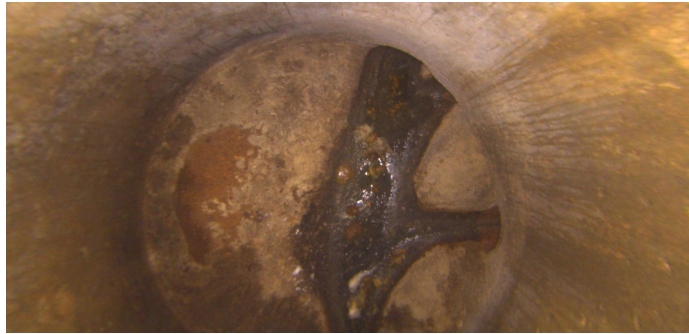
Code:	SRI
Description:	Surface Roughness Increased
Distance (ft):	.0
Structural Grade:	1
O&M Grade:	0
Clock Start/From:	12
Clock To:	12
1st Value:	
2nd Value:	
Value Percent:	
Step:	NO
Remarks:

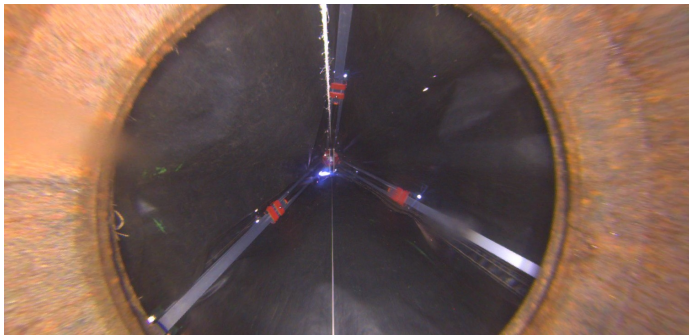
Code:	MGO
Description:	General Observation
Distance (ft):	.7
Structural Grade:	0
O&M Grade:	0
Clock Start/From:	
Clock To:	
1st Value:	
2nd Value:	
Value Percent:	
Step:	NO
Remarks:	underside of frame

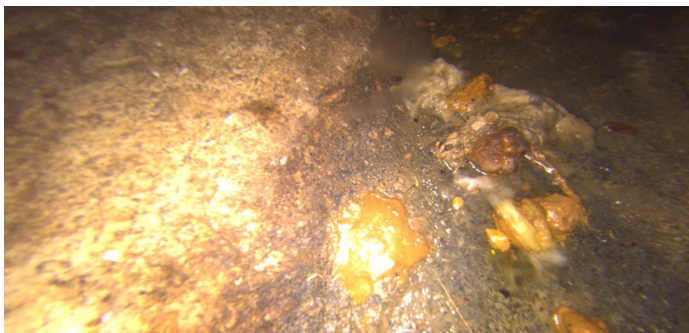
Code:	SAV
Description:	Surface Aggregate Visible
Distance (ft):	3.1
Structural Grade:	3
O&M Grade:	0
Clock Start/From:	12
Clock To:	12
1st Value:	
2nd Value:	
Value Percent:	
Step:	NO
Remarks:

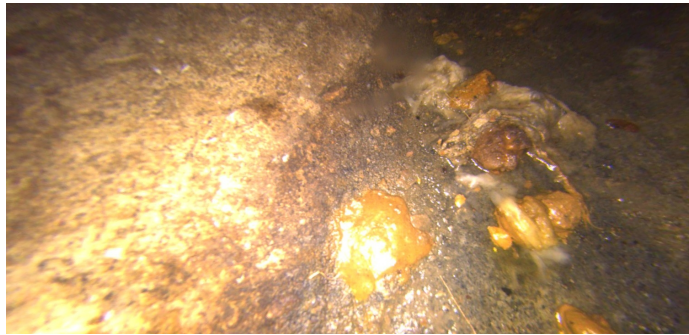
Code: **DSF**
Description: **Deposits Settled Fine**

Distance (ft): **3.1**
Structural Grade: **0**
O&M Grade: **5**
Clock Start/From: **4**
Clock To: **8**
1st Value:
2nd Value:
Value Percent: **40.000**
Step: **NO**
Remarks:

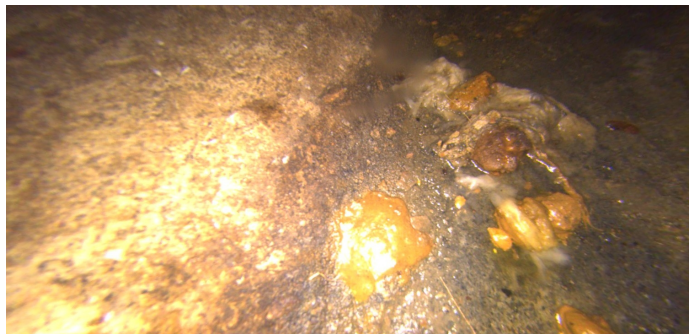
Code: **MGO**
Description: **General Observation**

Distance (ft): **3.1**
Structural Grade: **0**
O&M Grade: **0**
Clock Start/From:
Clock To:
1st Value:
2nd Value:
Value Percent:
Step: **NO**
Remarks: **end of survey**

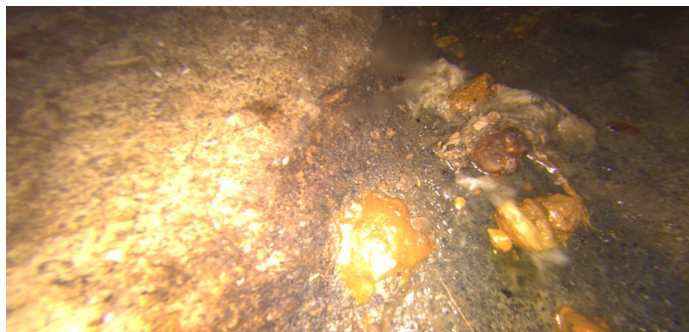
Code: **SRI**
Description: **Surface Roughness Increased**

Distance (ft): **3.1**
Structural Grade: **1**
O&M Grade: **0**
Clock Start/From: **12**
Clock To: **12**
1st Value:
2nd Value:
Value Percent:
Step: **NO**
Remarks:
