Manhole Inspection Report

Date:	05/14/2018	Weather:		Coding:	RZMACP
MH#:	M-704-057	Owner:	NA	Len. Surveyed:	3.6
P.O.#:		Surveyor:	Jen Costello	Rim to Invert:	3.9
Customer:		Cert. #:	U-907-5518	Wall Material:	Concrete (reinforced)

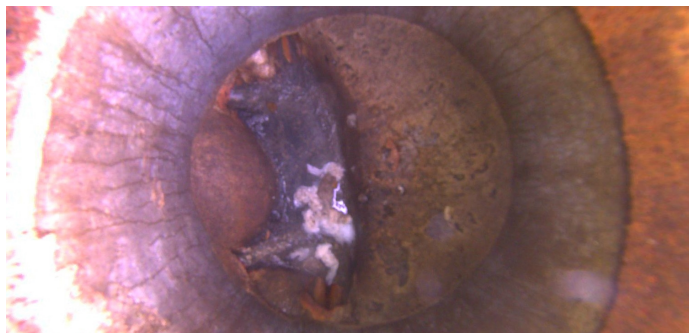
Code: **MGP**
Description: **General Photo**

Distance (ft): **.0**
Structural Grade: **0**
O&M Grade: **0**
Clock Start/From:
Clock To:
1st Value:
2nd Value:
Value Percent:
Step: **NO**
Remarks: **ACCESS MH**

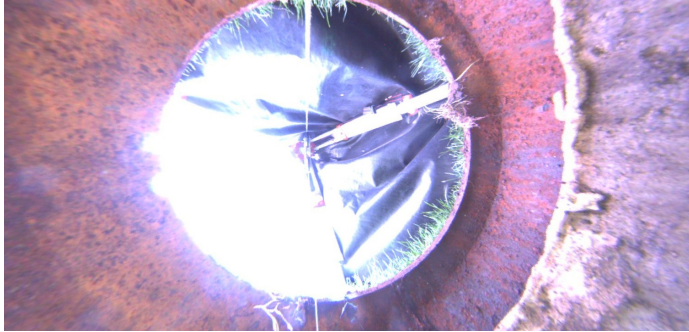
Code:	MGO
Description:	General Observation
Distance (ft):	1.4
Structural Grade:	0
O&M Grade:	0
Clock Start/From:	
Clock To:	
1st Value:	
2nd Value:	
Value Percent:	
Step:	NO
Remarks:	UNDERSIDE OF FRAME

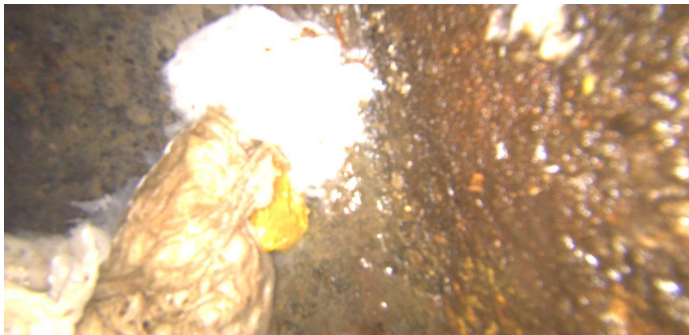
Code:	MGO
Description:	General Observation
Distance (ft):	3.6
Structural Grade:	0
O&M Grade:	0
Clock Start/From:	
Clock To:	
1st Value:	
2nd Value:	
Value Percent:	
Step:	NO
Remarks:	END SURVEY
