Manhole Inspection Report

Date:	05/16/2018	Weather:		Coding:	RZMACP
MH#:	M-704-058	Owner:	NA	Len. Surveyed:	5.0
P.O.#:		Surveyor:	Jen Costello	Rim to Invert:	5.3
Customer:		Cert. #:	U-907-5518	Wall Material:	Concrete (reinforced)

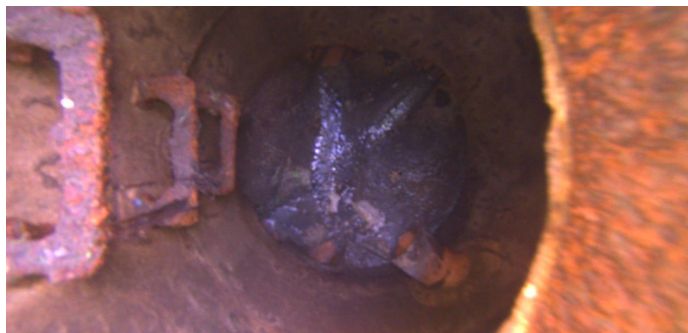
Code: **MGP**
Description: **General Photo**

Distance (ft): **.0**
Structural Grade: **0**
O&M Grade: **0**
Clock Start/From:
Clock To:
1st Value:
2nd Value:
Value Percent:
Step: **NO**
Remarks: **ACCESS MH**

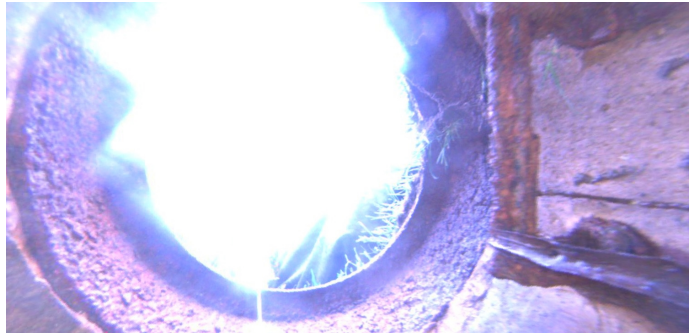
Code: **MGP**
Description: **General Photo**

Distance (ft): **2.1**
Structural Grade: **0**
O&M Grade: **0**
Clock Start/From:
Clock To:
1st Value:
2nd Value:
Value Percent:
Step: **NO**
Remarks: **ACCESS MH**

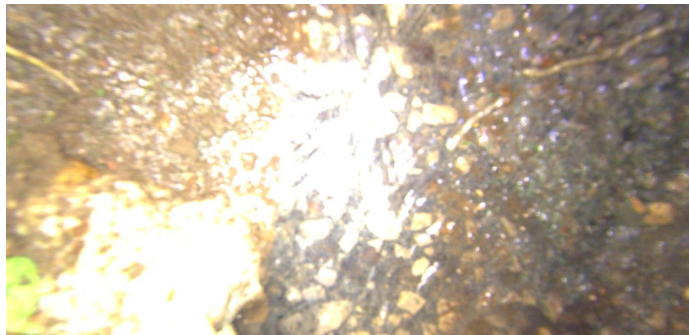
Code: **MGO**
Description: **General Observation**

Distance (ft): **5.0**
Structural Grade: **0**
O&M Grade: **0**
Clock Start/From:
Clock To:
1st Value:
2nd Value:
Value Percent:
Step: **NO**
Remarks: **END SURVEY**
