Manhole Inspection Report

Date:	05/14/2018	Weather:		Coding:	RZMACP
MH#:	M-704-060	Owner:	NA	Len. Surveyed:	3.2
P.O.#:		Surveyor:	Jen Costello	Rim to Invert:	3.8
Customer:		Cert. #:	U-907-5518	Wall Material:	Concrete (reinforced)

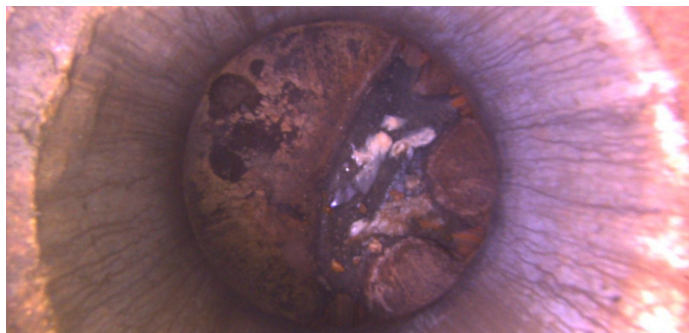
Code: **MGP**
Description: **General Photo**

Distance (ft): **.0**
Structural Grade: **0**
O&M Grade: **0**
Clock Start/From:
Clock To:
1st Value:
2nd Value:
Value Percent:
Step: **NO**
Remarks: **ACCESS MH**

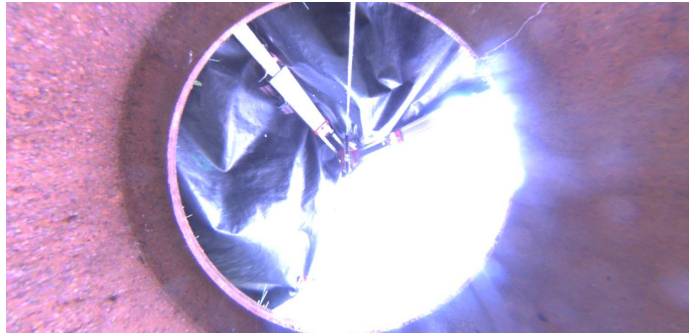
Code:	MGO
Description:	General Observation
Distance (ft):	1.2
Structural Grade:	0
O&M Grade:	0
Clock Start/From:	
Clock To:	
1st Value:	
2nd Value:	
Value Percent:	
Step:	NO
Remarks:	UNDERSIDE OF FRAME

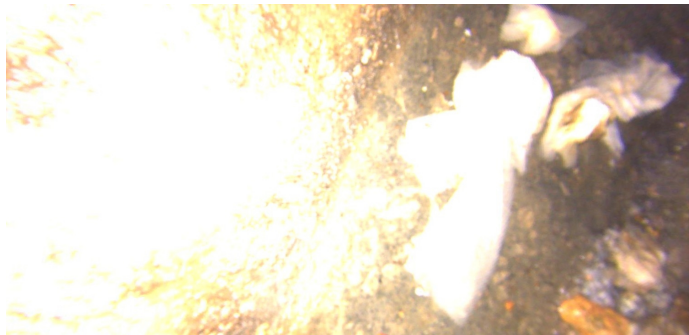
Code:	MGO
Description:	General Observation
Distance (ft):	3.2
Structural Grade:	0
O&M Grade:	0
Clock Start/From:	
Clock To:	
1st Value:	
2nd Value:	
Value Percent:	
Step:	NO
Remarks:	END SURVEY
