Manhole Inspection Report

Date:	05/16/2018	Weather:		Coding:	RZMACP
MH#:	M-704-061	Owner:	NA	Len. Surveyed:	3.3
P.O.#:		Surveyor:	Jen Costello	Rim to Invert:	3.8
Customer:		Cert. #:	U-907-5518	Wall Material:	Concrete (reinforced)

Street:	East of Lake Park Ave. 631'. West of	Project:	Hobart, IN
City:	Hobart, IN	GPS Northing:	2905072.66
Location:		GPS Easting:	2905072.66
Drain Area:	North	GPS Accuracy:	Sub-Meter
Cover Shape:	Circular	Evidence of Surcharge:	No
Cover Size:	22.5	Potential for Runoff:	None
Comments:

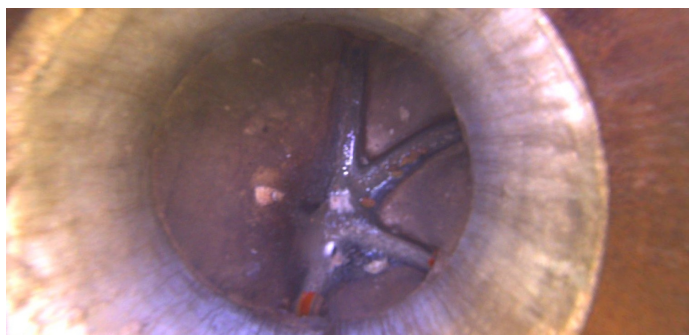
Code: **MGP**
Description: **General Photo**

Distance (ft): **.0**
Structural Grade: **0**
O&M Grade: **0**
Clock Start/From:
Clock To:
1st Value:
2nd Value:
Value Percent:
Step: **NO**
Remarks: **access mh**

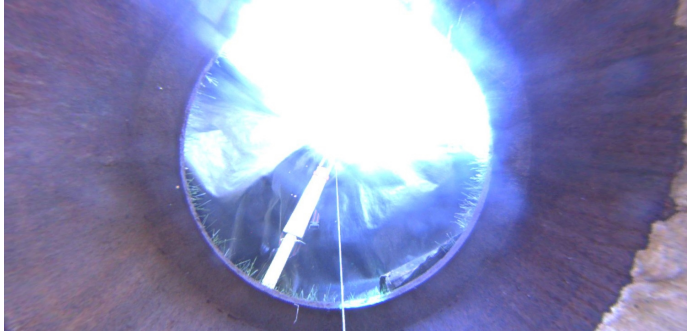
Code:	MGO
Description:	General Observation
Distance (ft):	1.6
Structural Grade:	0
O&M Grade:	0
Clock Start/From:	
Clock To:	
1st Value:	
2nd Value:	
Value Percent:	
Step:	NO
Remarks:	underside of frame

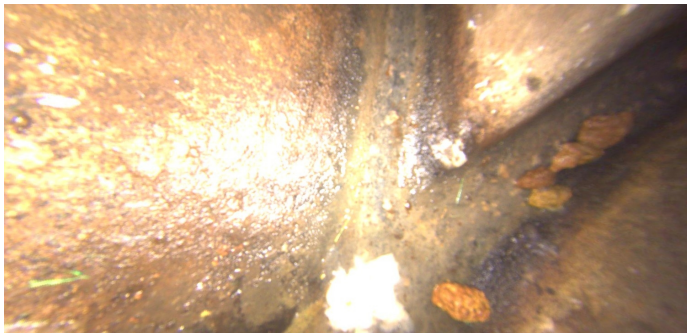
Code:	MGO
Description:	General Observation
Distance (ft):	3.3
Structural Grade:	0
O&M Grade:	0
Clock Start/From:	
Clock To:	
1st Value:	
2nd Value:	
Value Percent:	
Step:	NO
Remarks:	end survey
