Manhole Inspection Report

Date:	10/10/2022	Weather:		Coding:	RZMACP
MH#:	M-704-062	Owner:	NA	Len. Surveyed:	5.4
P.O.#:		Surveyor:	Jen Costello	Rim to Invert:	6.5
Customer:		Cert. #:	U-907-5518	Wall Material:	Concrete (cast in place)

Street:	West of Edgewater Dr. North Side of	Project:	Hobart, IN
City:	Hobart, IN	GPS Northing:	2292663.483
Location:	Other	GPS Easting:	2905381.605
Drain Area:	North	GPS Accuracy:	Sub-Meter
Cover Shape:	Circular	Evidence of Surcharge:	Yes
Cover Size:	24.0	Potential for Runoff:	None
Comments:

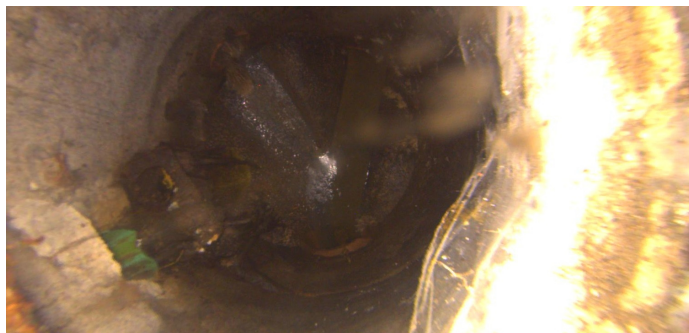
Code: **MGO**
Description: **General Observation**

Distance (ft): **.0**
Structural Grade: **0**
O&M Grade: **0**
Clock Start/From:
Clock To:
1st Value:
2nd Value:
Value Percent:
Step: **NO**
Remarks: **access mh**

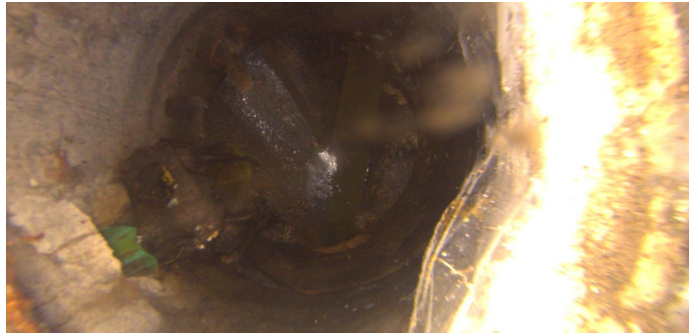
Code: **SRI**
Description: **Surface Roughness Increased**

Distance (ft): **.0**
Structural Grade: **1**
O&M Grade: **0**
Clock Start/From: **12**
Clock To: **12**
1st Value:
2nd Value:
Value Percent:
Step: **NO**
Remarks:

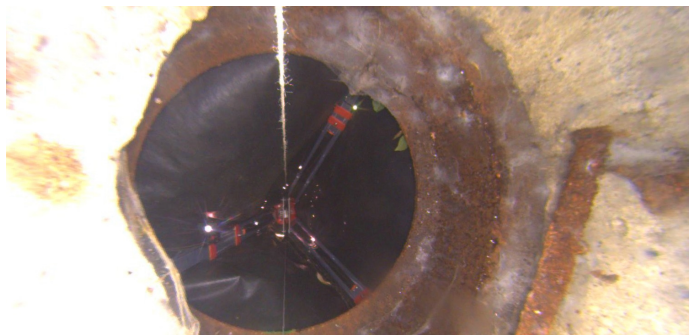
Code: **MGO**
Description: **General Observation**

Distance (ft): **1.8**
Structural Grade: **0**
O&M Grade: **0**
Clock Start/From:
Clock To:
1st Value:
2nd Value:
Value Percent:
Step: **NO**
Remarks: **underside of frame**

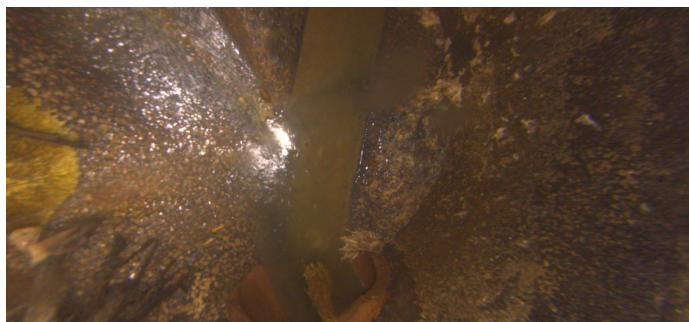
Code: **RFC**
Description: **Roots Fine Connection**

Distance (ft): **3.1**
Structural Grade: **0**
O&M Grade: **1**
Clock Start/From: **6**
Clock To:
1st Value:
2nd Value:
Value Percent:
Step: **NO**
Remarks:

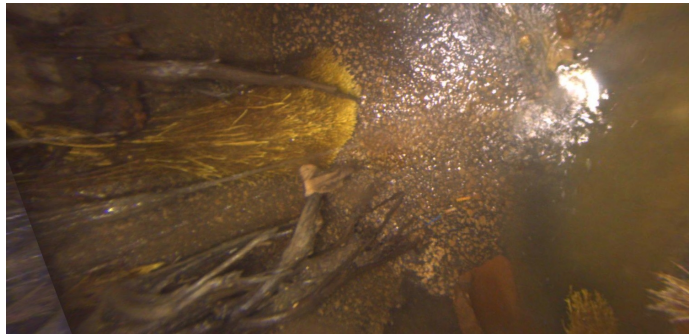
Code: **RMB**
Description: **Roots Medium Barrel**

Distance (ft): **3.4**
Structural Grade: **0**
O&M Grade: **4**
Clock Start/From: **7**
Clock To: **9**
1st Value:
2nd Value:
Value Percent: **10.000**
Step: **NO**
Remarks:

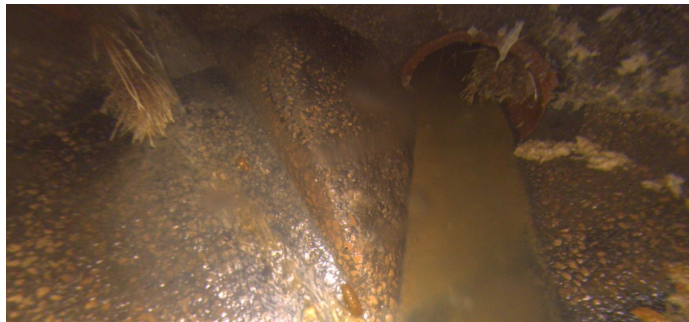
Code: **RML**
Description: **Roots Medium Lateral**

Distance (ft): **4.3**
Structural Grade: **0**
O&M Grade: **3**
Clock Start/From: **10**
Clock To:
1st Value:
2nd Value:
Value Percent: **5.000**
Step: **NO**
Remarks:

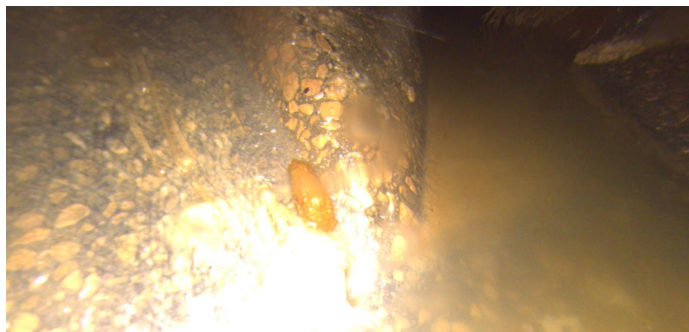
Code: **SRI**
Description: **Surface Roughness Increased**

Distance (ft): **5.4**
Structural Grade: **1**
O&M Grade: **0**
Clock Start/From: **12**
Clock To: **12**
1st Value:
2nd Value:
Value Percent:
Step: **NO**
Remarks:

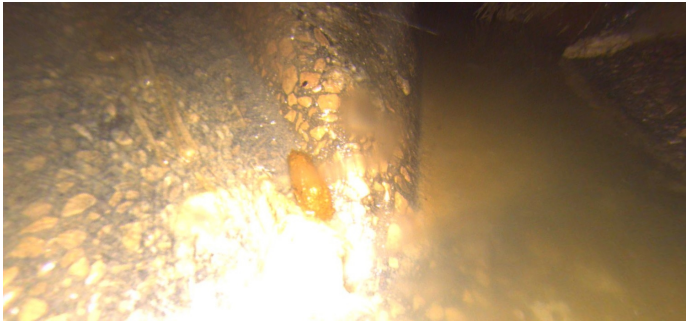
Code: **SAP**
Description: **Surface Aggregate Projecting**

Distance (ft): **5.4**
Structural Grade: **3**
O&M Grade: **0**
Clock Start/From: **12**
Clock To: **12**
1st Value:
2nd Value:
Value Percent:
Step: **NO**
Remarks:

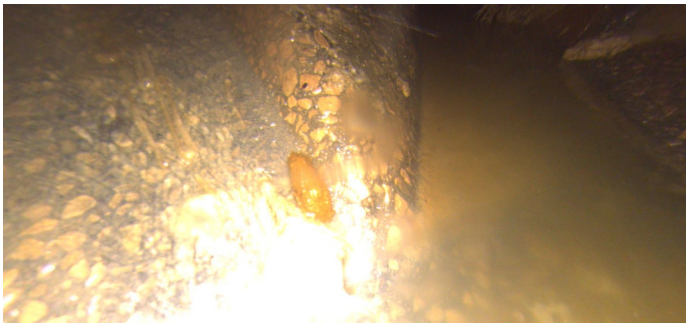
Code: **MGO**
Description: **General Observation**

Distance (ft): **5.4**
Structural Grade: **0**
O&M Grade: **0**
Clock Start/From:
Clock To:
1st Value:
2nd Value:
Value Percent:
Step: **NO**
Remarks: **end of survey**
