Manhole Inspection Report

Date:	05/16/2018	Weather:		Coding:	RZMACP
MH#:	M-704-066	Owner:	NA	Len. Surveyed:	9.6
P.O.#:		Surveyor:	Jen Costello	Rim to Invert:	9.8
Customer:		Cert. #:	U-907-5518	Wall Material:	Concrete (reinforced)

Street:	Edgewater Dr. 555' South of Fox Trail	Project:	Hobart, IN
City:	Hobart, IN	GPS Northing:	2905693.422
Location:		GPS Easting:	2905693.422
Drain Area:	North	GPS Accuracy:	Sub-Meter
Cover Shape:	Circular	Evidence of Surcharge:	No
Cover Size:	22.5	Potential for Runoff:	None
Comments:

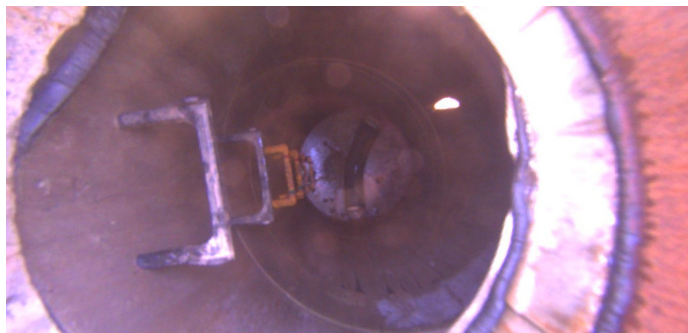
Code: **MGP**
Description: **General Photo**

Distance (ft): **.0**
Structural Grade: **0**
O&M Grade: **0**
Clock Start/From:
Clock To:
1st Value:
2nd Value:
Value Percent:
Step: **NO**
Remarks: **access mh**

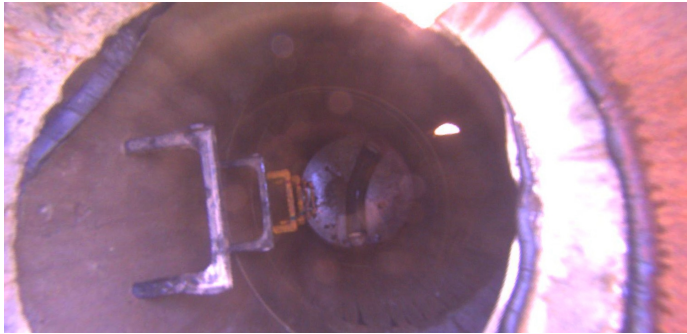
Code:	ISSR
Description:	Intruding Sealing Ring
Distance (ft):	.0
Structural Grade:	0
O&M Grade:	2
Clock Start/From:	10
Clock To:	11
1st Value:	
2nd Value:	
Value Percent:	5.000
Step:	NO
Remarks:

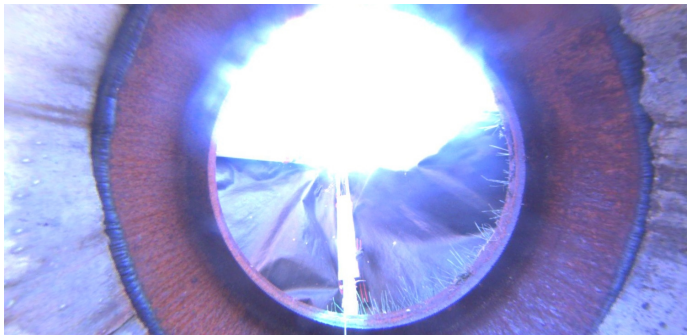
Code:	MGO
Description:	General Observation
Distance (ft):	1.6
Structural Grade:	0
O&M Grade:	0
Clock Start/From:	
Clock To:	
1st Value:	
2nd Value:	
Value Percent:	
Step:	NO
Remarks:	underside of frame

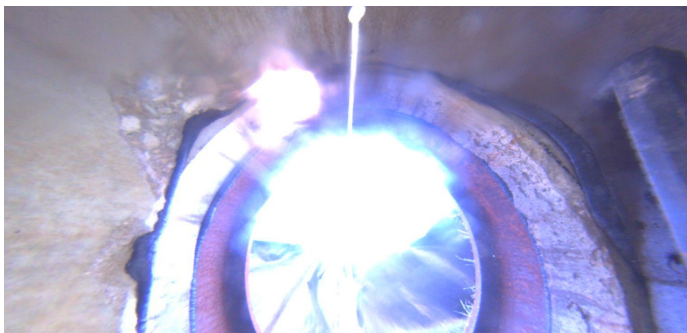
Code:	SSS
Description:	Surface Spalling
Distance (ft):	2.1
Structural Grade:	2
O&M Grade:	0
Clock Start/From:	1
Clock To:	
1st Value:	
2nd Value:	
Value Percent:	
Step:	NO
Remarks:
