# Manhole Inspection Report

Date:	<b>05/16/2018</b>	Weather:		Coding:	<b>RZMACP</b>
MH#:	<b>M-704-073</b>	Owner:	<b>NA</b>	Len. Surveyed:	<b>6.4</b>
P.O.#:		Surveyor:	<b>Jen Costello</b>	Rim to Invert:	<b>6.4</b>
Customer:		Cert. #:	<b>U-907-5518</b>	Wall Material:	<b>Concrete (reinforced)</b>

Street:	<b>The Edgewater Drive Cul De Sac.</b>	Project:	<b>Hobart, IN</b>
City:	<b>Hobart, IN</b>	GPS Northing:	<b>2906090.717</b>
Location:		GPS Easting:	<b>2906090.717</b>
Drain Area:	<b>North</b>	GPS Accuracy:	<b>Sub-Meter</b>
Cover Shape:	<b>Circular</b>	Evidence of Surcharge:	<b>No</b>
Cover Size:	<b>22.5</b>	Potential for Runoff:	<b>None</b>
Comments:

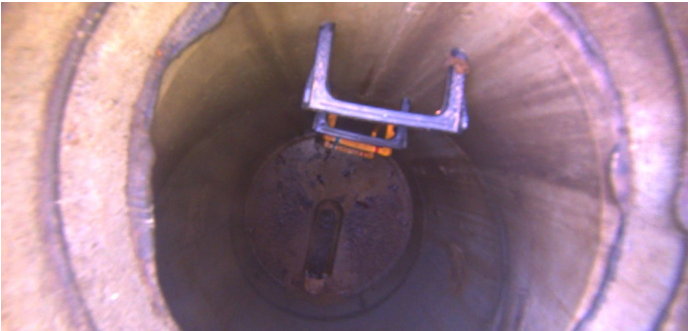
.0

General Photo

ACCESS MH

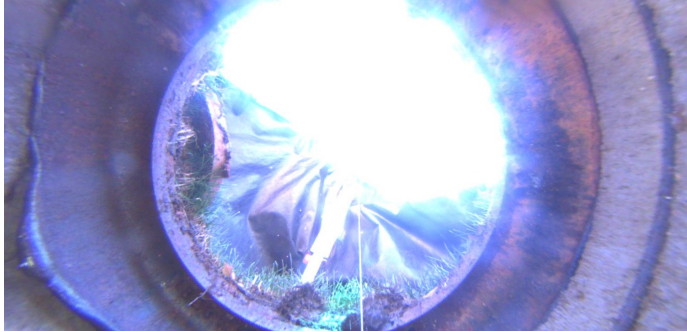
Code: **MGO**  
Description: **General Observation**

Distance (ft): **1.4**  
Structural Grade: **0**  
O&M Grade: **0**  
Clock Start/From:  
Clock To:  
1st Value:  
2nd Value:  
Value Percent:  
Step: **NO**  
Remarks: **UNDERSIDE OF FRAME**

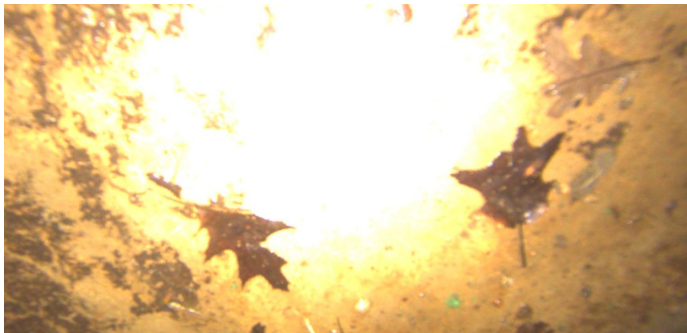
Code: **MGO**  
Description: **General Observation**

Distance (ft): **6.4**  
Structural Grade: **0**  
O&M Grade: **0**  
Clock Start/From:  
Clock To:  
1st Value:  
2nd Value:  
Value Percent:  
Step: **NO**  
Remarks: **END SURVEY**
