Manhole Inspection Report

Date:	05/16/2018	Weather:		Coding:	RZMACP
MH#:	M-704-075	Owner:	NA	Len. Surveyed:	6.7
P.O.#:		Surveyor:	Jen Costello	Rim to Invert:	7.1
Customer:		Cert. #:	U-907-5518	Wall Material:	Concrete (reinforced)

Street:	On Harbor Club Drive. 140' West of	Project:	Hobart, IN
City:	Hobart, IN	GPS Northing:	2904706.495
Location:		GPS Easting:	2904706.495
Drain Area:	North	GPS Accuracy:	Sub-Meter
Cover Shape:	Circular	Evidence of Surcharge:	No
Cover Size:	22.5	Potential for Runoff:	None
Comments:

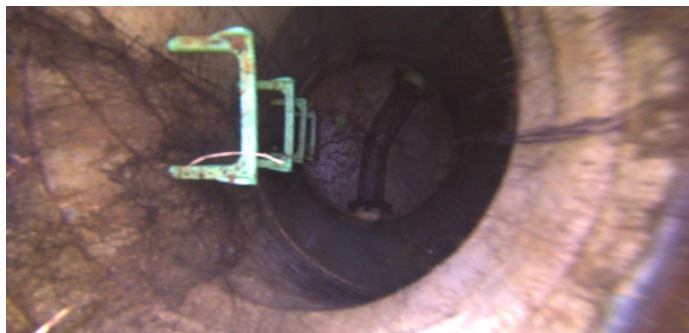
Code: **MGP**
Description: **General Photo**

Distance (ft): **.0**
Structural Grade: **0**
O&M Grade: **0**
Clock Start/From:
Clock To:
1st Value:
2nd Value:
Value Percent:
Step: **NO**
Remarks: **ACCESS MH**

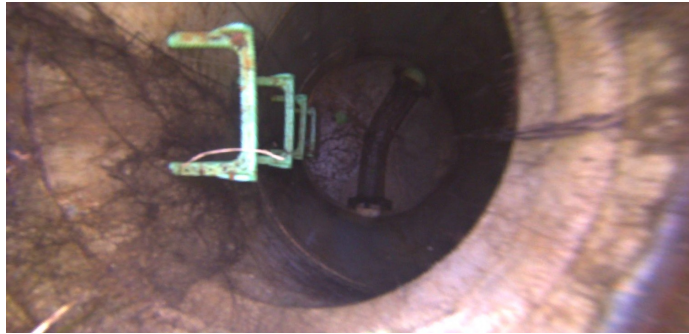
Code: **RFJ**
Description: **Roots Fine Joint**

Distance (ft): **.0**
Structural Grade: **0**
O&M Grade: **1**
Clock Start/From: **12**
Clock To: **12**
1st Value:
2nd Value:
Value Percent:
Step: **NO**
Remarks:

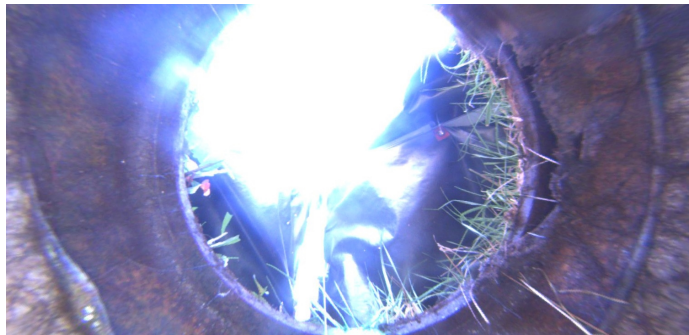
Code: **MGO**
Description: **General Observation**

Distance (ft): **1.4**
Structural Grade: **0**
O&M Grade: **0**
Clock Start/From:
Clock To:
1st Value:
2nd Value:
Value Percent:
Step: **NO**
Remarks: **UNDERSIDE OF FRAME**

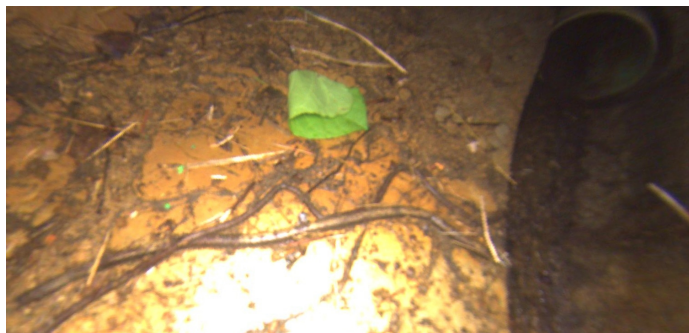
Code: **MGO**
Description: **General Observation**

Distance (ft): **6.7**
Structural Grade: **0**
O&M Grade: **0**
Clock Start/From:
Clock To:
1st Value:
2nd Value:
Value Percent:
Step: **NO**
Remarks: **END SURVEY**
