Manhole Inspection Report

Date:	05/04/2018	Weather:		Coding:	RZMACP
MH#:	M-705-002	Owner:	NA	Len. Surveyed:	17.8
P.O.#:		Surveyor:	Jen Costello	Rim to Invert:	20.3
Customer:		Cert. #:	U-907-5518	Wall Material:	Concrete (reinforced)

Street:	221' South of 3rd St. East of New St.	Project:	Hobart, IN
City:	Hobart, IN	GPS Northing:	2906874.968
Location:		GPS Easting:	2906874.968
Drain Area:	South	GPS Accuracy:	Sub-Meter
Cover Shape:	Circular	Evidence of Surcharge:	No
Cover Size:	22.5	Potential for Runoff:	None
Comments:

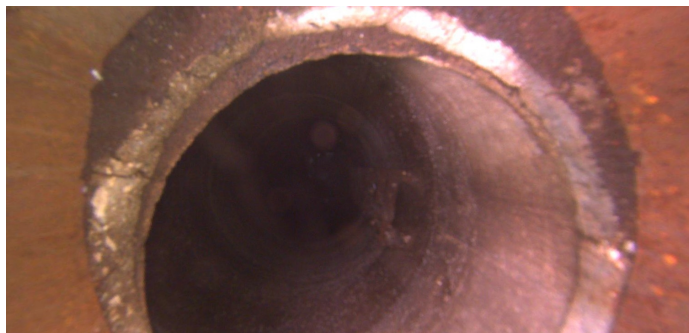
Code: **MGP**
Description: **General Photo**

Distance (ft): **.0**
Structural Grade: **0**
O&M Grade: **0**
Clock Start/From:
Clock To:
1st Value:
2nd Value:
Value Percent:
Step: **NO**
Remarks: **access MH**

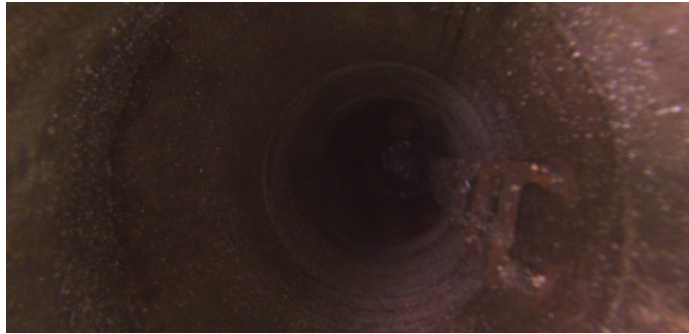
Code: **SAV**
Description: **Surface Aggregate Visible**

Distance (ft): **1.5**
Structural Grade: **3**
O&M Grade: **0**
Clock Start/From: **12**
Clock To: **12**
1st Value:
2nd Value:
Value Percent:
Step: **NO**
Remarks:

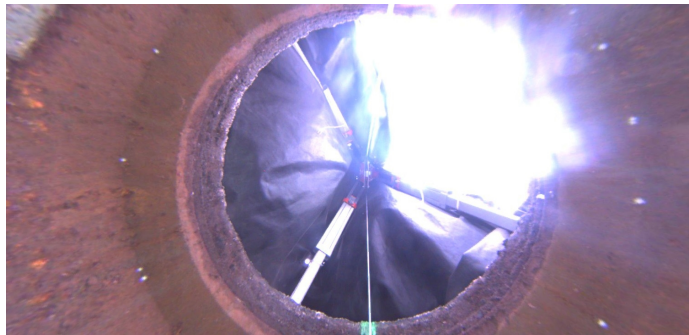
Code: **MGO**
Description: **General Observation**

Distance (ft): **1.5**
Structural Grade: **0**
O&M Grade: **0**
Clock Start/From:
Clock To:
1st Value:
2nd Value:
Value Percent:
Step: **NO**
Remarks: **UNDERSIDE OF FRAME**

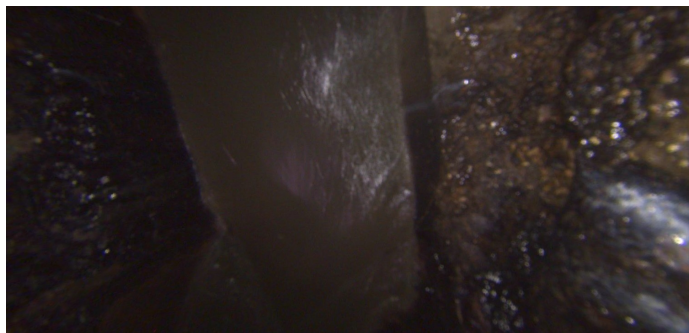
Code: **MGO**
Description: **General Observation**

Distance (ft): **17.8**
Structural Grade: **0**
O&M Grade: **0**
Clock Start/From:
Clock To:
1st Value:
2nd Value:
Value Percent:
Step: **NO**
Remarks: **END SURVEY**
