Manhole Inspection Report

Date:	05/04/2018	Weather:		Coding:	RZMACP
MH#:	M-705-003	Owner:	NA	Len. Surveyed:	6.3
P.O.#:		Surveyor:	Jen Costello	Rim to Invert:	20.0
Customer:		Cert. #:	U-907-5518	Wall Material:	Concrete (reinforced)

Street:	40' South of 3rd St. East of New St.	Project:	Hobart, IN
City:	Hobart, IN	GPS Northing:	41.53321457
Location:		GPS Easting:	-87.2511673
Drain Area:	South	GPS Accuracy:	Nearest Meter
Cover Shape:	Circular	Evidence of Surcharge:	No
Cover Size:	22.5	Potential for Runoff:	None
Comments:

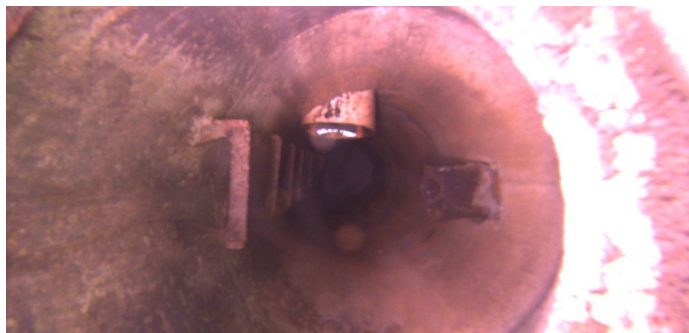
Code:	MGP
Description:	General Photo
Distance (ft):	.0
Structural Grade:	0
O&M Grade:	0
Clock Start/From:	
Clock To:	
1st Value:	
2nd Value:	
Value Percent:	
Step:	NO
Remarks:	ACCESS MH

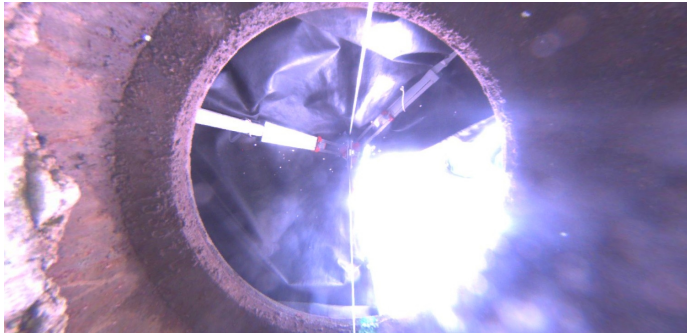
Code:	MGO
Description:	General Observation
Distance (ft):	1.4
Structural Grade:	0
O&M Grade:	0
Clock Start/From:	
Clock To:	
1st Value:	
2nd Value:	
Value Percent:	
Step:	NO
Remarks:	UNDERSIDE OF FRAME

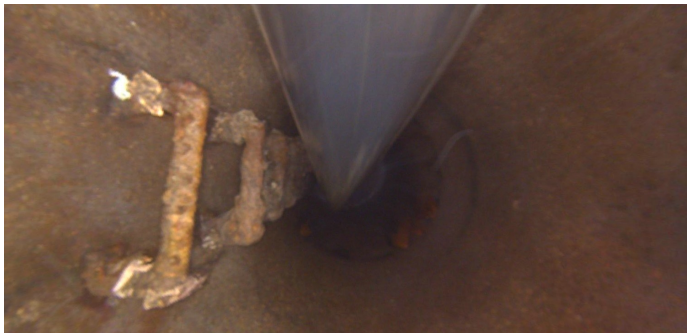
Code:	MSA
Description:	Abandoned Survey
Distance (ft):	6.3
Structural Grade:	0
O&M Grade:	0
Clock Start/From:	
Clock To:	
1st Value:	
2nd Value:	
Value Percent:	
Step:	NO
Remarks:	INTRUDING LINES
