Manhole Inspection Report

Date:	05/06/2018	Weather:		Coding:	RZMACP
MH#:	M-705-004	Owner:	NA	Len. Surveyed:	18.0
P.O.#:		Surveyor:	Jen Costello	Rim to Invert:	19.5
Customer:		Cert. #:	U-907-5518	Wall Material:	Concrete (reinforced)

Street:	North of 3rd St. 202' East of New St.	Project:	Hobart, IN
City:	Hobart, IN	GPS Northing:	2906705.095
Location:		GPS Easting:	2906705.095
Drain Area:	South	GPS Accuracy:	Sub-Meter
Cover Shape:	Circular	Evidence of Surcharge:	No
Cover Size:	22.5	Potential for Runoff:	None
Comments:

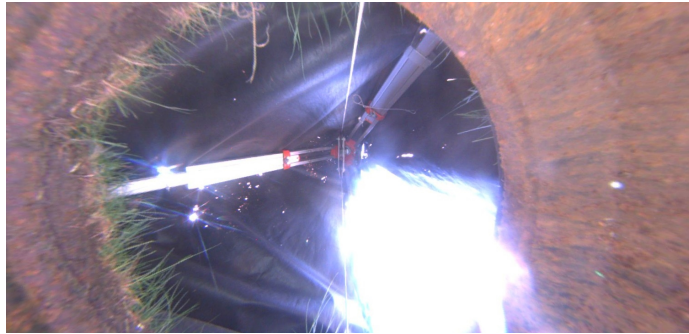
Code:	MGO
Description:	General Observation
Distance (ft):	1.2
Structural Grade:	0
O&M Grade:	0
Clock Start/From:	
Clock To:	
1st Value:	
2nd Value:	
Value Percent:	
Step:	NO
Remarks:	UNDERSIDE OF FRAME

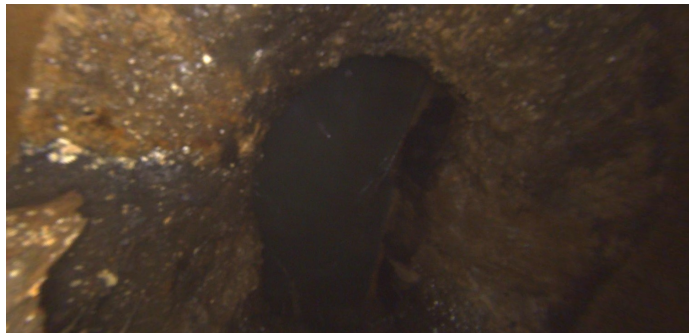
Code:	MGO
Description:	General Observation
Distance (ft):	18.0
Structural Grade:	0
O&M Grade:	0
Clock Start/From:	
Clock To:	
1st Value:	
2nd Value:	
Value Percent:	
Step:	NO
Remarks:	END SURVEY
