# Manhole Inspection Report

Date:	05/03/2018	Weather:		Coding:	RZMACP
MH#:	M-705-015	Owner:	NA	Len. Surveyed:	4.2
P.O.#:		Surveyor:	Jen Costello	Rim to Invert:	4.7
Customer:		Cert. #:	U-907-5518	Wall Material:	Brick

Street:	Intersection of 5th St. and Center St.	Project:	Hobart, IN
City:	Hobart, IN	GPS Northing:	2906550.36
Location:		GPS Easting:	2906550.36
Drain Area:	South	GPS Accuracy:	Sub-Meter
Cover Shape:	Circular	Evidence of Surcharge:	No
Cover Size:	22.5	Potential for Runoff:	None
Comments:

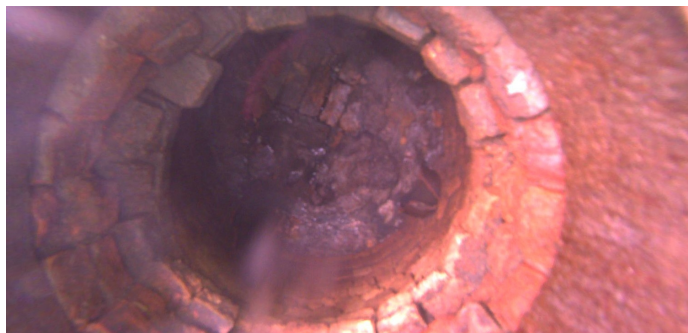
Code: **MGP**  
Description: **General Photo**

Distance (ft): **.0**  
Structural Grade: **0**  
O&M Grade: **0**  
Clock Start/From:  
Clock To:  
1st Value:  
2nd Value:  
Value Percent:  
Step: **NO**  
Remarks: **access MH**

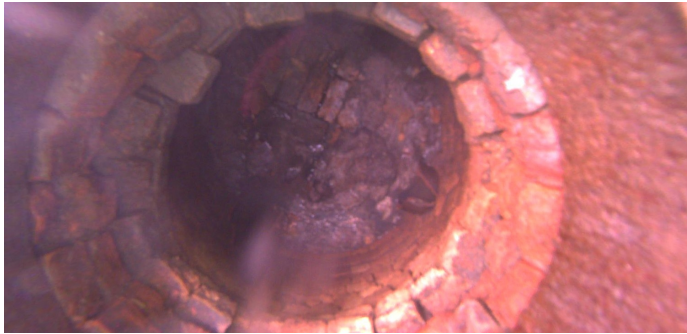
Code: **DB**  
Description: **Displaced Brick**

Distance (ft): **.0**  
Structural Grade: **3**  
O&M Grade: **0**  
Clock Start/From: **12**  
Clock To: **12**  
1st Value:  
2nd Value:  
Value Percent:  
Step: **NO**  
Remarks:

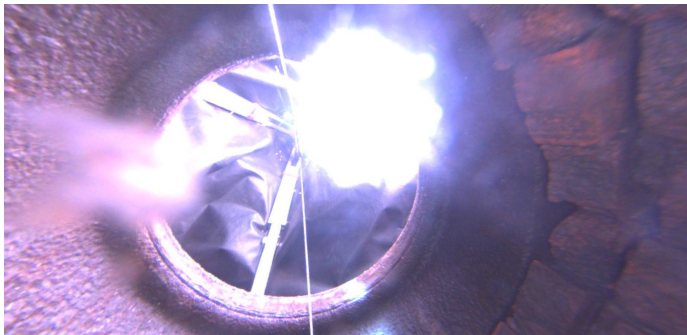
Code: **MGO**  
Description: **General Observation**

Distance (ft): **1.7**  
Structural Grade: **0**  
O&M Grade: **0**  
Clock Start/From:  
Clock To:  
1st Value:  
2nd Value:  
Value Percent:  
Step: **NO**  
Remarks: **UNDERSIDE OF FRAME**

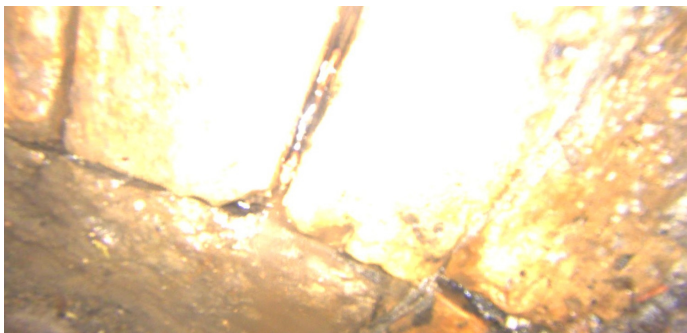
Code: **MGO**  
Description: **General Observation**

Distance (ft): **4.2**  
Structural Grade: **0**  
O&M Grade: **0**  
Clock Start/From:  
Clock To:  
1st Value:  
2nd Value:  
Value Percent:  
Step: **NO**  
Remarks: **END SURVEY**
