Manhole Inspection Report

Date:	04/27/2018	Weather:		Coding:	RZMACP
MH#:	M-705-021	Owner:	NA	Len. Surveyed:	7.1
P.O.#:		Surveyor:	Jen Costello	Rim to Invert:	6.6
Customer:		Cert. #:	U-907-5518	Wall Material:	Concrete (reinforced)

Street:	Intersection of Water St. and 6th St.	Project:	Hobart, IN
City:	Hobart, IN	GPS Northing:	41.52903748
Location:		GPS Easting:	-87.2559433
Drain Area:	South	GPS Accuracy:	Nearest Meter
Cover Shape:	Circular	Evidence of Surcharge:	No
Cover Size:	22.5	Potential for Runoff:	None
Comments:

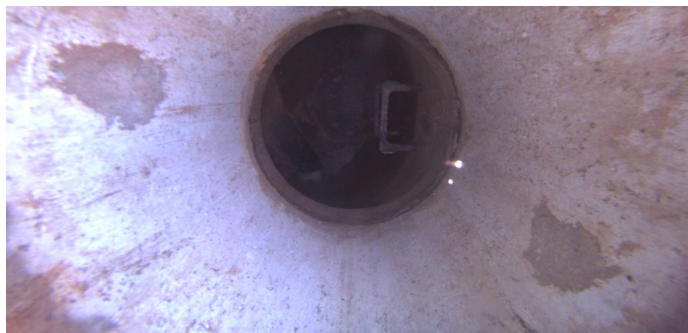
Code: **MGO**
Description: **General Observation**

Distance (ft): **1.0**
Structural Grade: **0**
O&M Grade: **0**
Clock Start/From:
Clock To:
1st Value:
2nd Value:
Value Percent:
Step: **NO**
Remarks: **ACCESS MH**

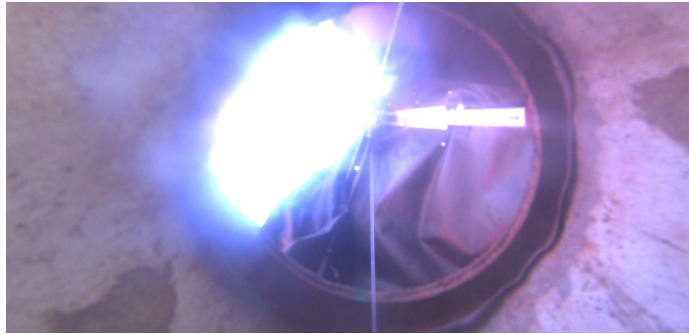
Code:	MGP
Description:	General Photo
Distance (ft):	2.9
Structural Grade:	0
O&M Grade:	0
Clock Start/From:	
Clock To:	
1st Value:	
2nd Value:	
Value Percent:	
Step:	NO
Remarks:	UNDERSIDE OF FRAME

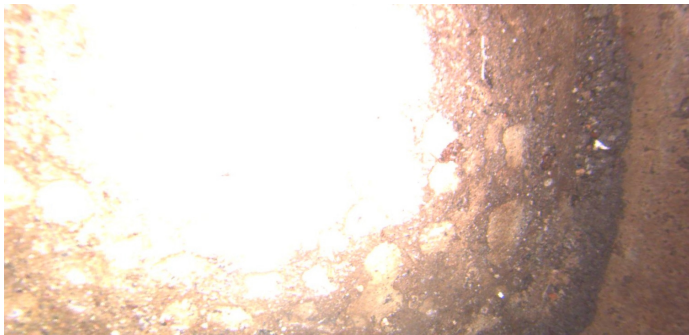
Code:	MGO
Description:	General Observation
Distance (ft):	7.1
Structural Grade:	0
O&M Grade:	0
Clock Start/From:	
Clock To:	
1st Value:	
2nd Value:	
Value Percent:	
Step:	NO
Remarks:	END SURVEY
